INTRODUCTION

GENERAL CONDITION OF BUILDING

The building is an east facing two-story masonry structure on slab with a flat (mansard) type roof design. The building was constructed circa 1923. The building had been extensively renovated circa 2000 - 2003.

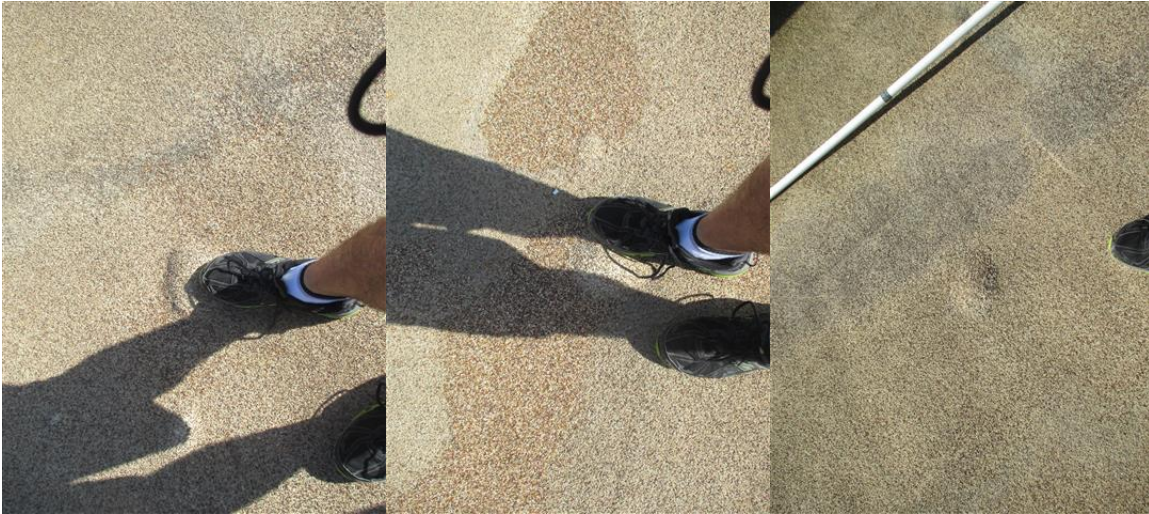
Repair Needed: We noted some blistering to the foam roofing material near the midpoint of the roof.

Recommendation: A licensed roofing contractor should complete any necessary repairs to this roof.

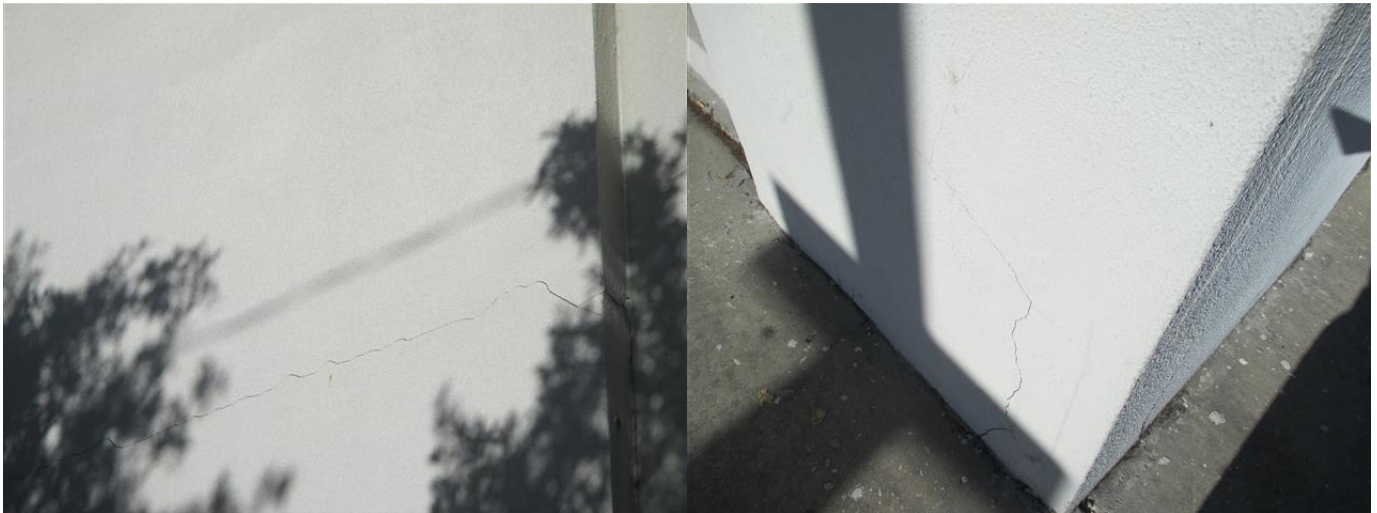
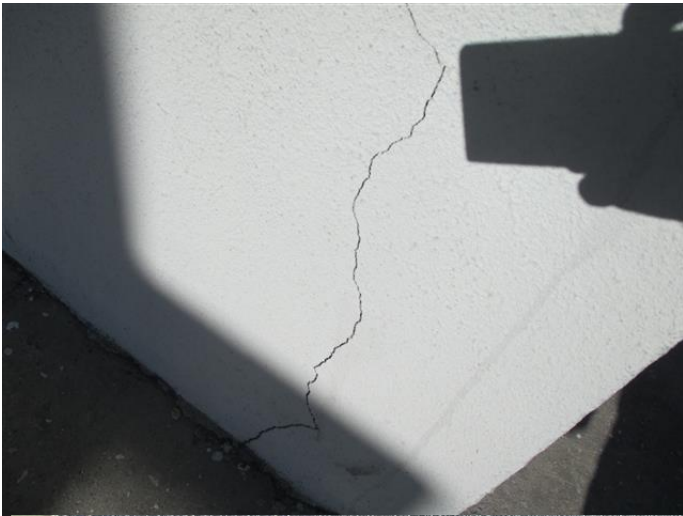
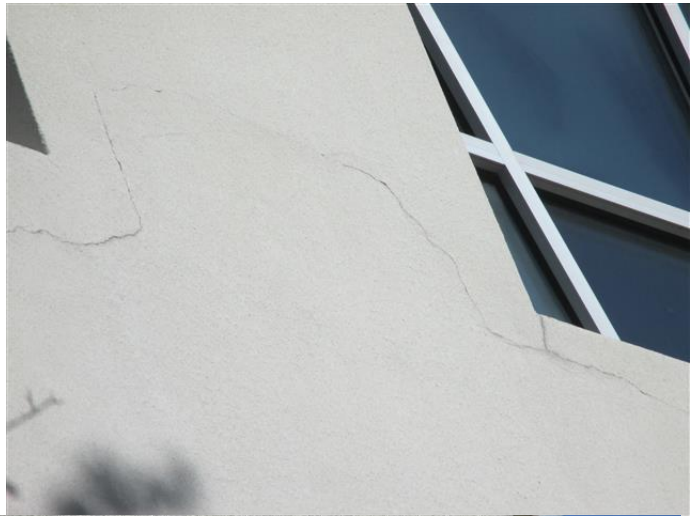
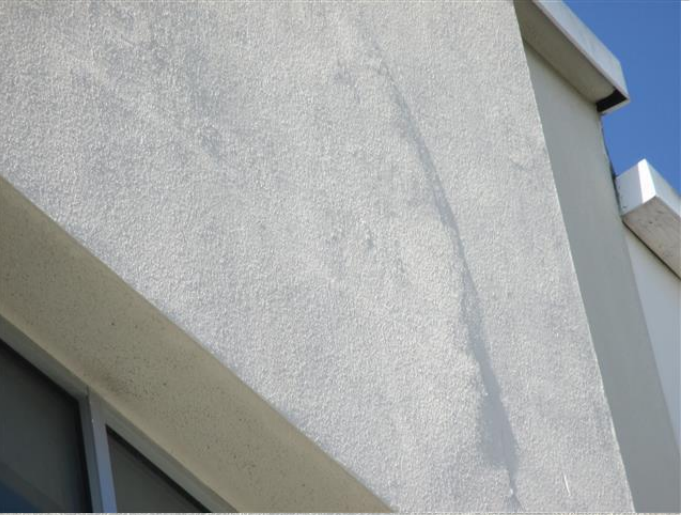
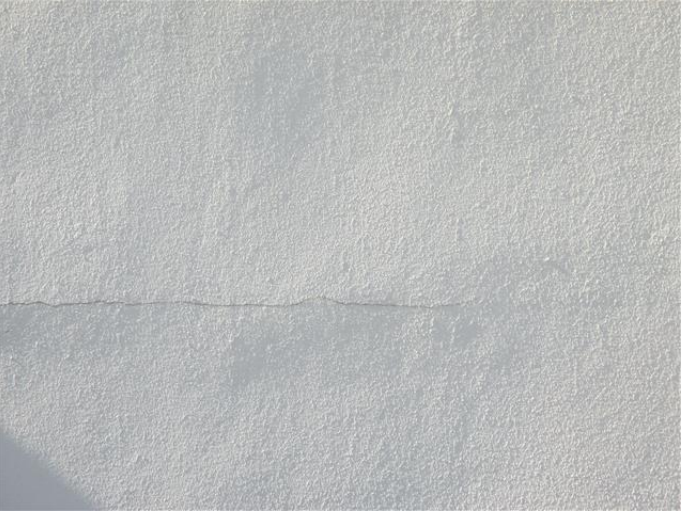
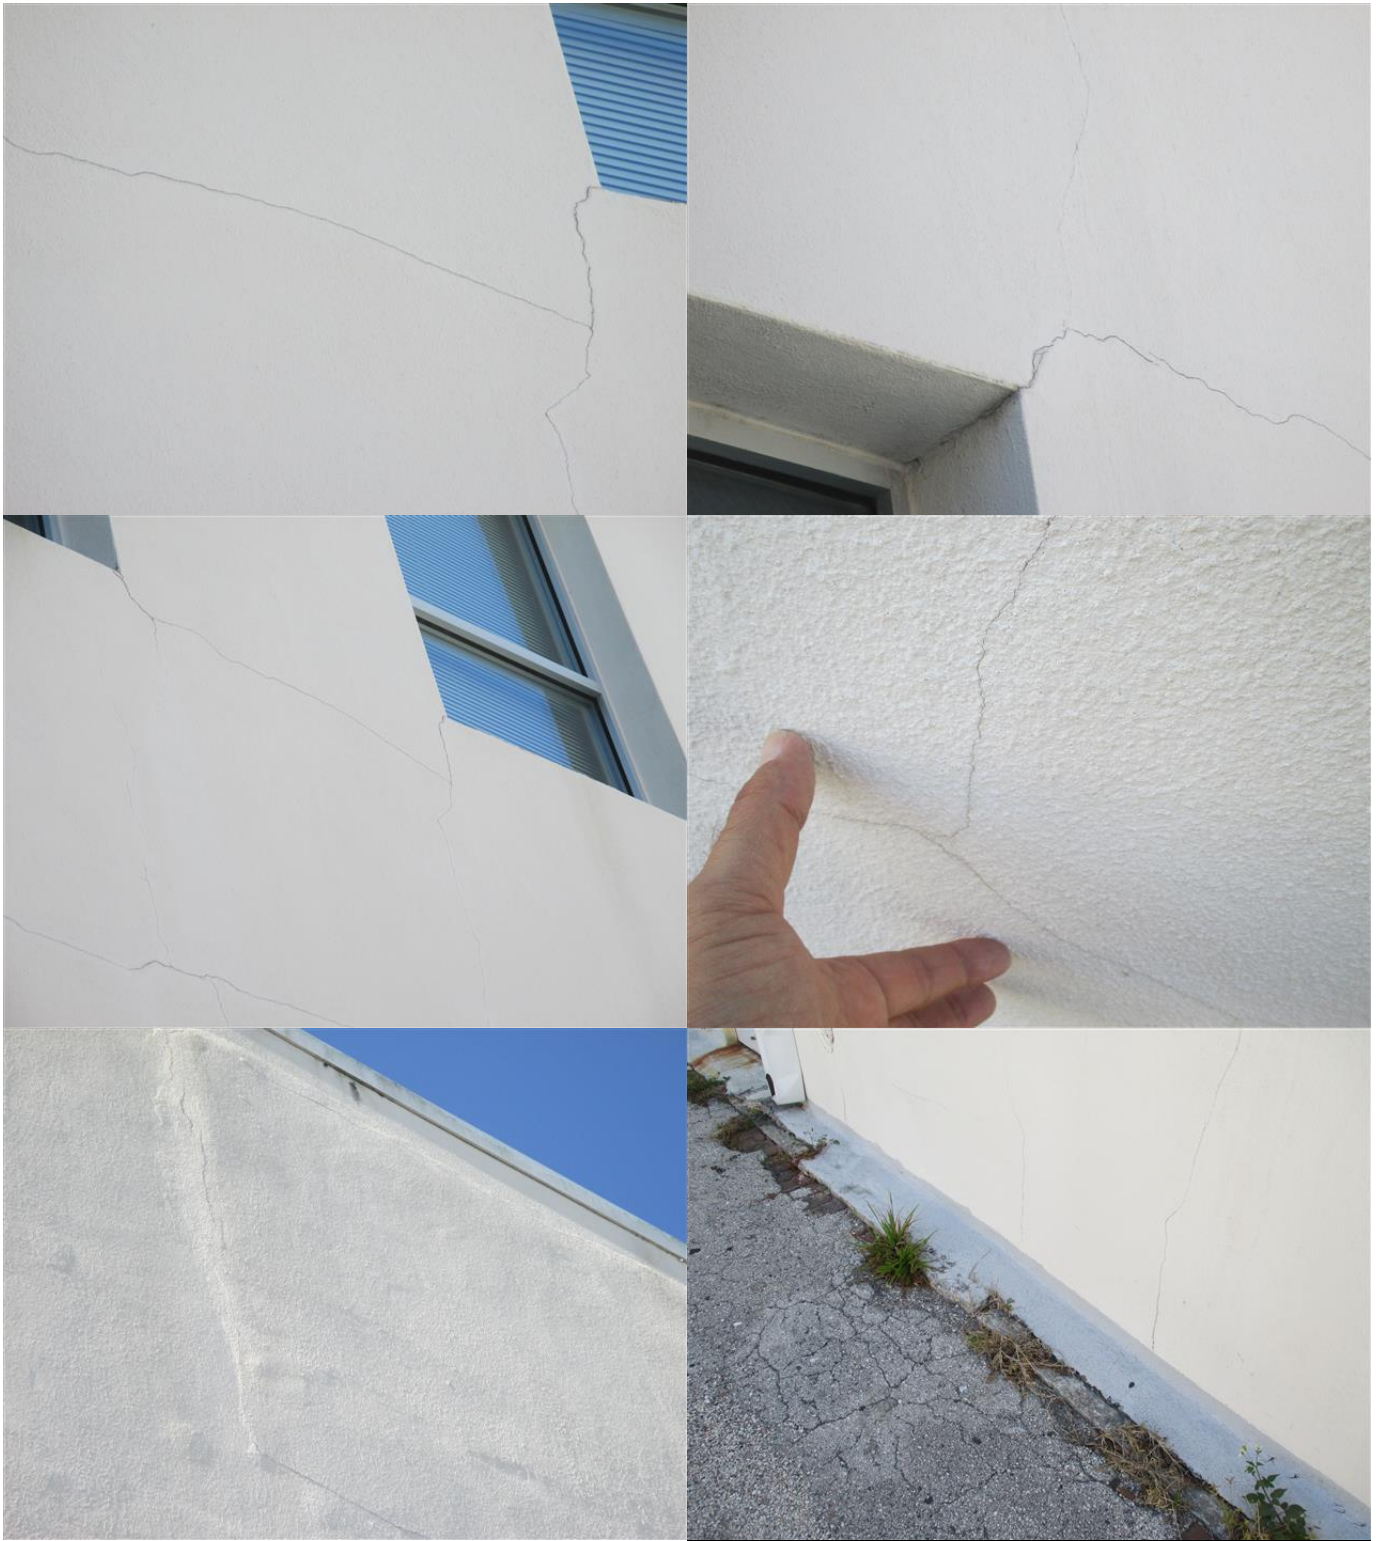
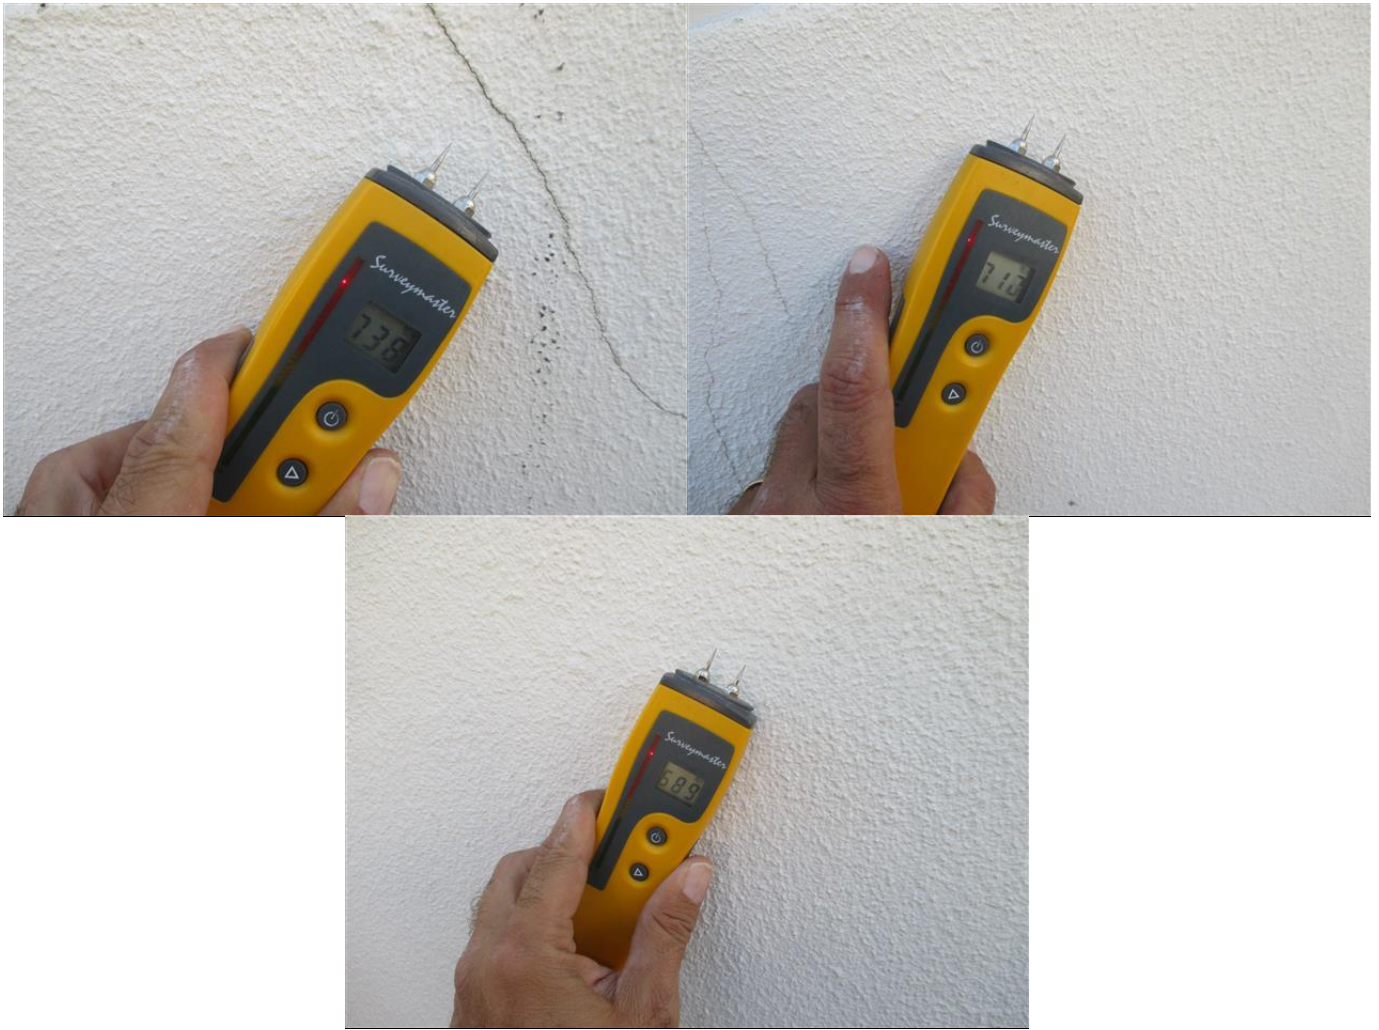
Replacement Needed: We noted numerous cracks and deterioration to the stucco around the perimeter of the building (see below). We noted evidence of moisture intrusion at many of the cracks (electronic moisture meter). The stucco siding had been installed without the proper weep screeds to allow the stucco drain any water that enters between the siding and the exterior wall. The stucco condition is such that it is not repairable and will likely need to be removed and replaced on the entire exterior of the building. We recommend contacting a licensed stucco contractor for further evaluation of the siding. Any new stucco siding should comply with current standards for installation, particularly in regards the horizontal drainage. Sufficient control joints should also be added to minimize further cracking in the stucco.

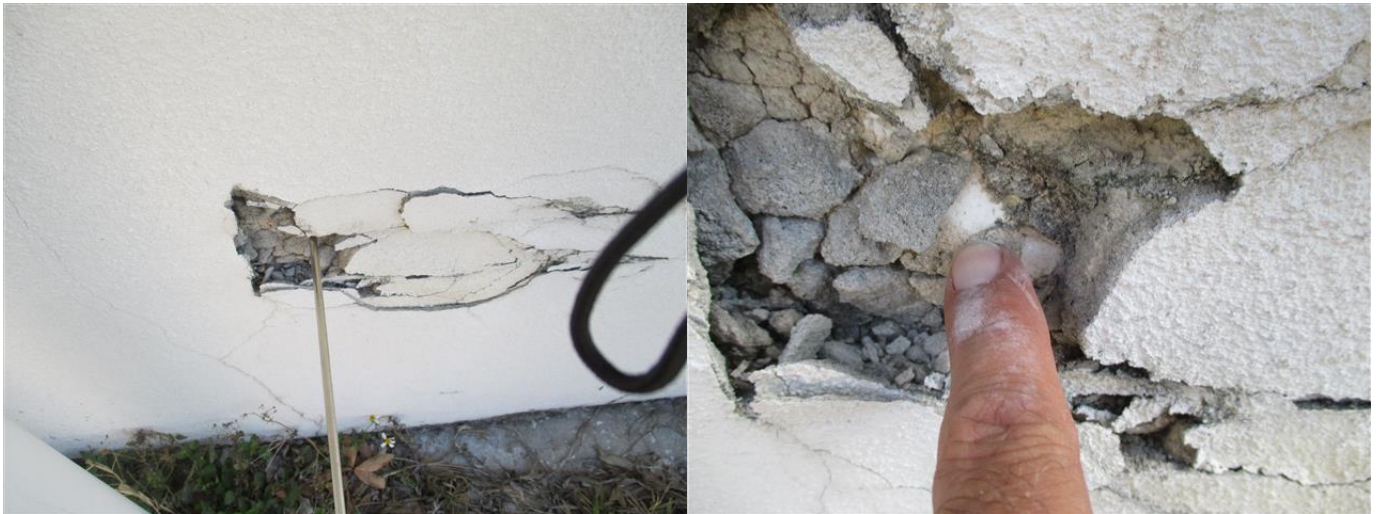
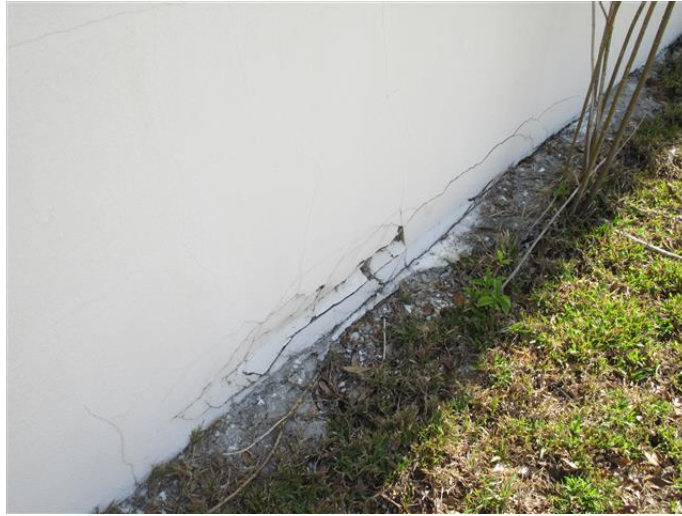
Repair Needed: We noted mechanical damage to some of the stucco on the west and south elevations.

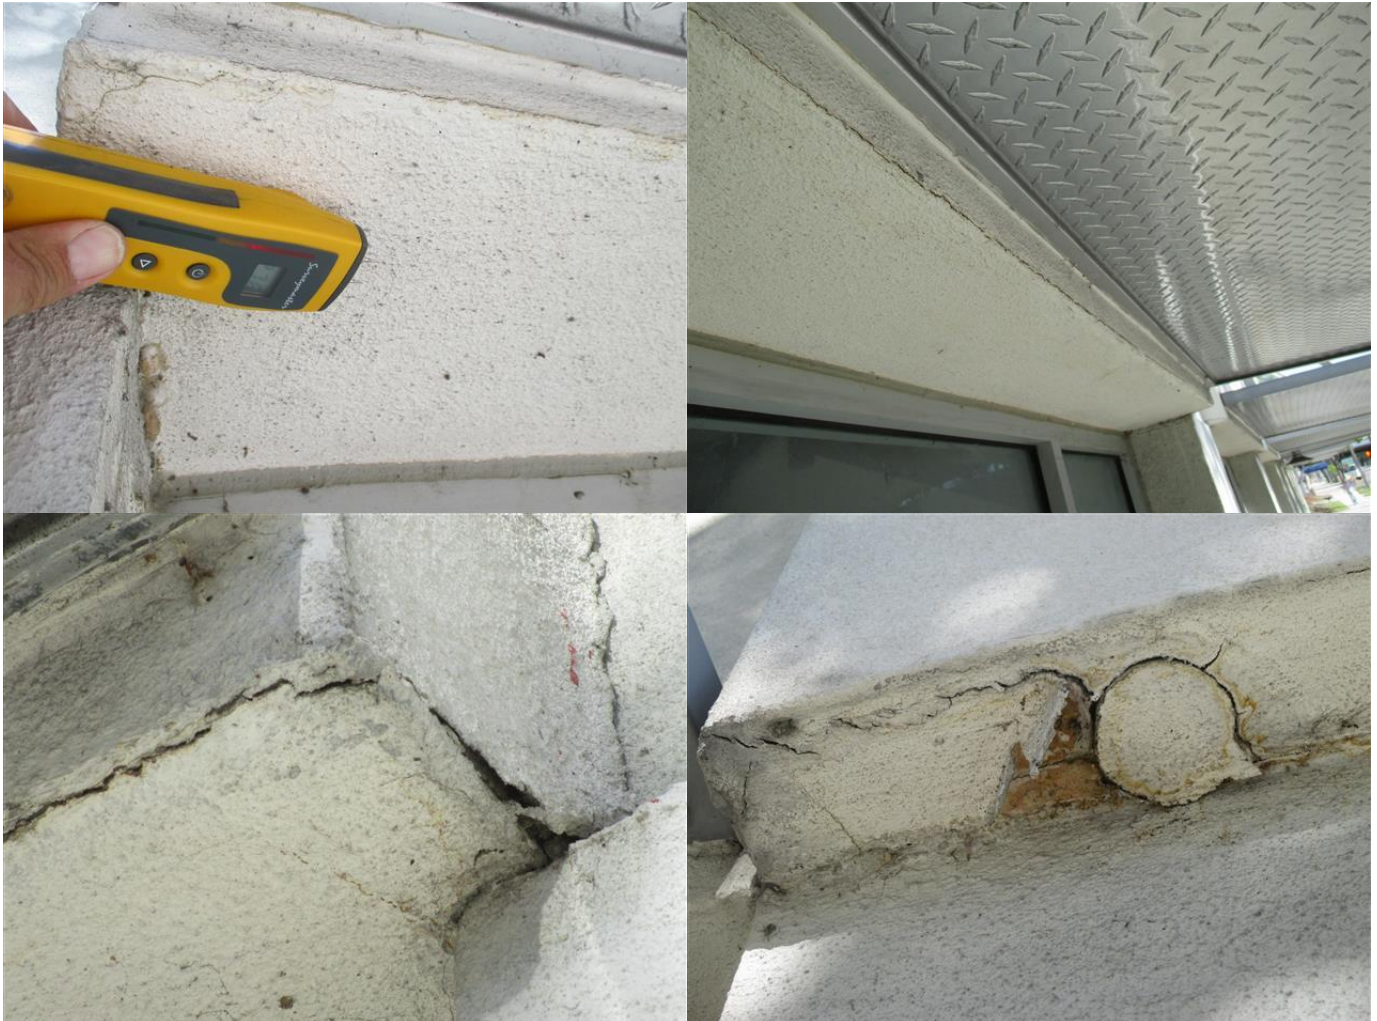
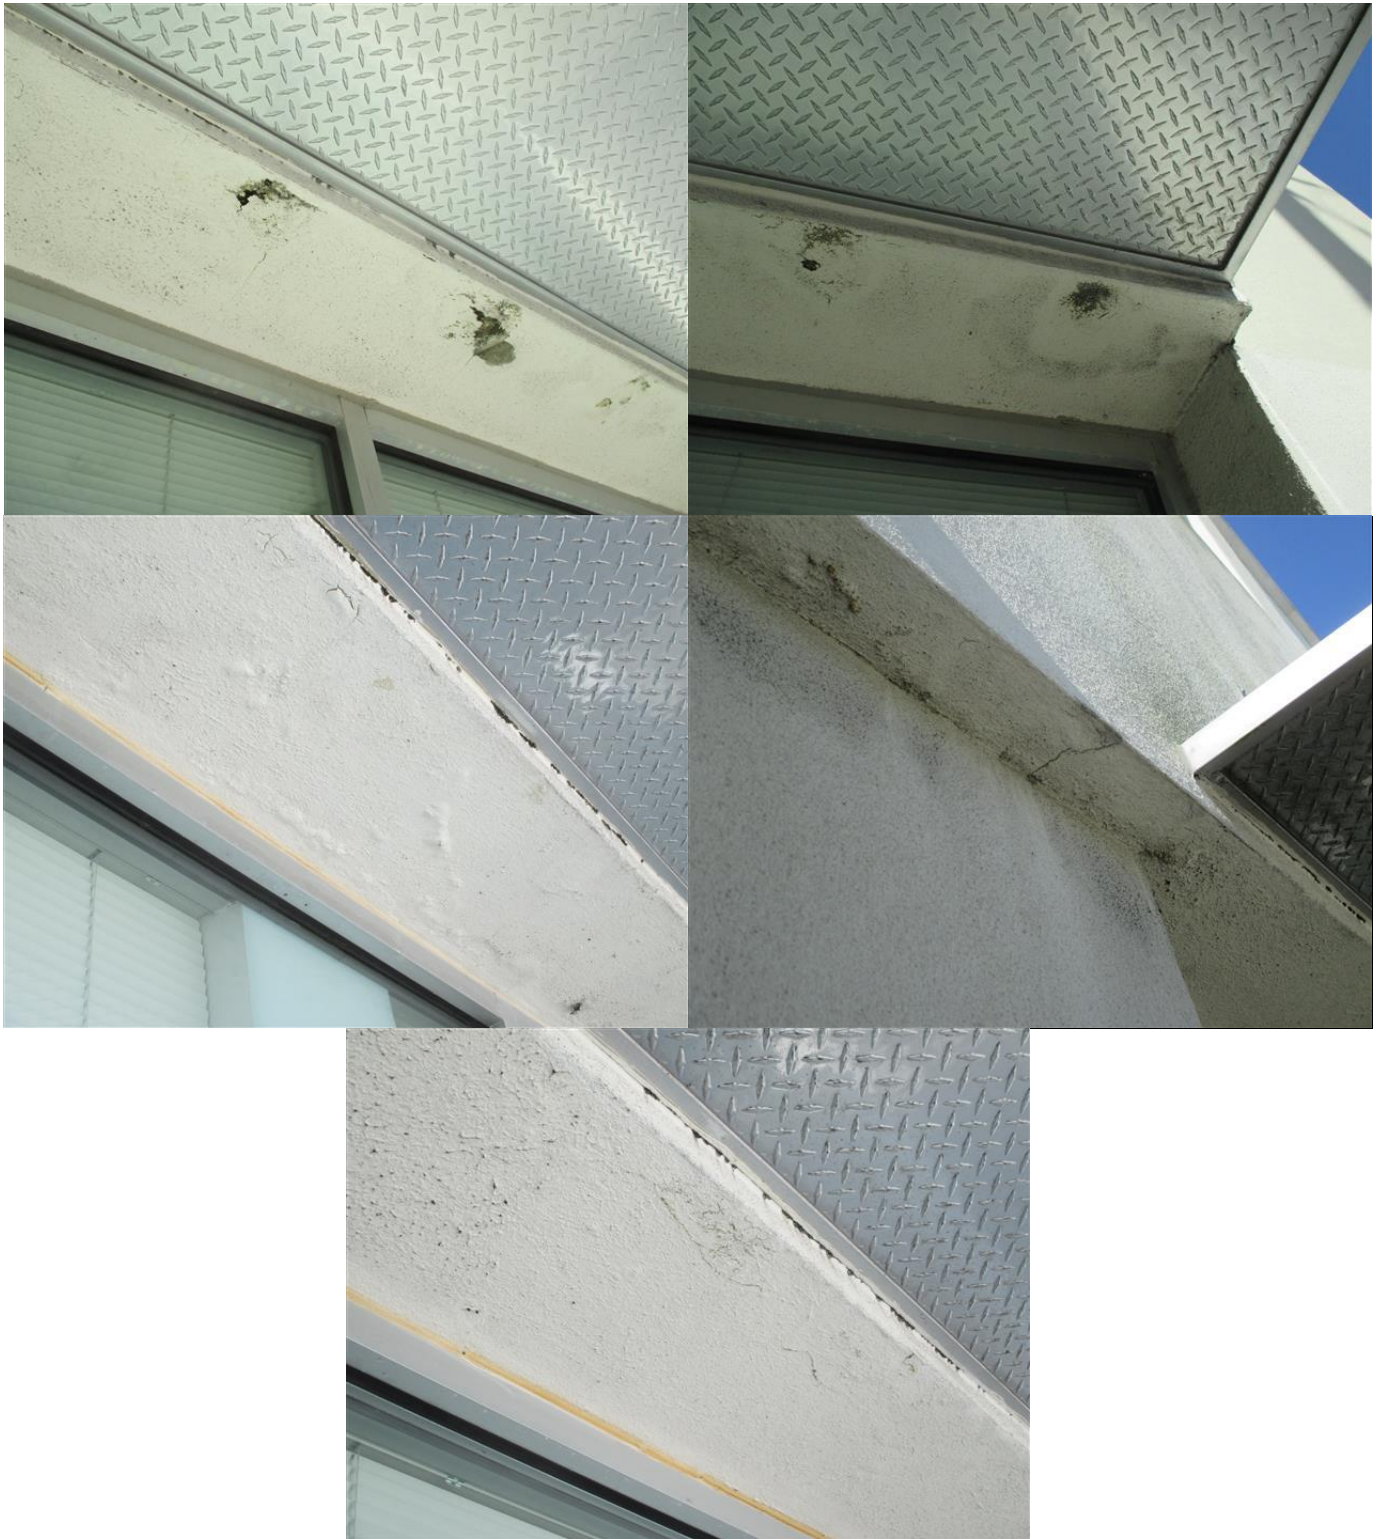
Concern Item: Along the east elevation, we noted staining and deterioration to the stucco banding running along the door and window openings on the first floor. This indicates areas of moisture intrusion (also detected with an electronic moisture meter). The moisture also appears to be penetrating into the interior stucco columns along the elevation (also see Interior notes).

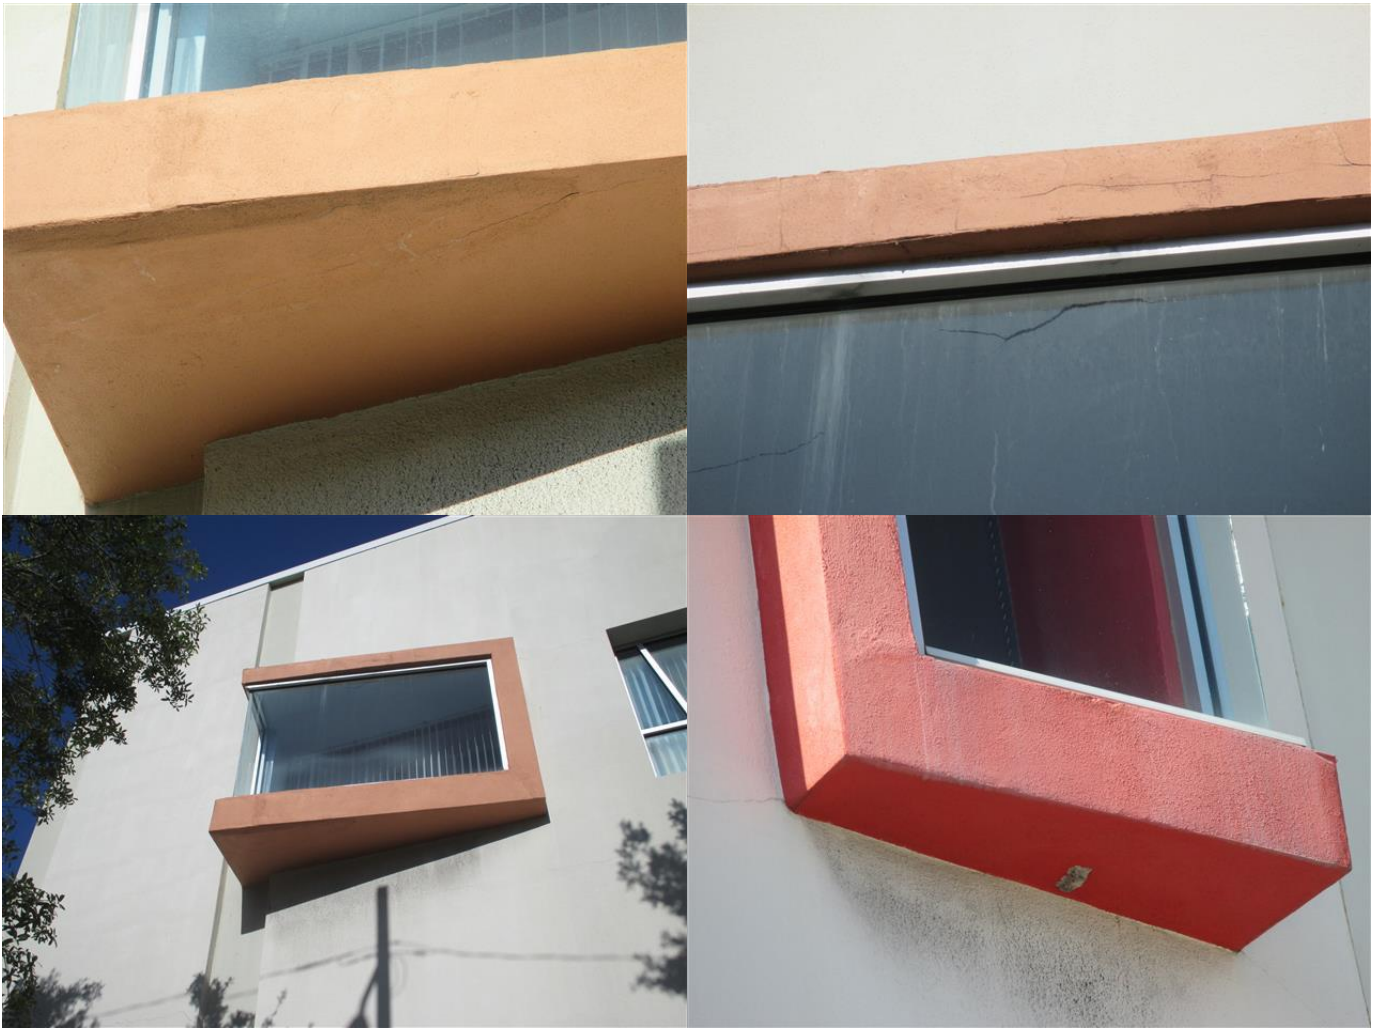
Repair Needed: We noted staining and deterioration to the stucco for the built out windows at the southeast and northwest corners of the second floor, indicating areas of active moisture intrusion (also see Interior notes). Because these areas are likely framed, we recommend removing the stucco to allow further inspection of the framing and sheathing.

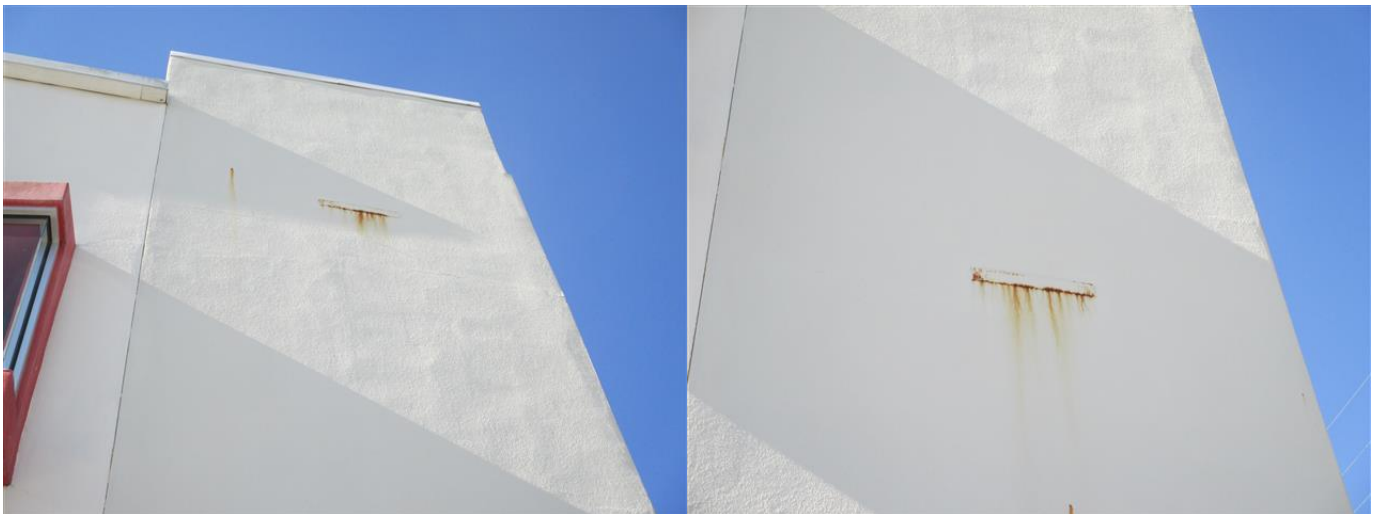
Maintenance Needed: We noted corrosion to the metal bars installed along the northwest corner of the building. The metal should be treated and sealed prevent further deterioration.

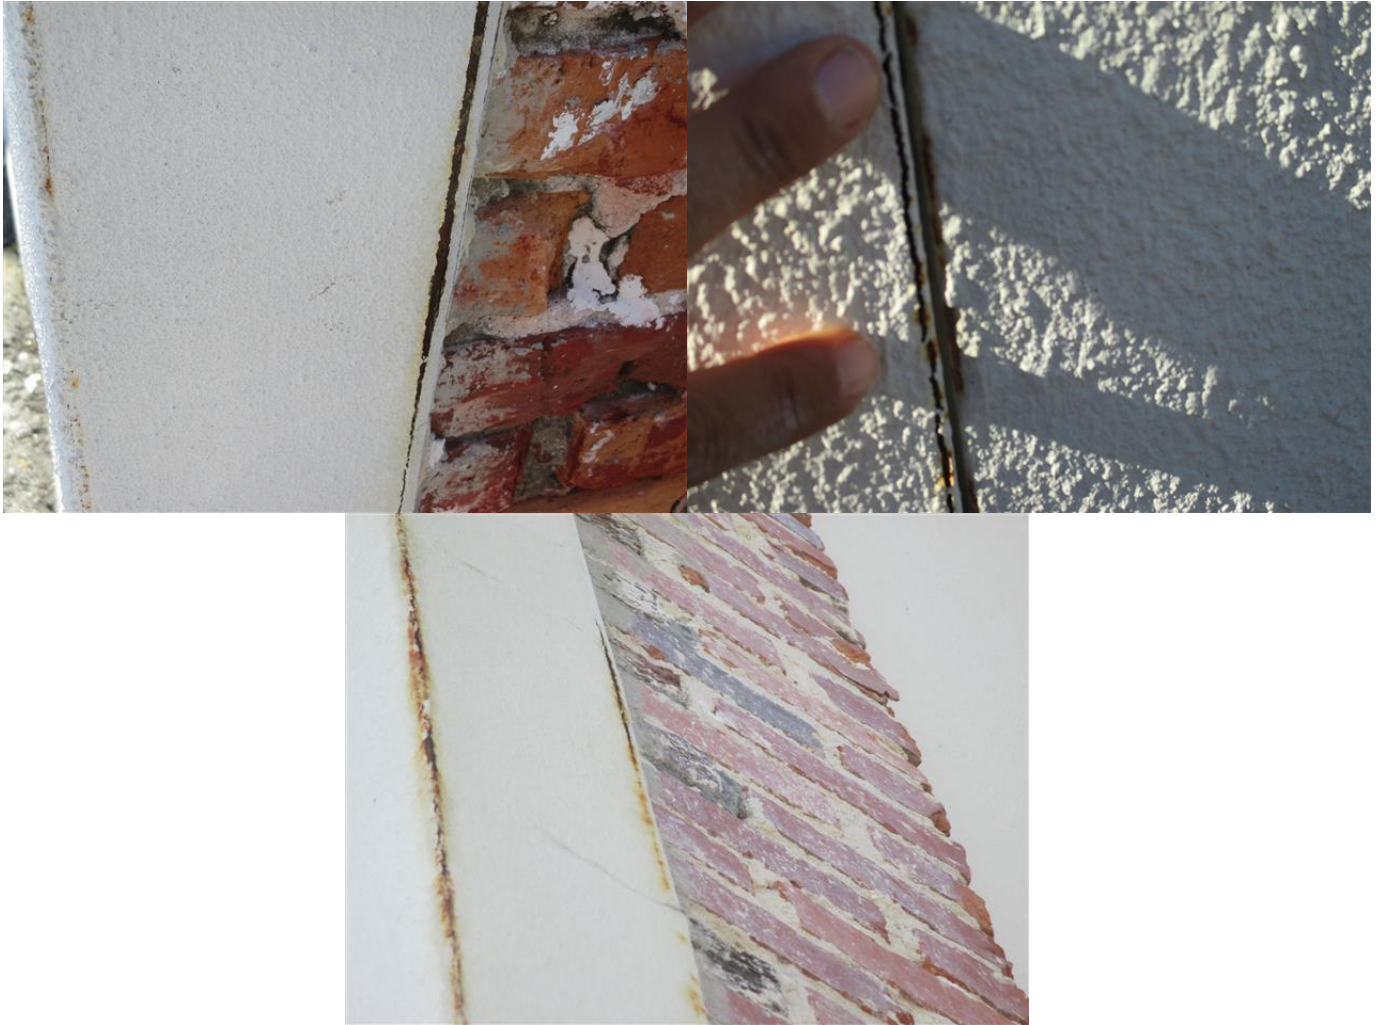
Repair Needed: The control joint near the northwest corner of the building was heavily corroded and should be removed and replaced.

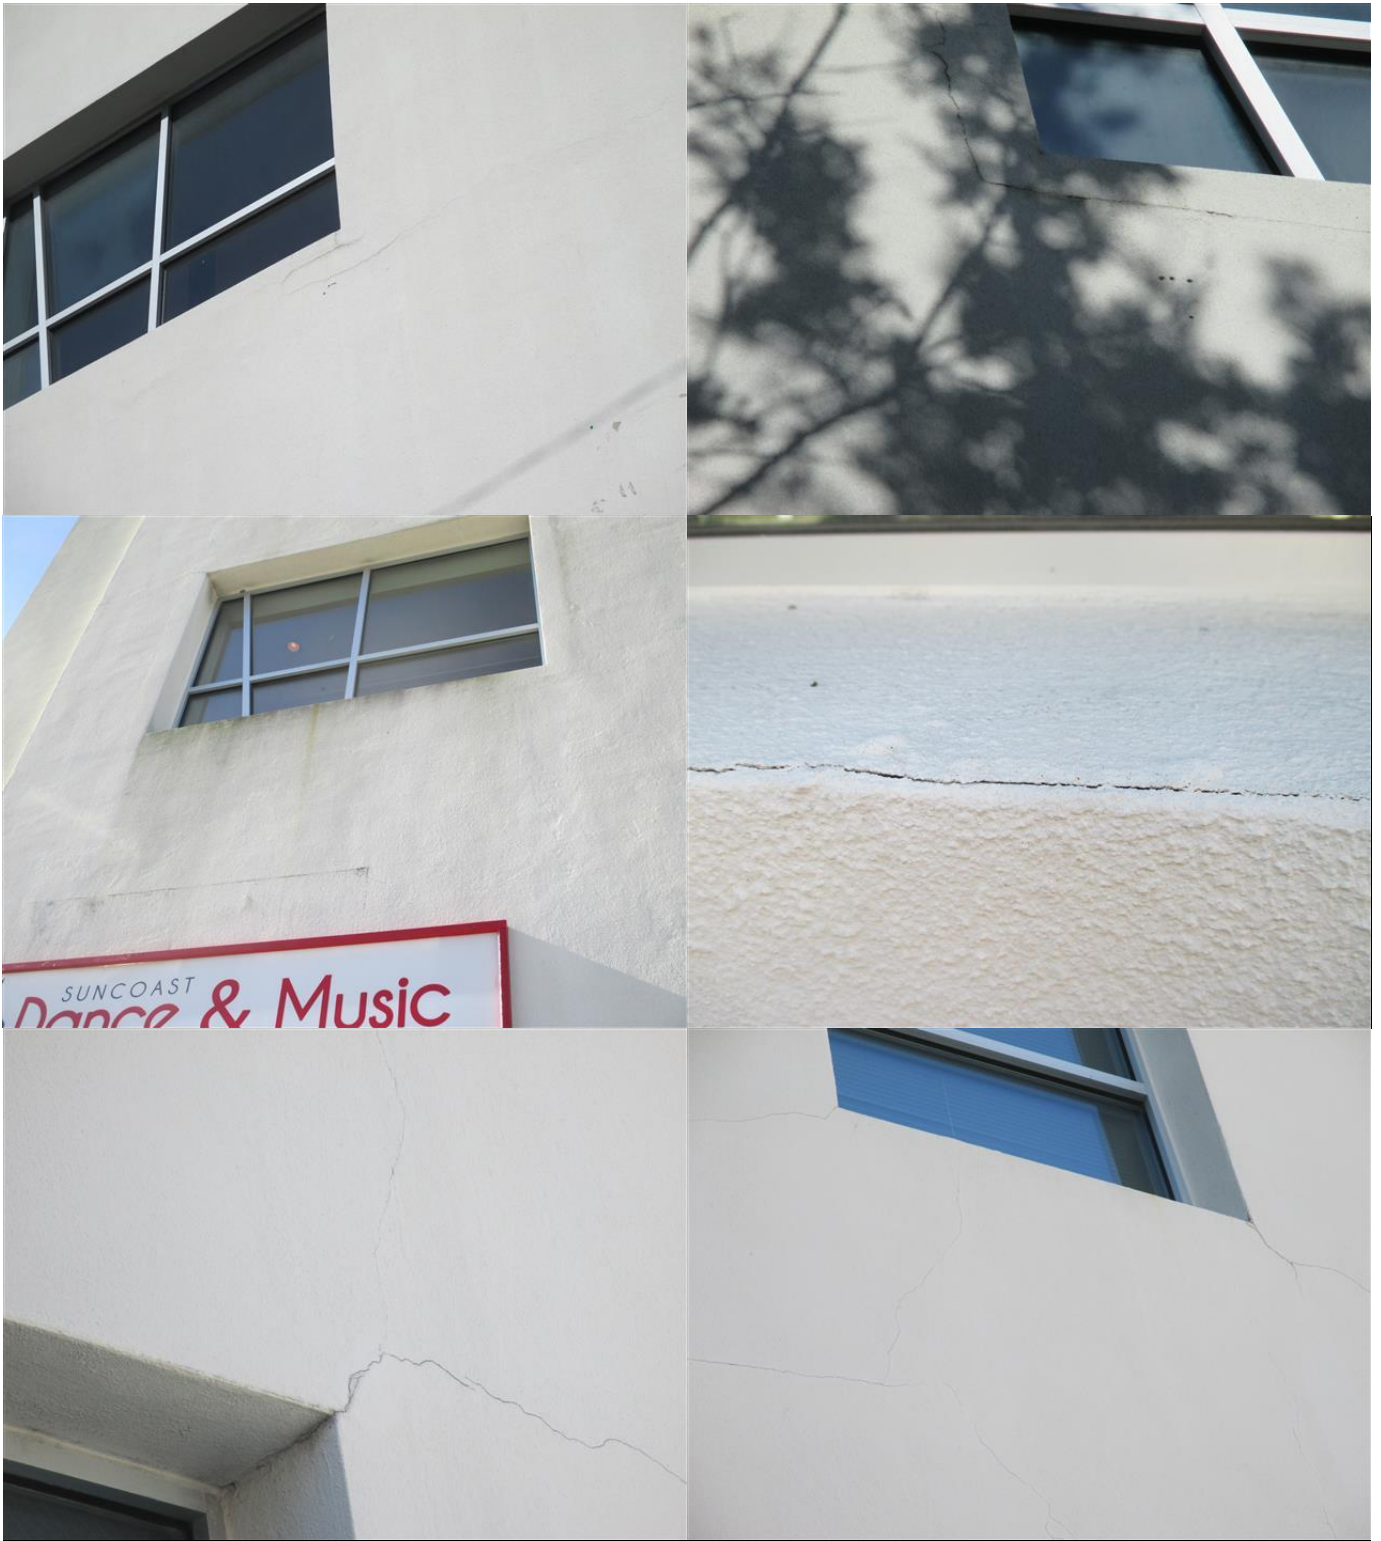
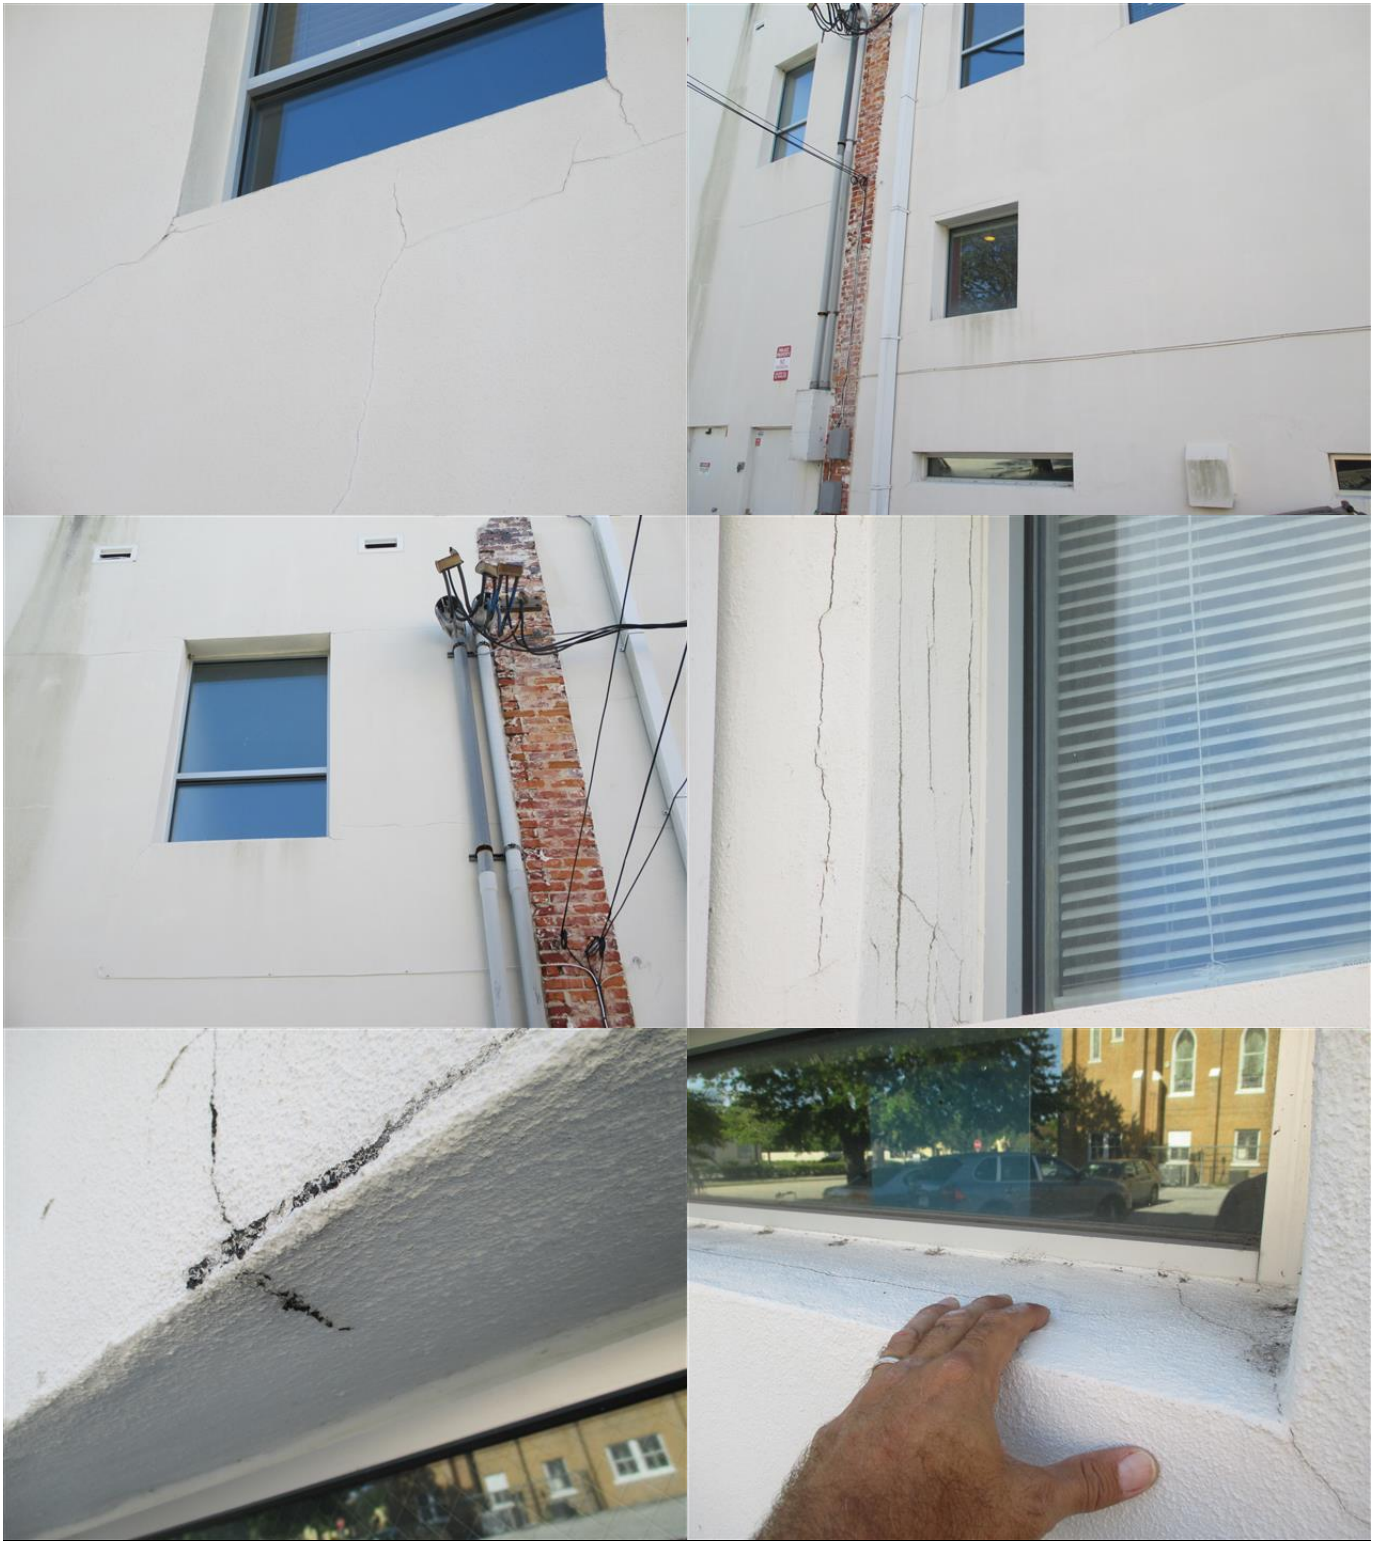
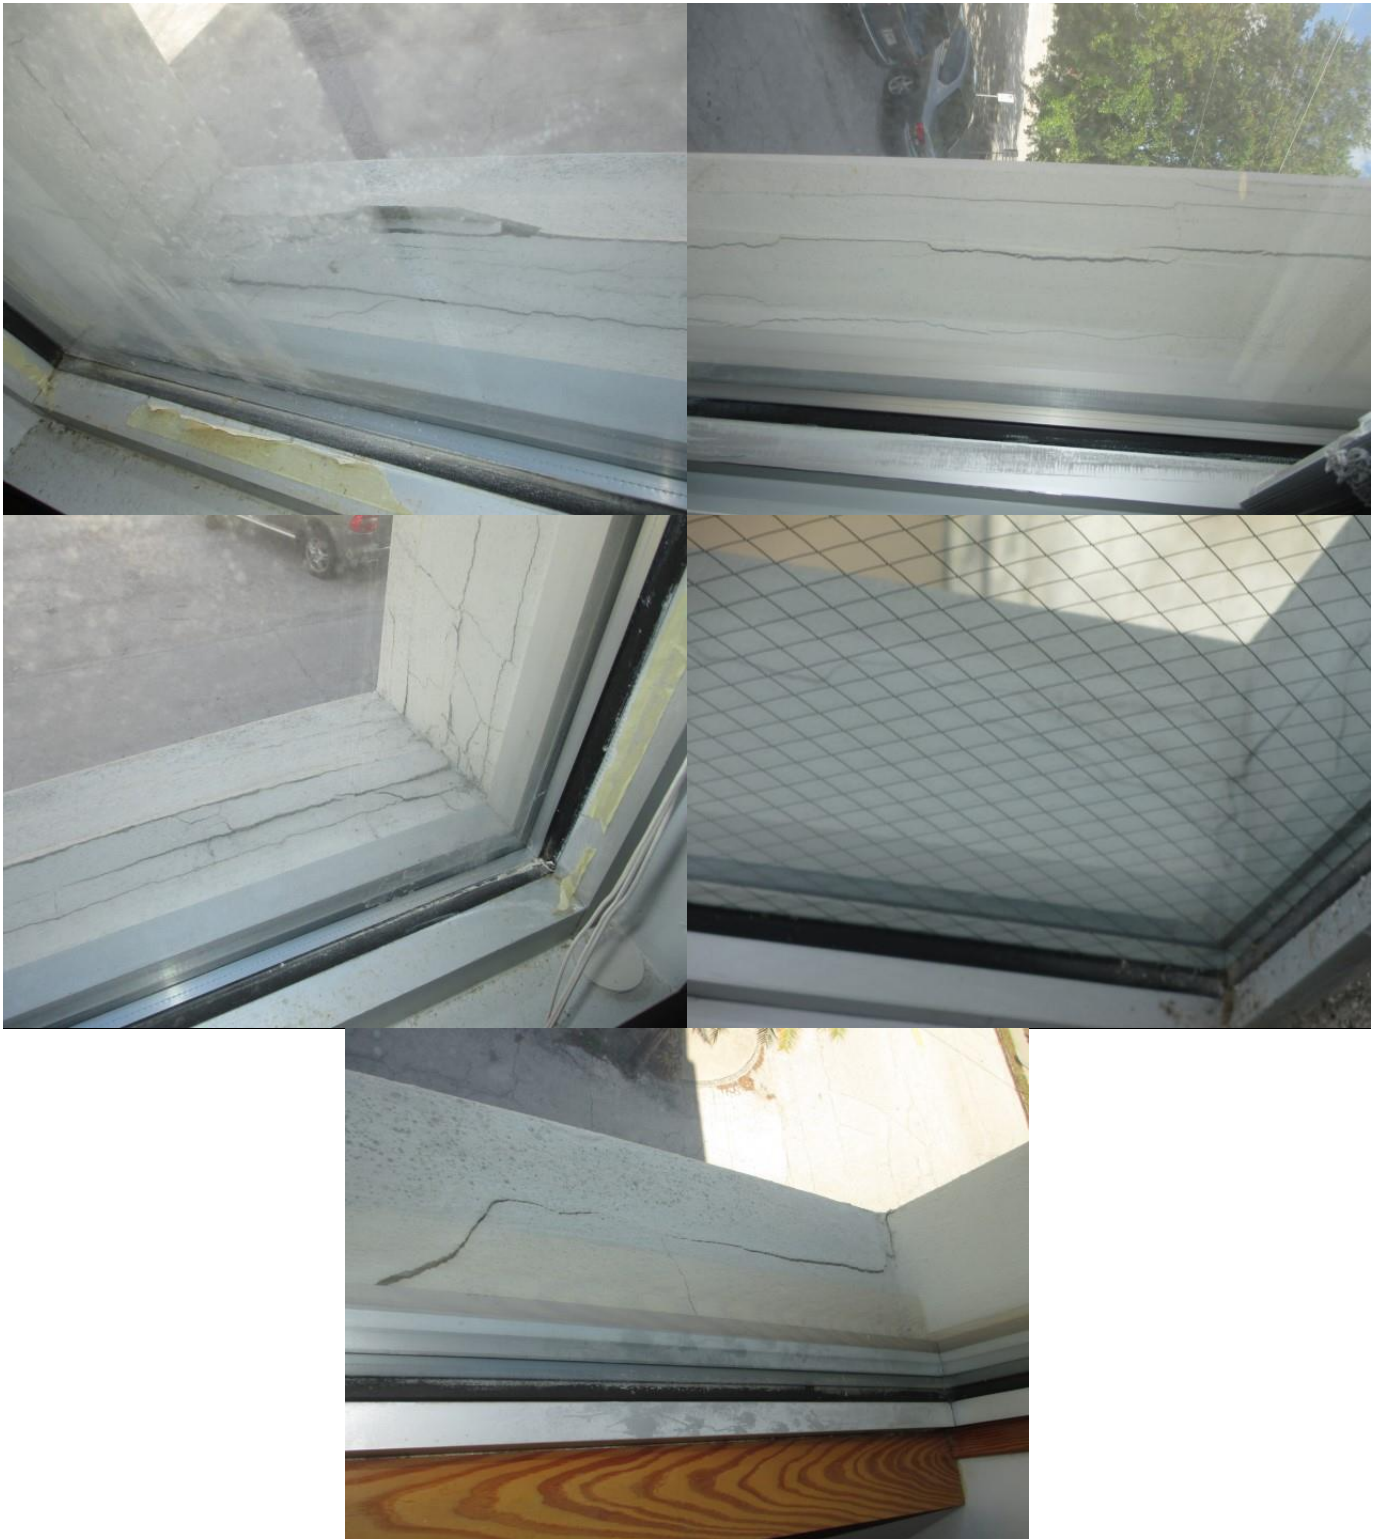
Correction Needed: We noted cracks in the stucco for most of the window openings. Many of the window openings also showed signs of staining, indicating moisture intrusion at the openings. The openings did not have windowsills installed, which appears to be allowing moisture to penetrate through the stucco and into the wall cavity between the siding and the exterior wall. Either windowsills should be added to the openings or a flashing should be installed at the bottom of the openings to prevent moisture intrusion behind the stucco.

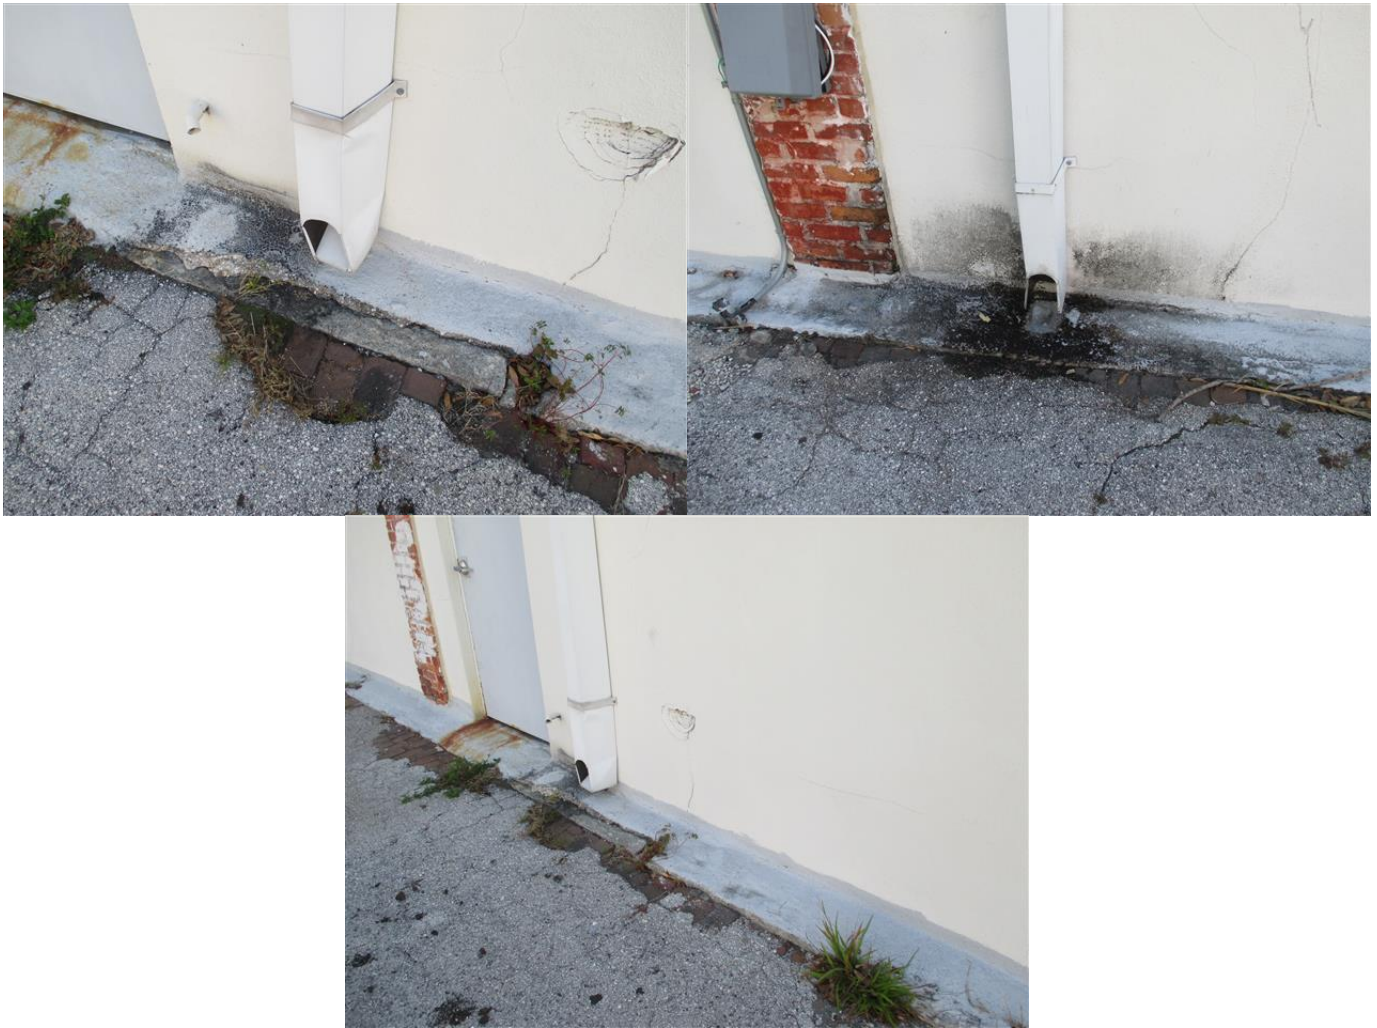
Correction Needed: The gutters connected to the scupper drains should be extended so they discharge a minimum of 12 inches away from the foundation.
