INTRODUCTION

GENERAL CONDITION OF BUILDING

The building is an east facing two-story masonry structure on slab with a flat (mansard) type roof design. The building was constructed circa 1923. The building had been extensively renovated circa 2000 - 2003.

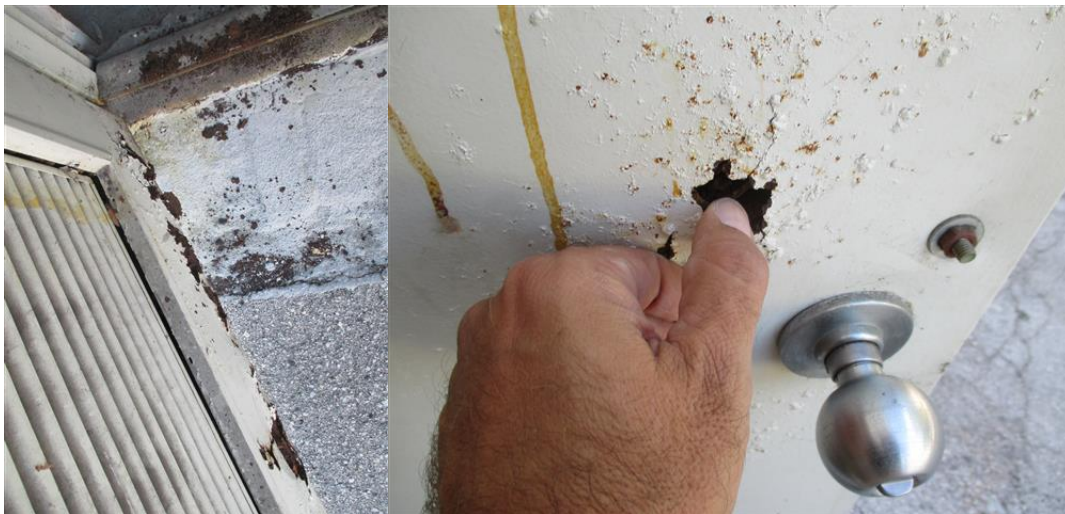
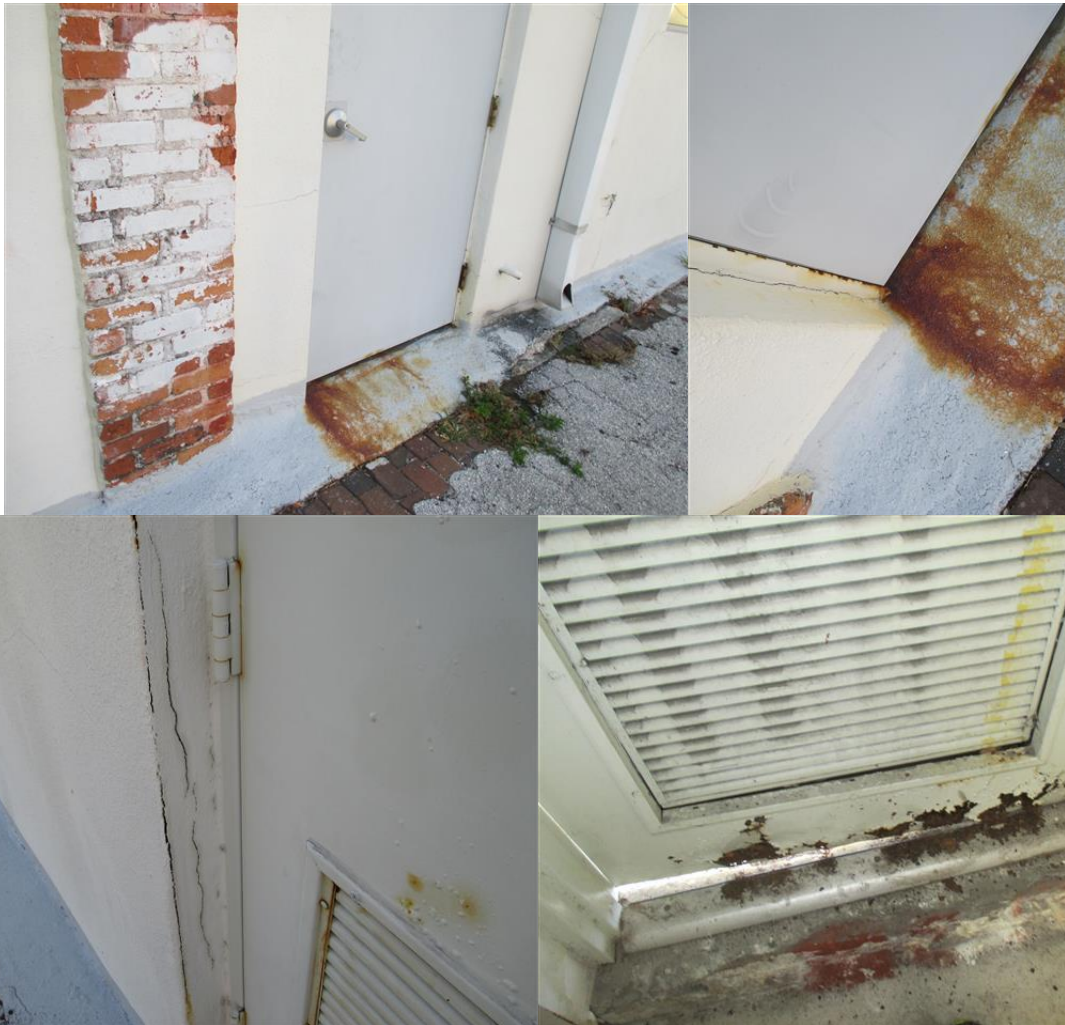
Repair Needed: The exterior doors along the west elevation were heavily corroded and will need either repair or replacement.

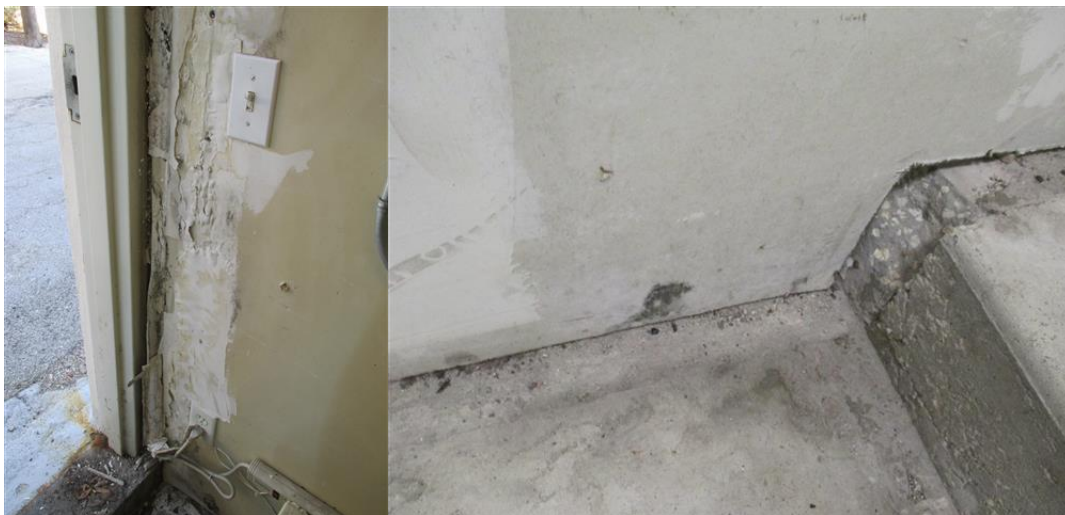
Repair Needed: We noted damage and detected active moisture intrusion in the drywall at the doorway for the electrical room on the west elevation. We also noted what appeared to be mold on some of the drywall (on both sides of the wall). We recommend having a licensed mold assessor evaluate the area of prior to any repairs.

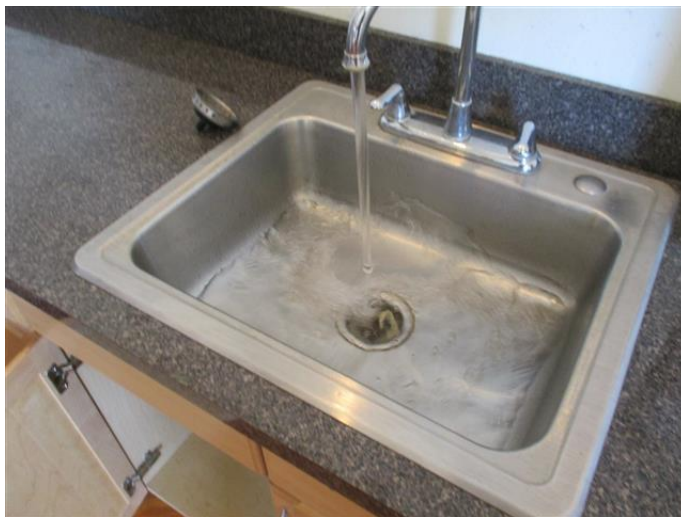
Further Evaluation Needed: We noted that the sink in suite 200 was very noisy when draining, which may indicate that the sink does not have sufficient venting. A licensed plumbing contractor should be contacted for further evaluation.

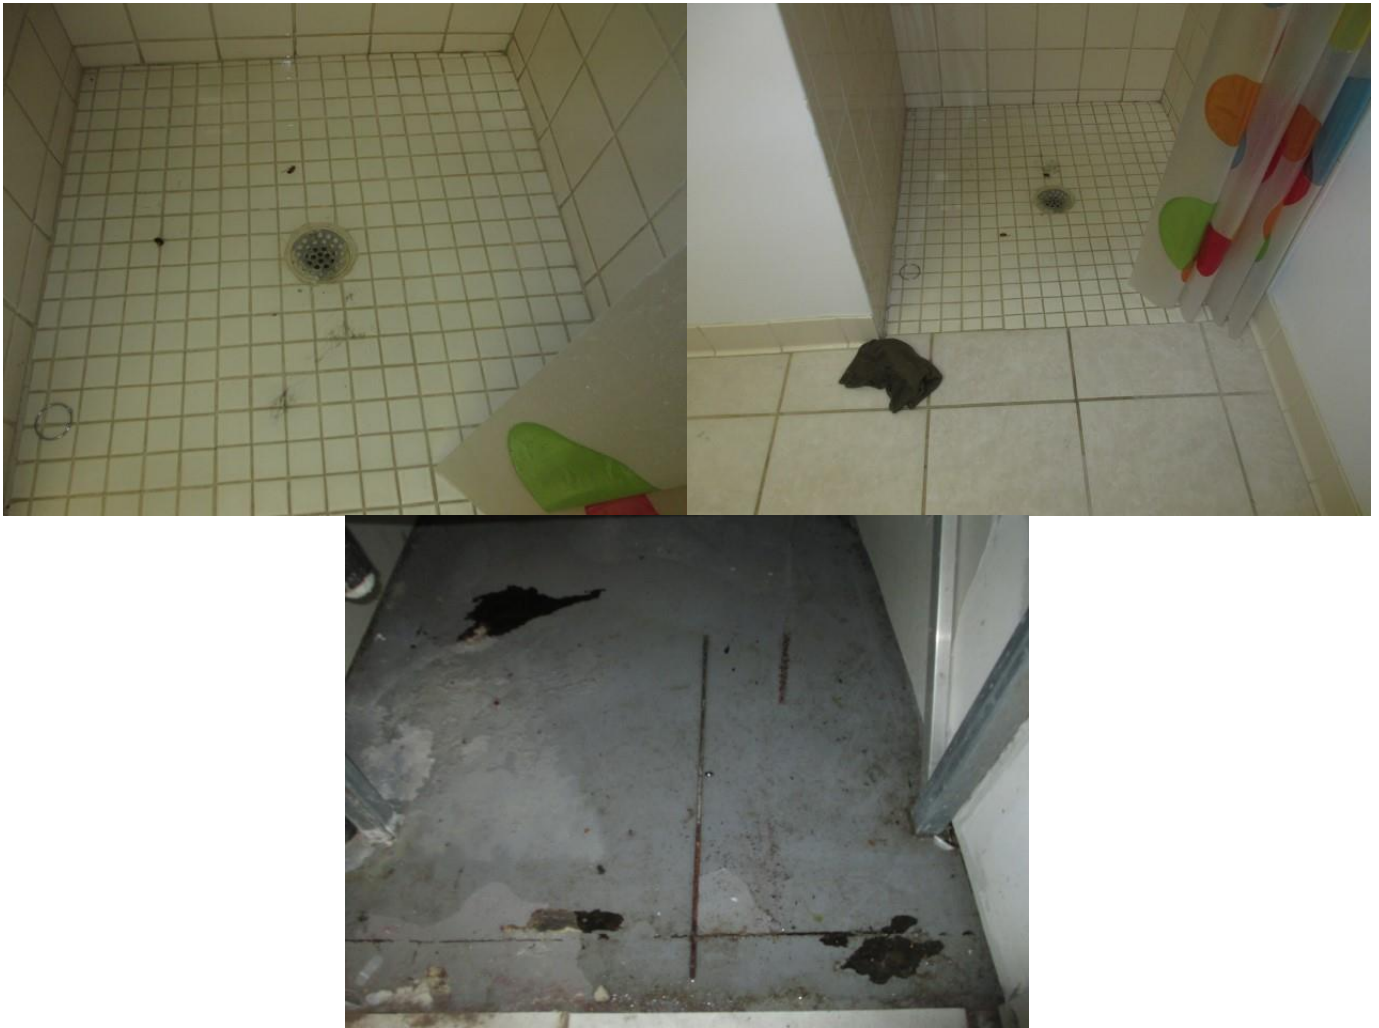
Correction Needed: The shower was not equipped with the threshold and was draining slowly in the southwest second-floor bathroom. This allowed water to flow onto the bathroom floor. It also appeared that the shower did not have a drain pan installed as we noted water in the air handler closet behind the wall (in break room area).

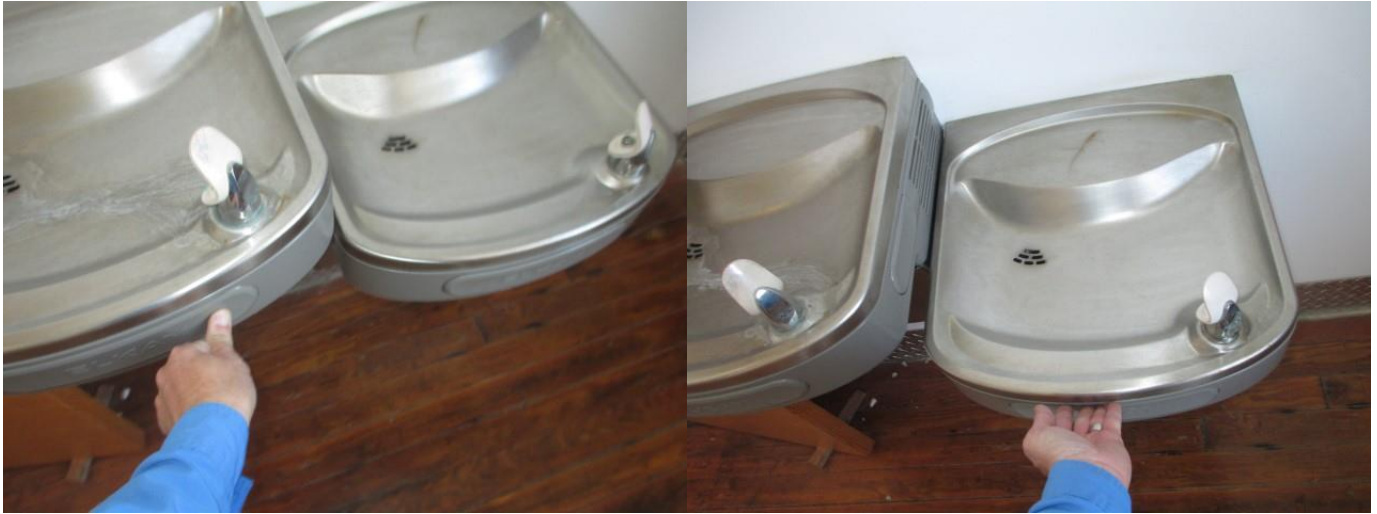
Repair Needed: The water fountains were not operational north third-floor stairwell.

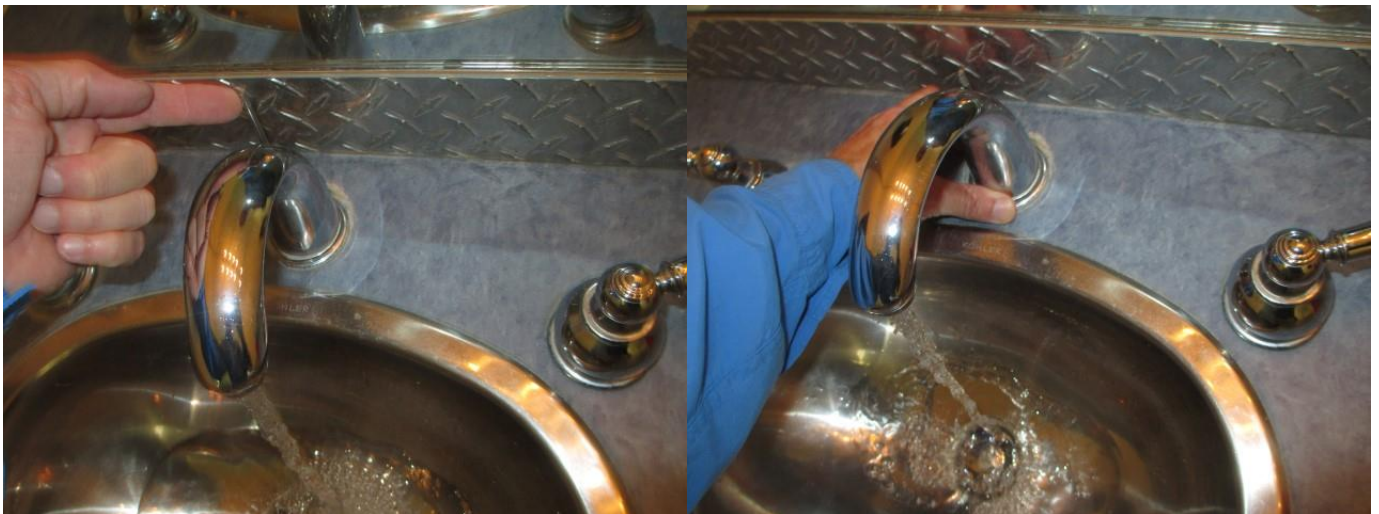
Repair Needed: The drain stop knob was missing in the faucet was loose on the left women's bathroom sink in the 1st floor dance studio.

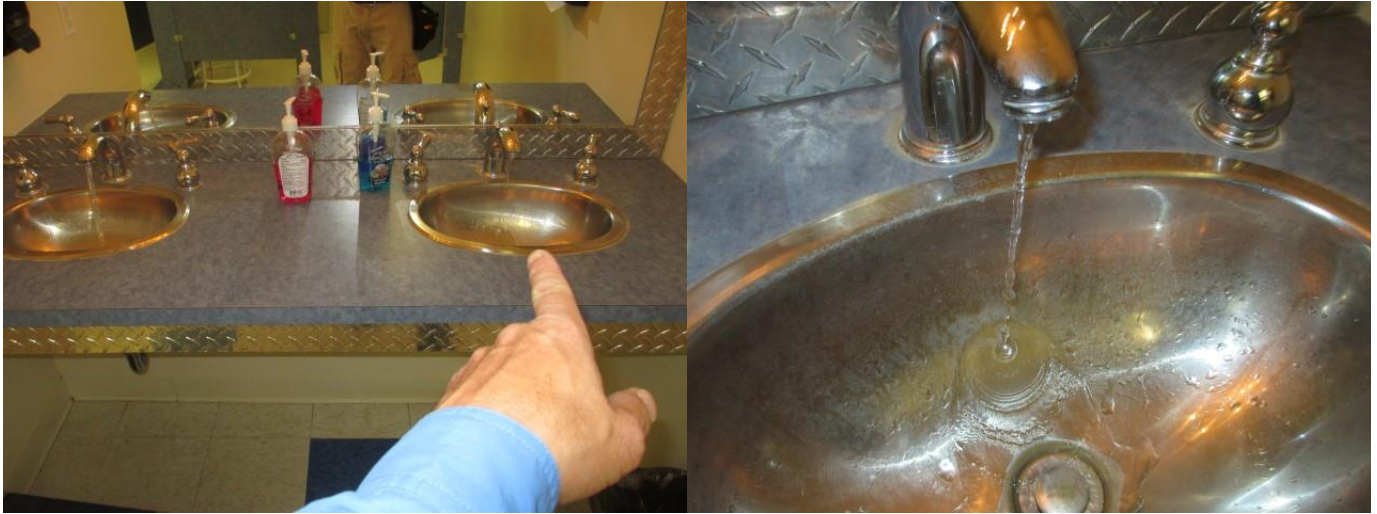
Repair Needed: We noted low flow from the hot control to the faucet on the right women's bathroom sink in the 1st floor dance studio.

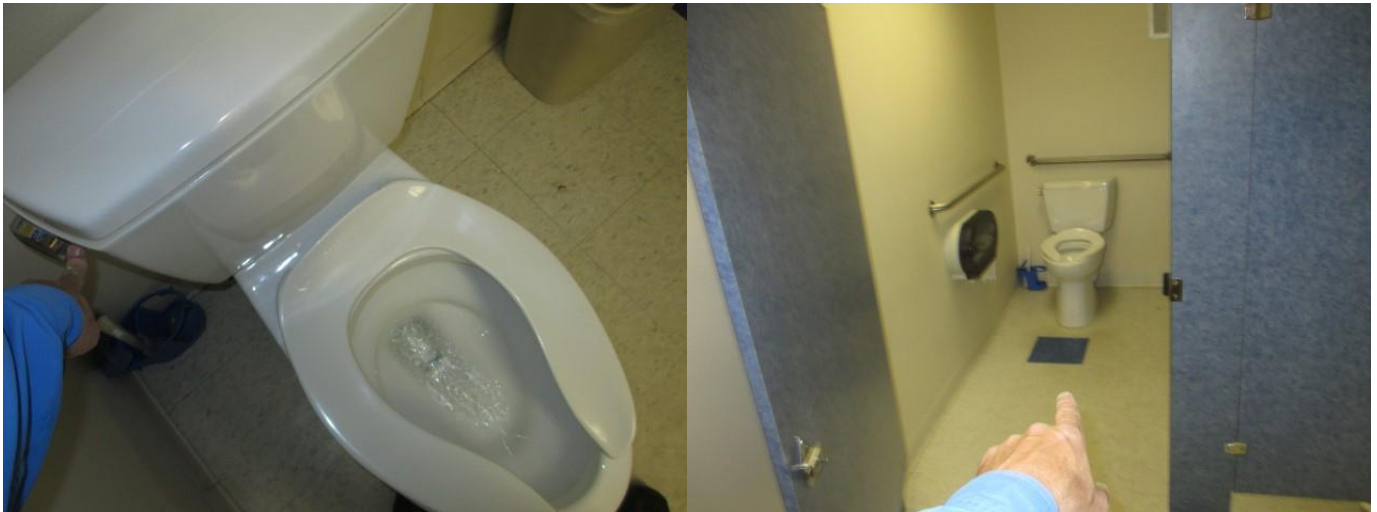
Repair Needed: The handle had to be held down in order to flush the commode in the handicap stall of the women's bathroom in the 1st floor dance studio.

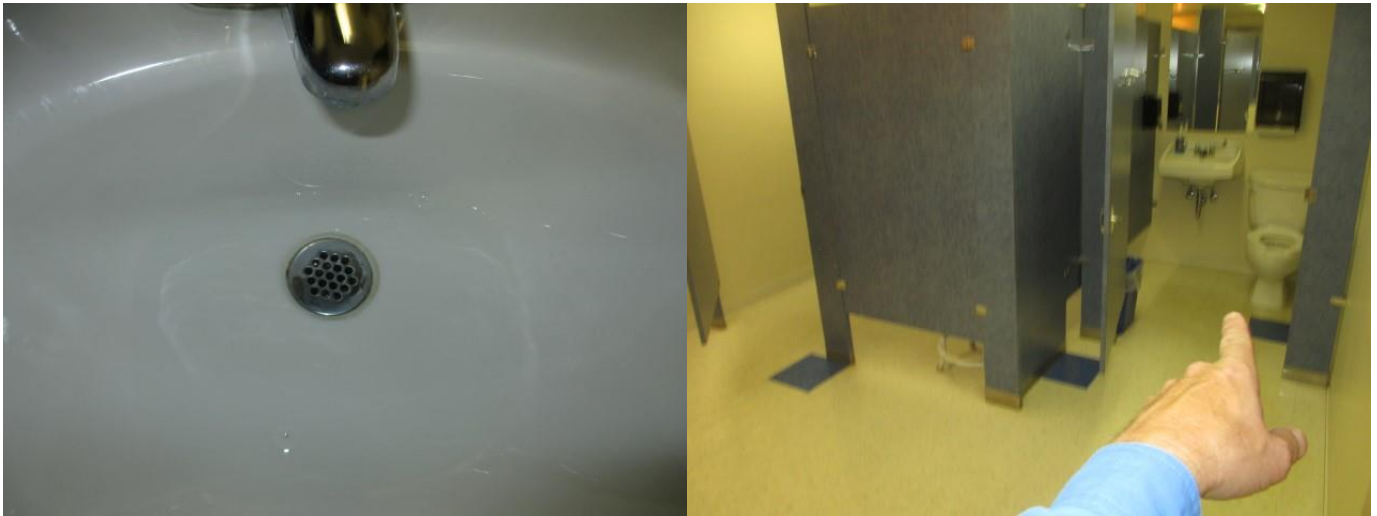
Maintenance Needed: We noted that the sink drained slowly in the right stall of the 1st floor women's bathroom sink (dance studio).

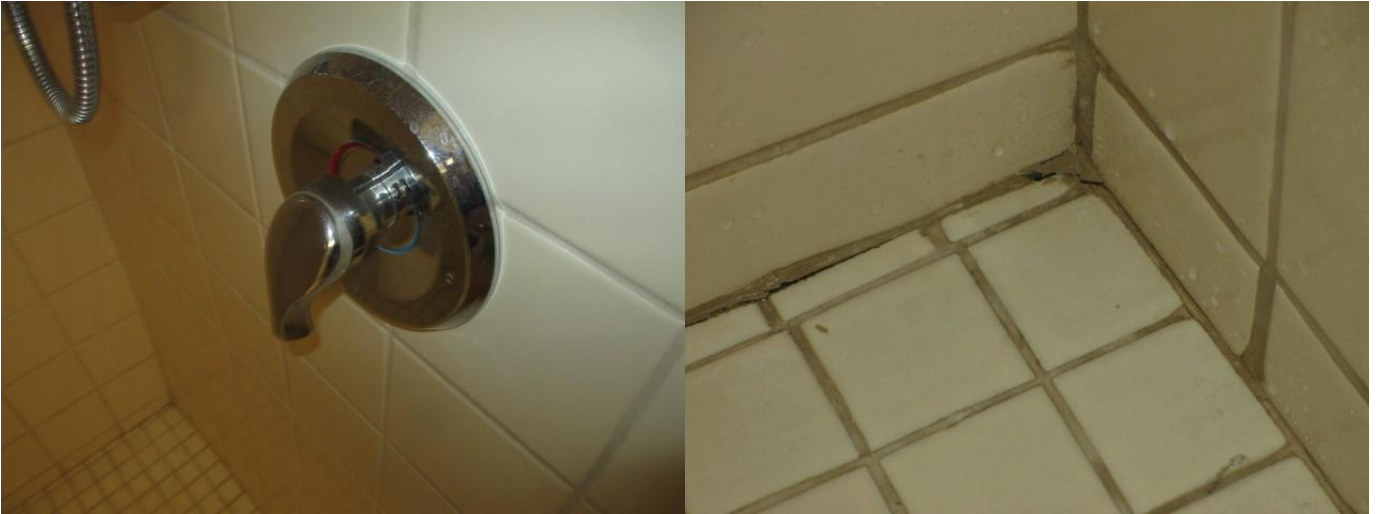
Maintenance Needed: The control plate and cracked grout in the southwest second-floor bathroom shower should be resealed to prevent moisture intrusion.

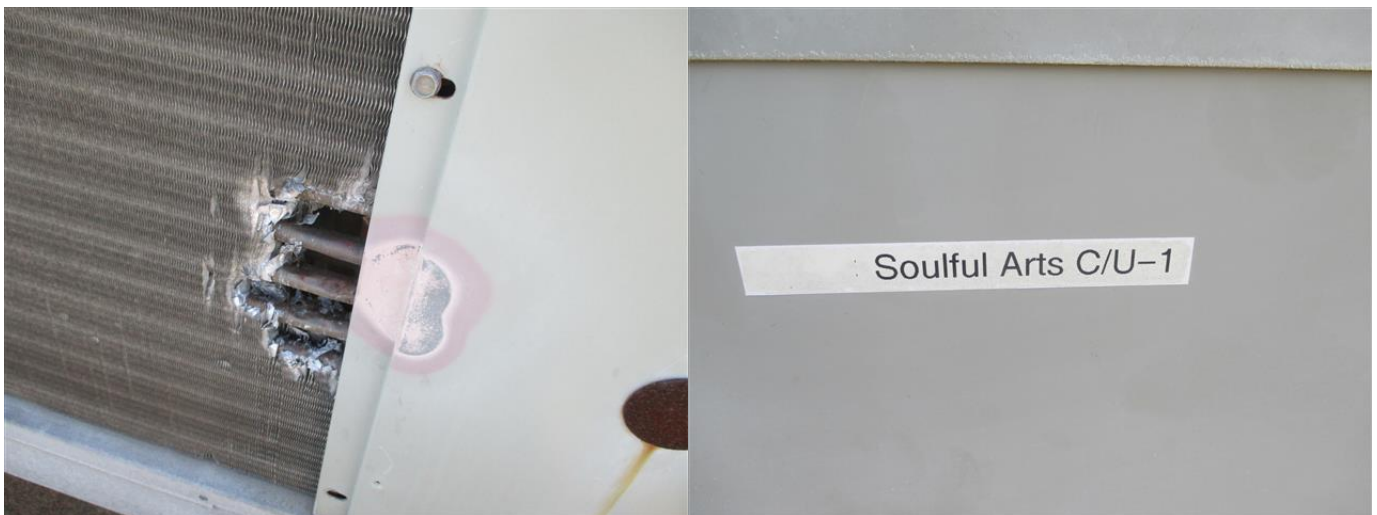
Repair Needed: We noted damage to the exterior fins on the 12.5 ton condenser unit on the roof.

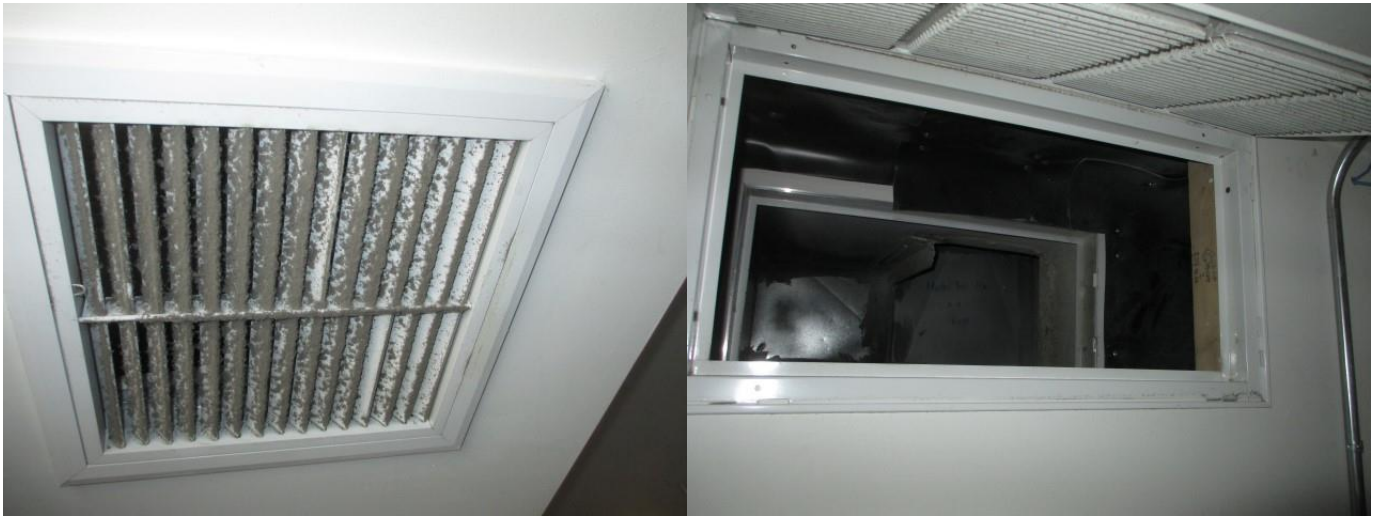
Maintenance Needed: We noted that filters were not installed in the majority of the return registers at the time of the inspection.

As a normal maintenance item, change or clean the return filters every few months or as per the manufacturer's specification.

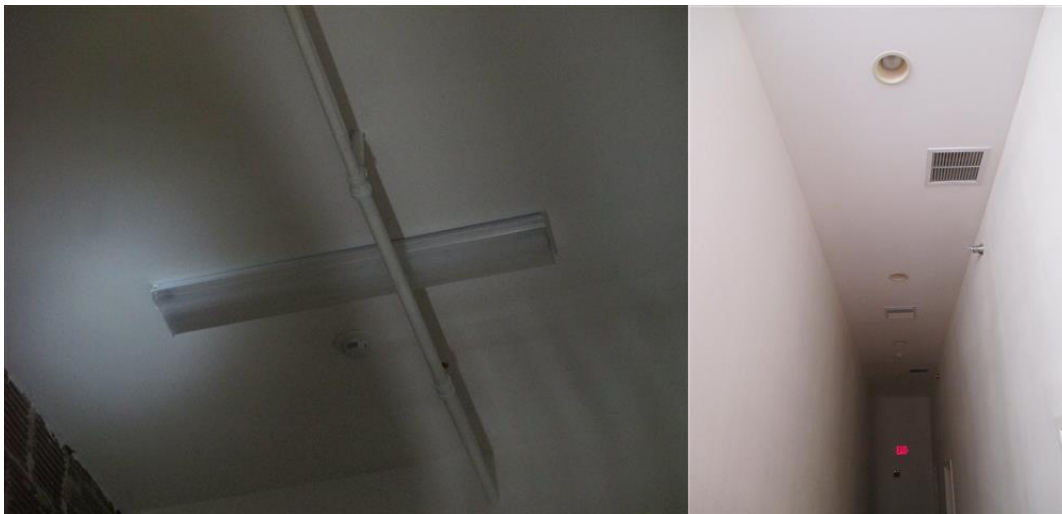
Repair Needed: The light fixtures in the south hallway on the second floor and at the top of the south stairwell were not operational the time of inspection.

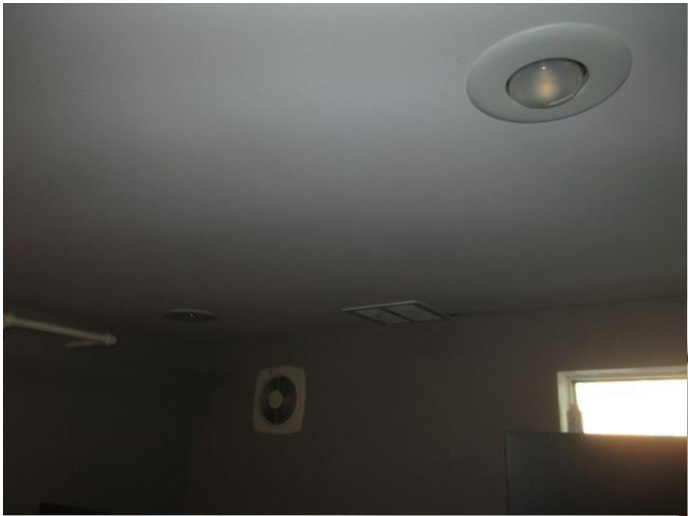
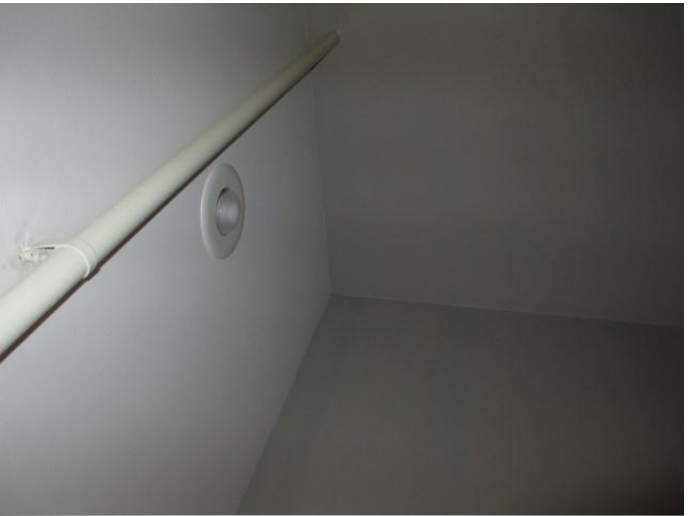
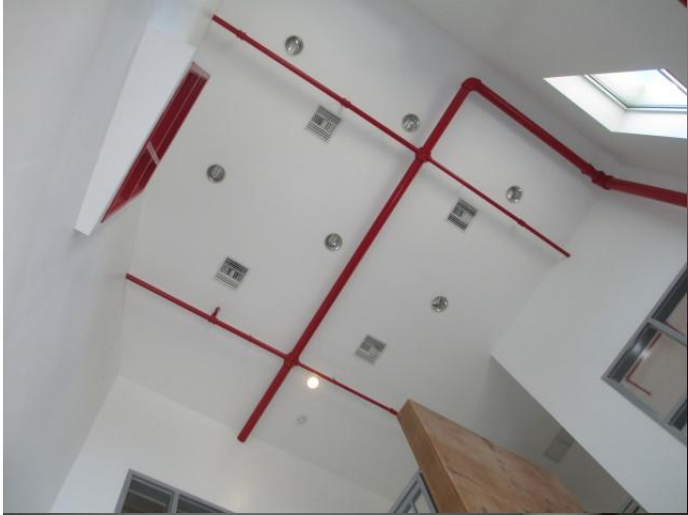
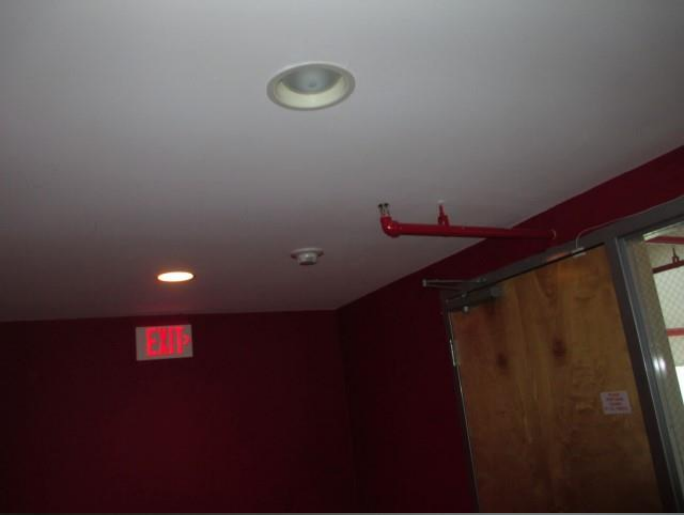
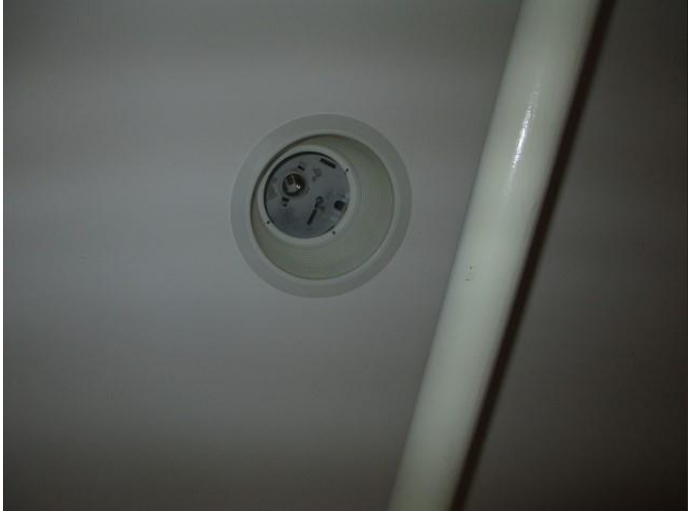
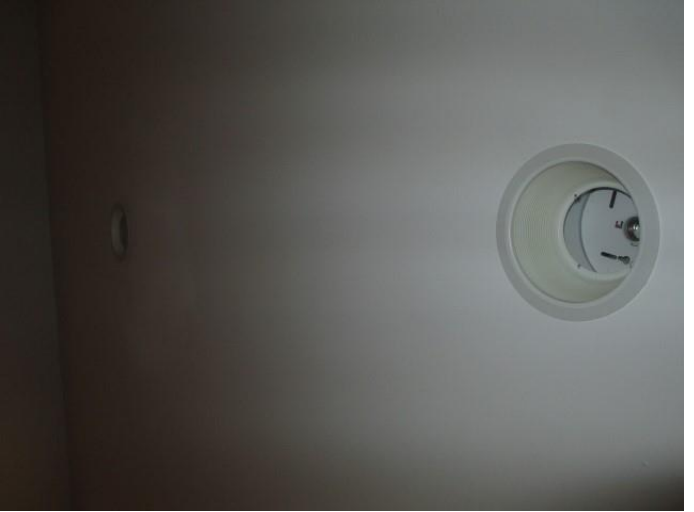
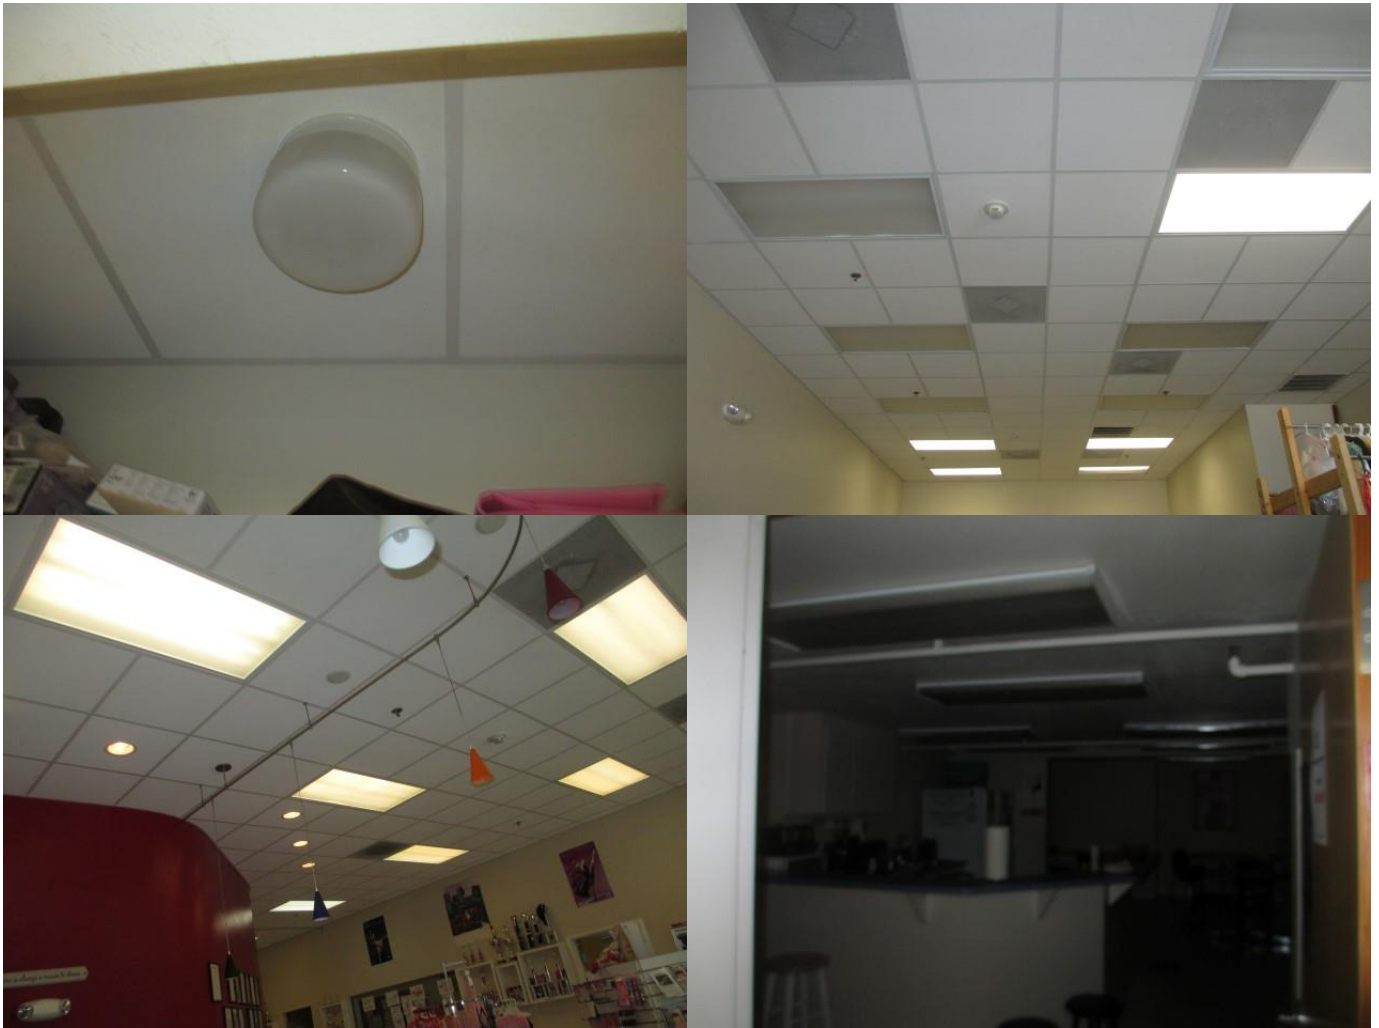
Repair Needed: We noted numerous light fixtures that were not operational or that were missing light bulbs throughout the building at the time the inspection and likely needs the bulb replaced.

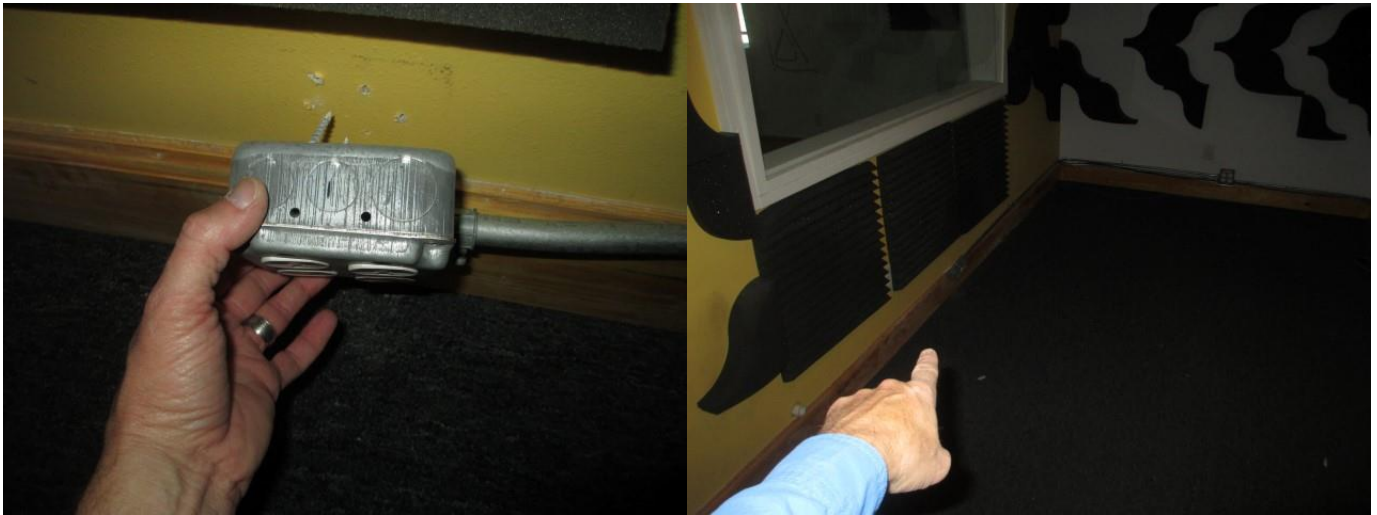
Maintenance Needed: The receptacle was loose in the northwest recording booth on the south wall of the 2nd floor and should be properly secured.

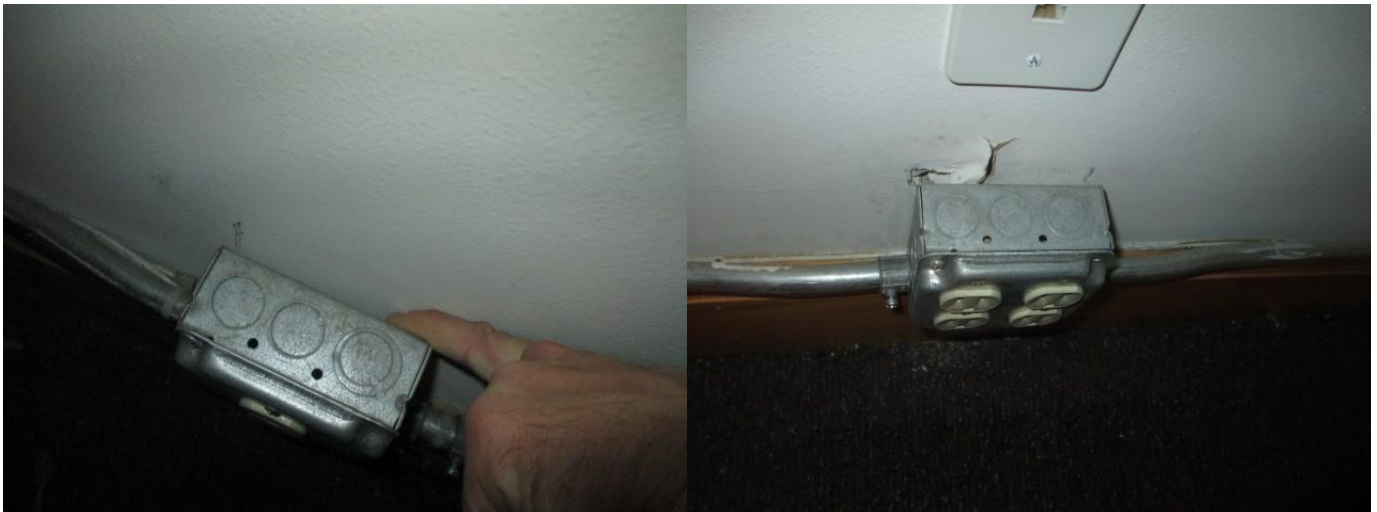
Maintenance Needed: The receptacles on the south wall in the recording studio was loose and should be secured.

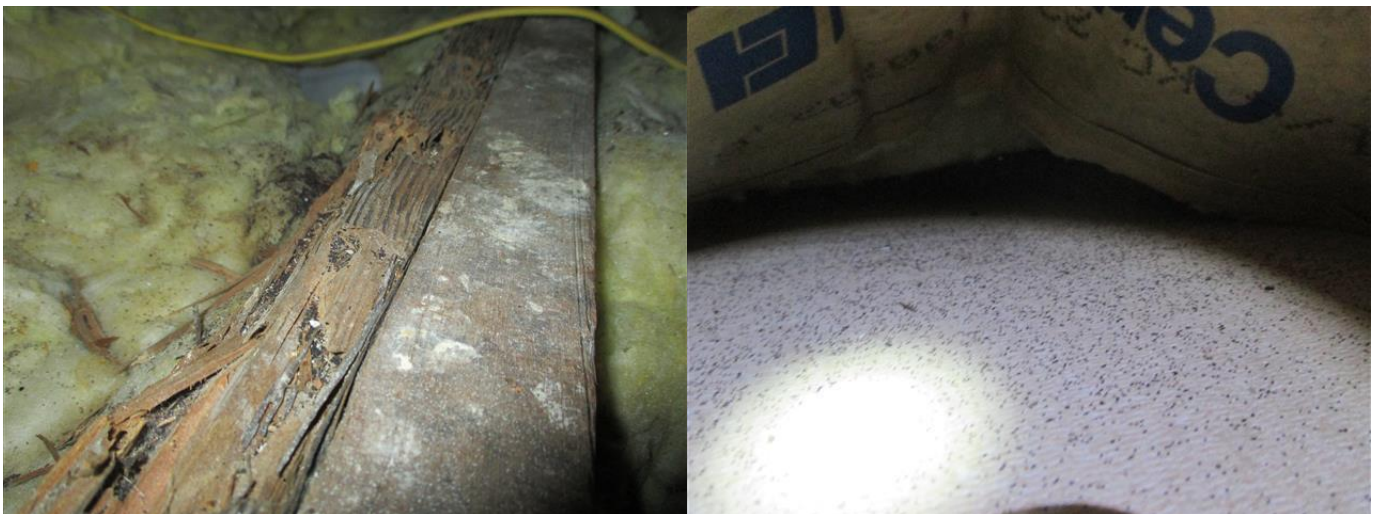
Concern Item: We noted evidence of termite intrusion in the attic area (droppings, damage etc.). Some the droppings were noted on top of the ceiling tiles in the west offices, indicating that they were deposited since the building had last been renovated. We recommend contacting a licensed pest specialist for further evaluation and remediation.

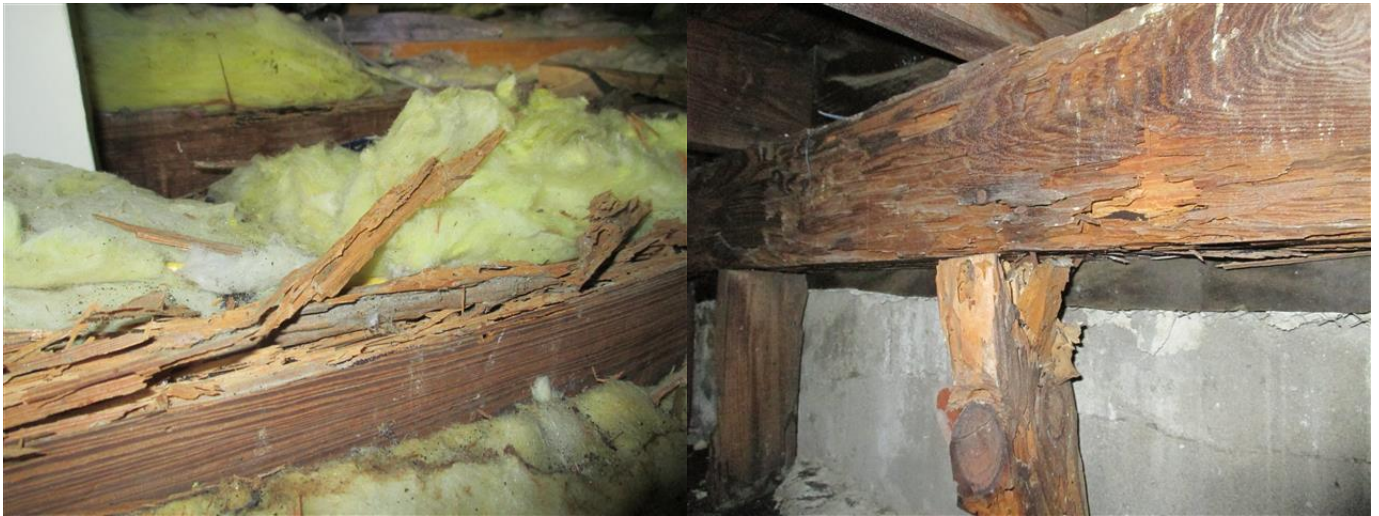
Repair Needed (Structural Concern): Some of the framing around the latter opening to the roof was heavily deteriorated and will need reinforcement.

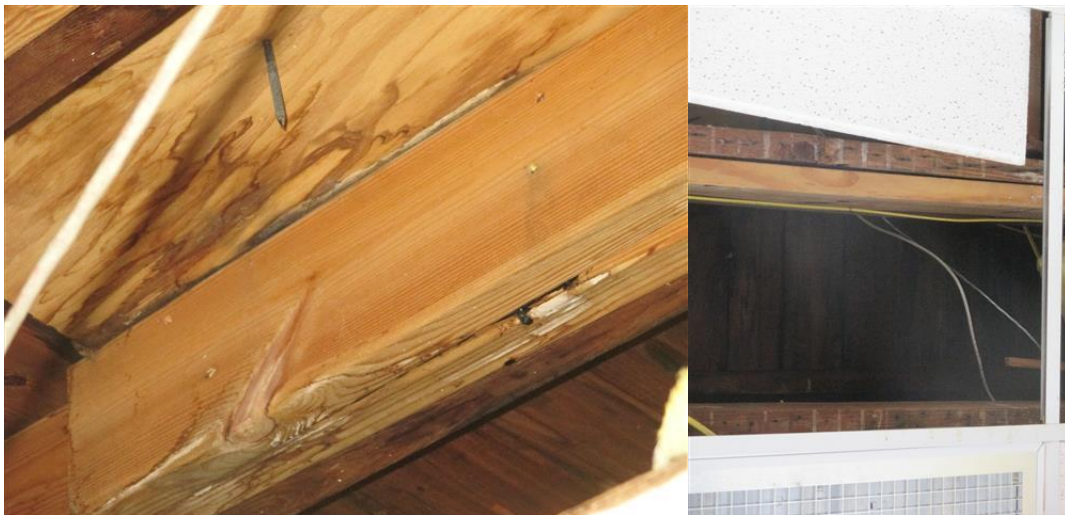
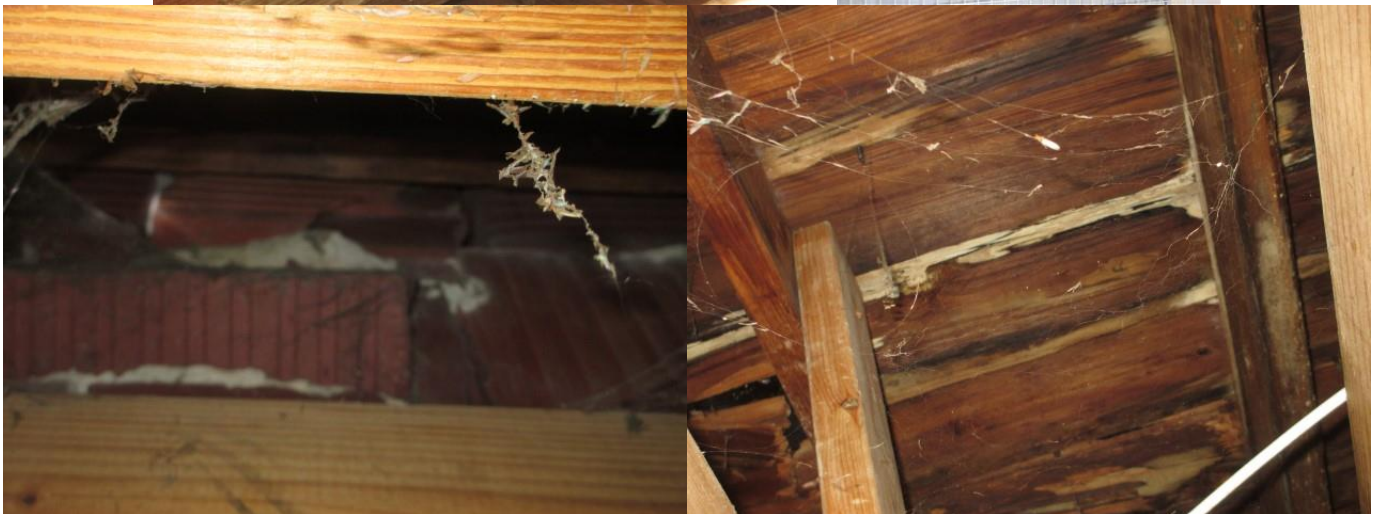
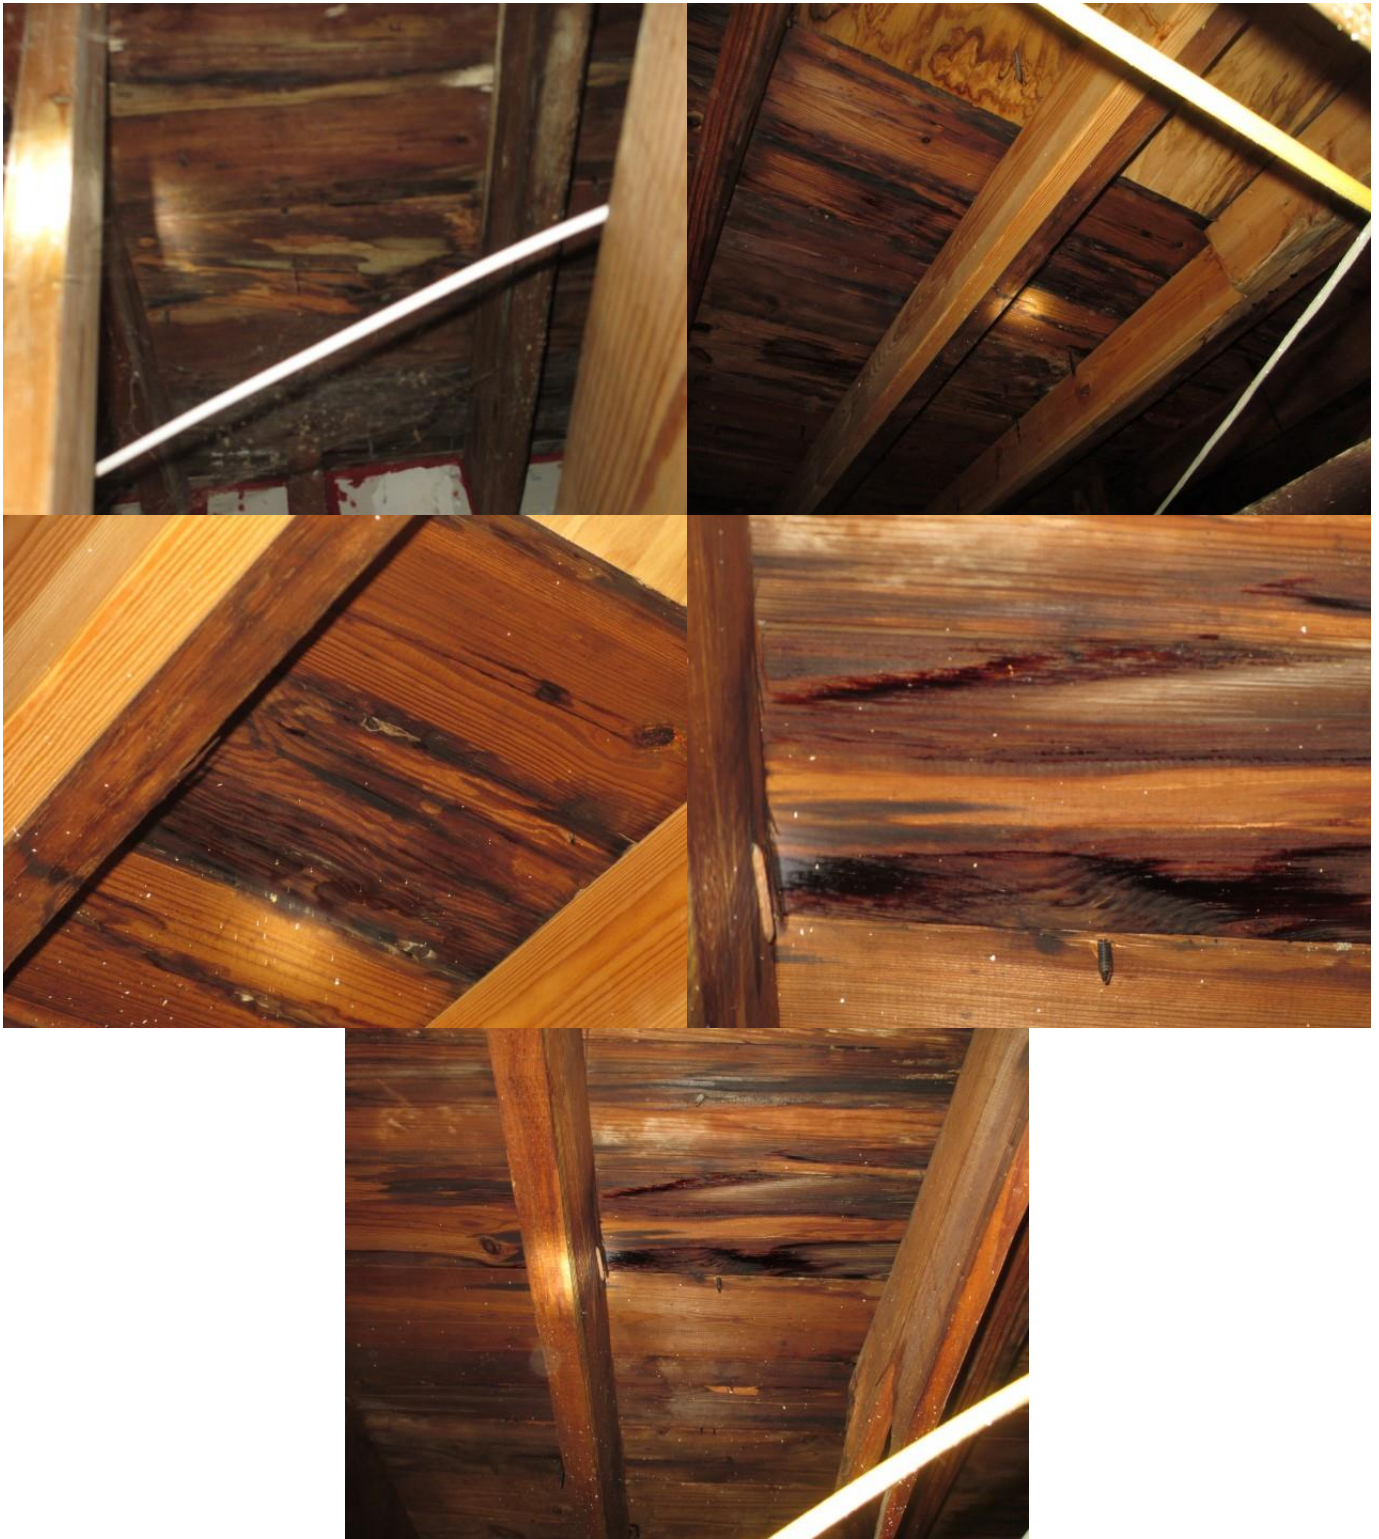
Concern Item: We noted staining to the roof deck along the west side of the attic. The areas tested positive for active moisture intrusion at the time of inspection, indicating active roof leakage.

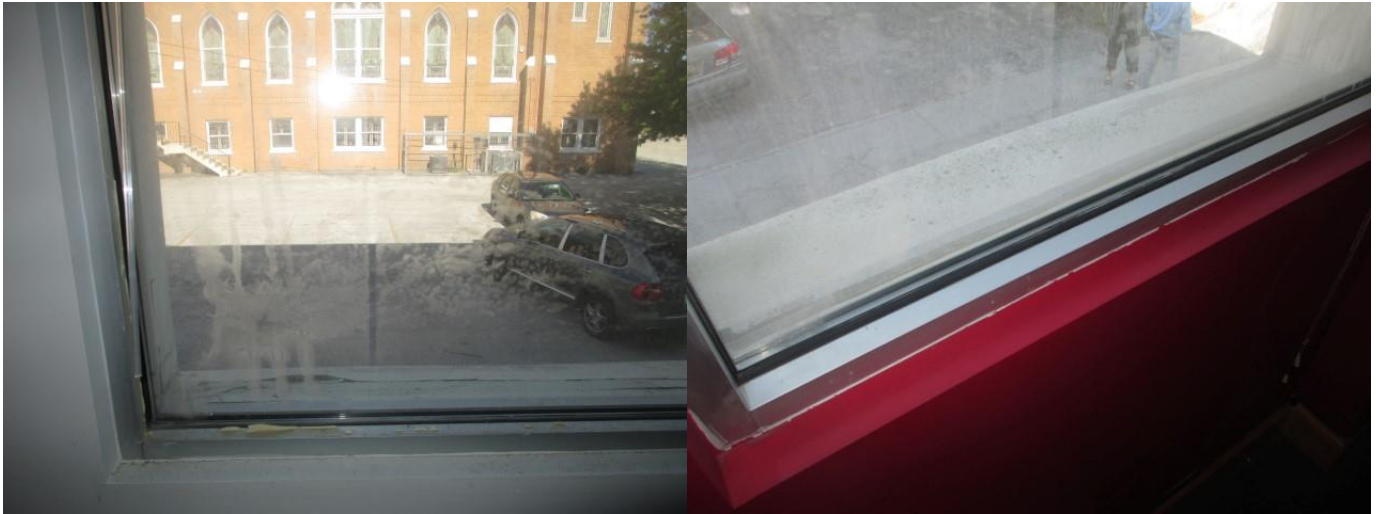
Repair Needed: We noted what appeared to be a breach in the internal seal of the windows on the west wall of the reception area and in the northwest recording studio on the 2nd floor.
