INTRODUCTION

GENERAL CONDITION OF BUILDING

The building is an east facing two-story masonry structure on slab with a flat (mansard) type roof design. The building was constructed circa 1923. The building had been extensively renovated circa 2000 - 2003.

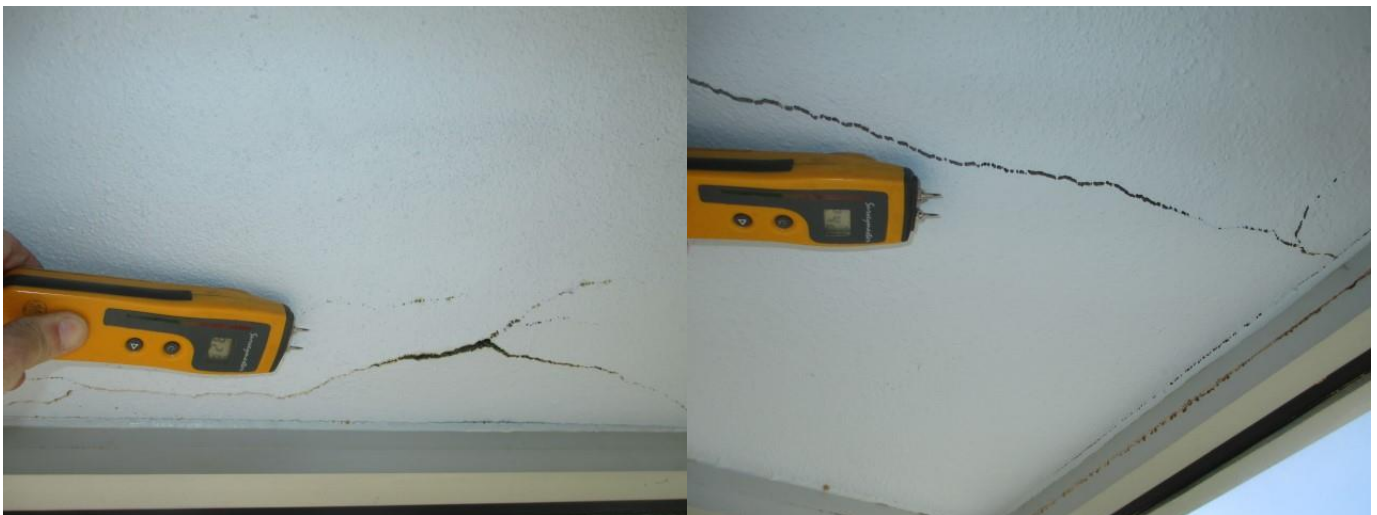
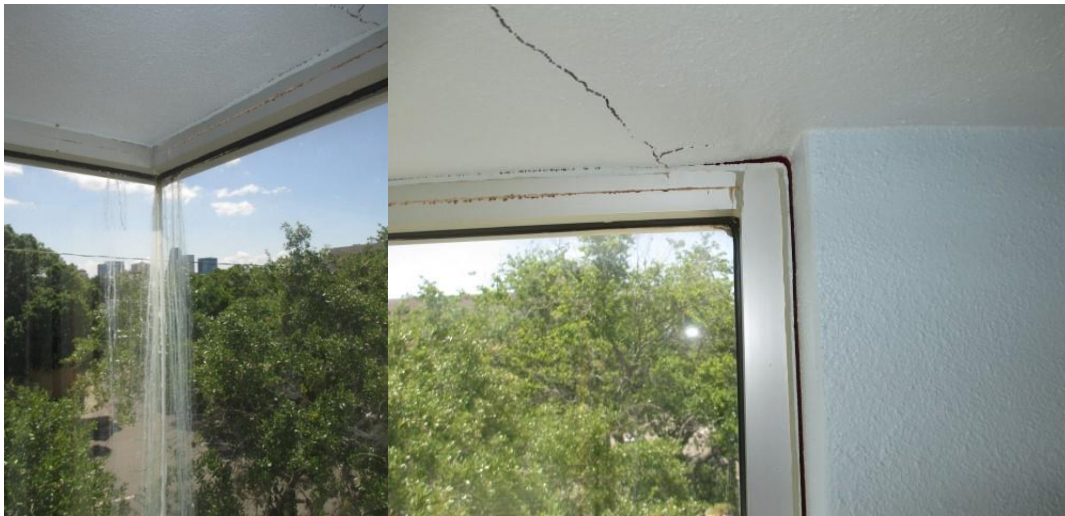
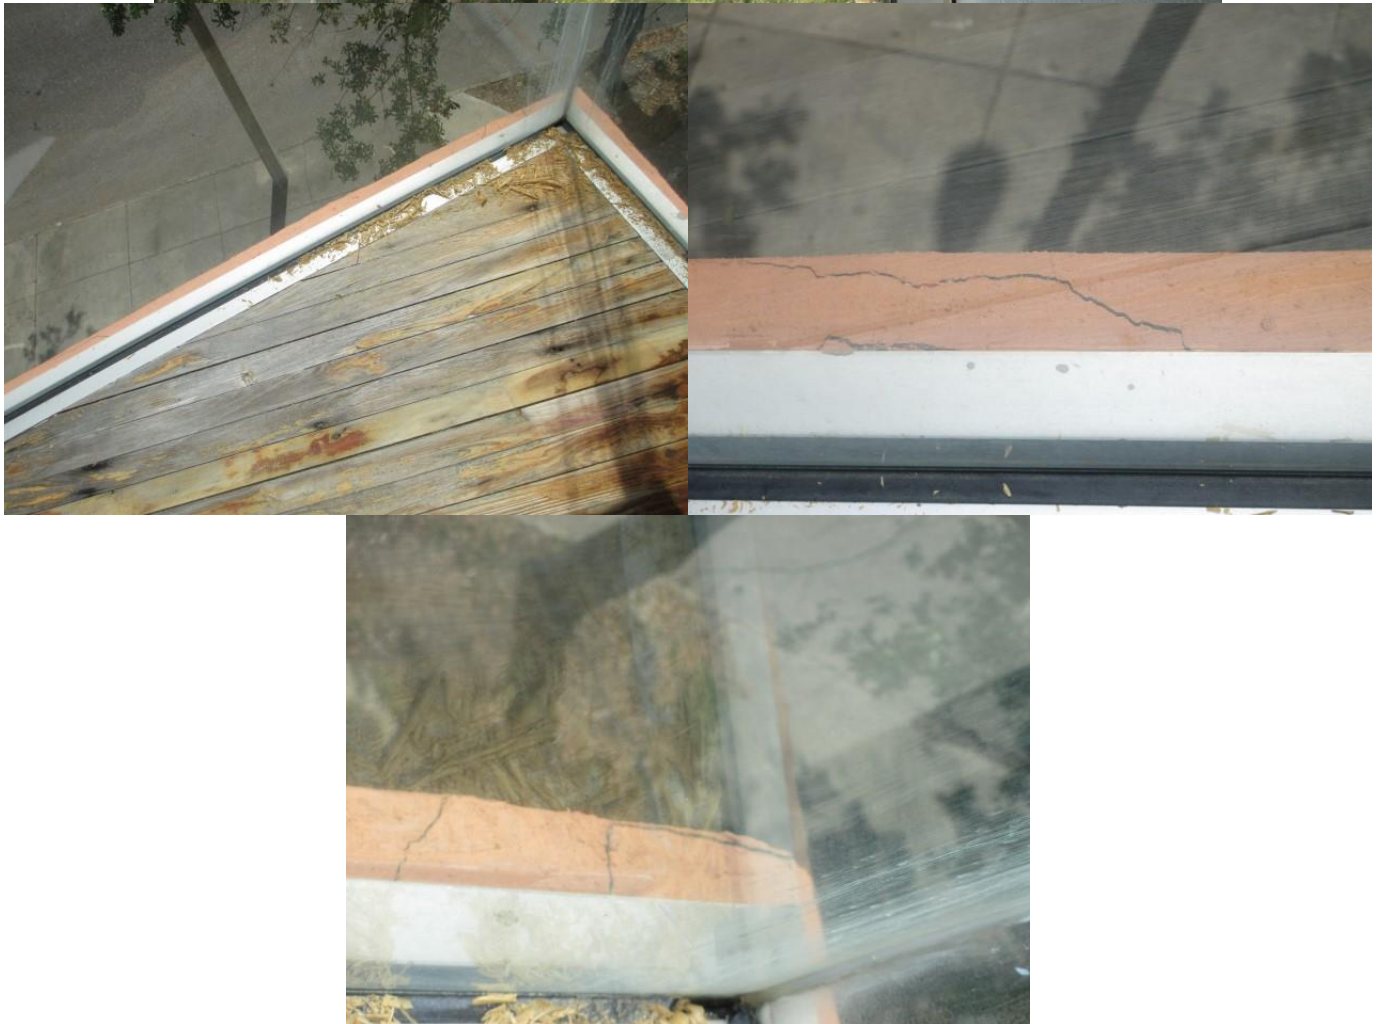
Repair Needed: We noted cracking to the stucco around the exterior of the window for the built out window at the northwest corner of the third floor, indicating areas of active moisture intrusion (also see Exterior notes). The window unit appeared to be leaning forward and separating from the wall. Because these areas are likely framed, we recommend removing the stucco to allow further inspection of the framing and sheathing.

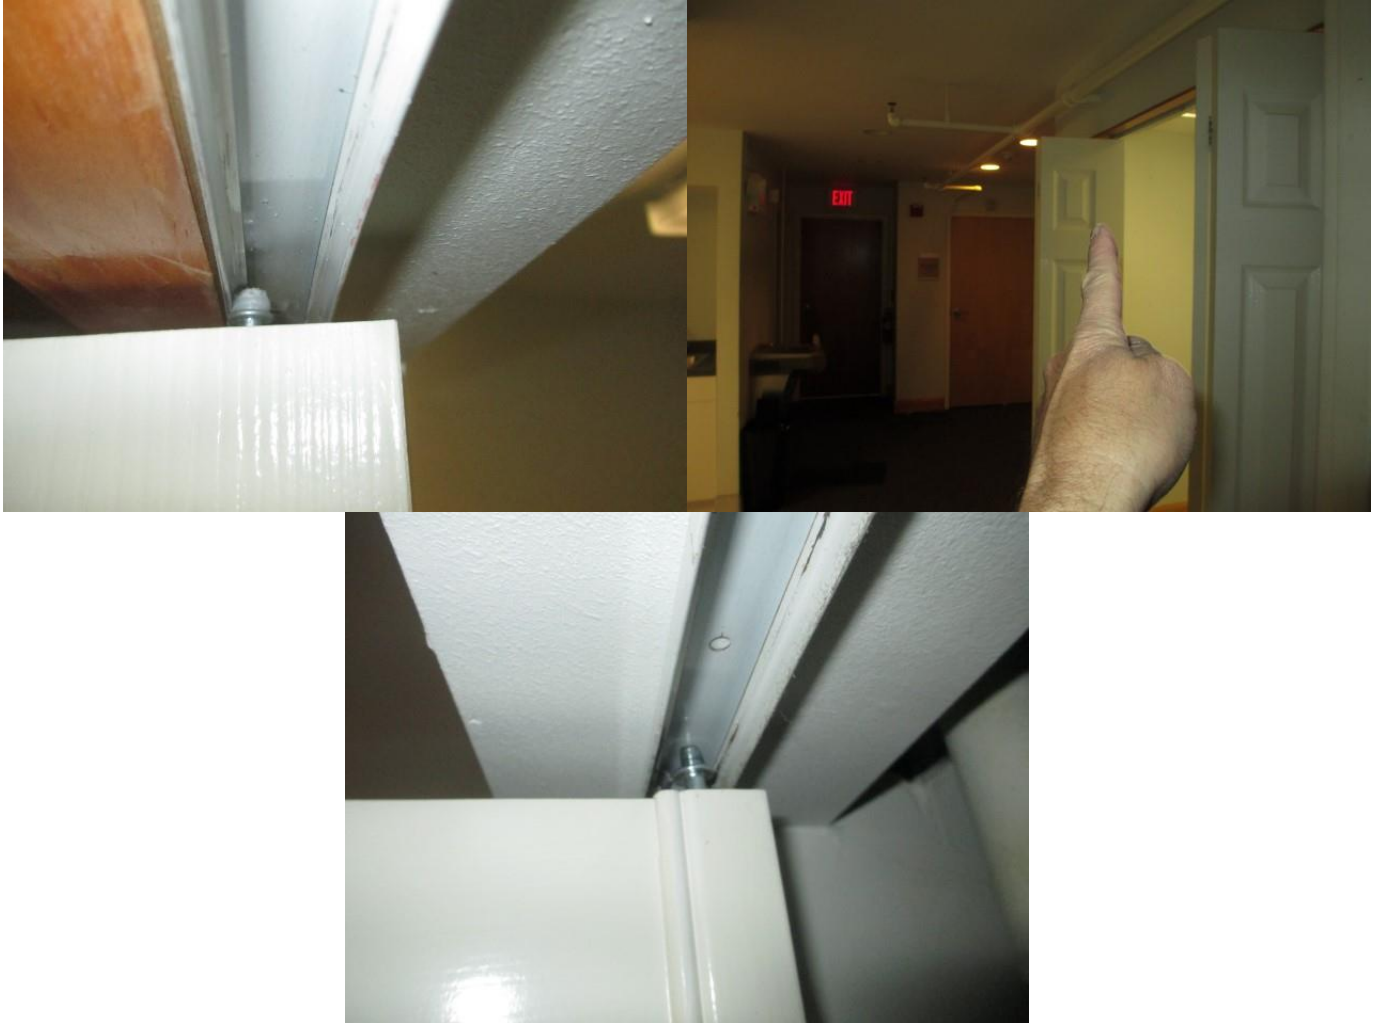
Repair Needed: We noted that the top track roller was damaged on the south hall closet (by the break room) and on the air handler closet in the break room on the 2nd floor should be replaced and ordered operate properly.

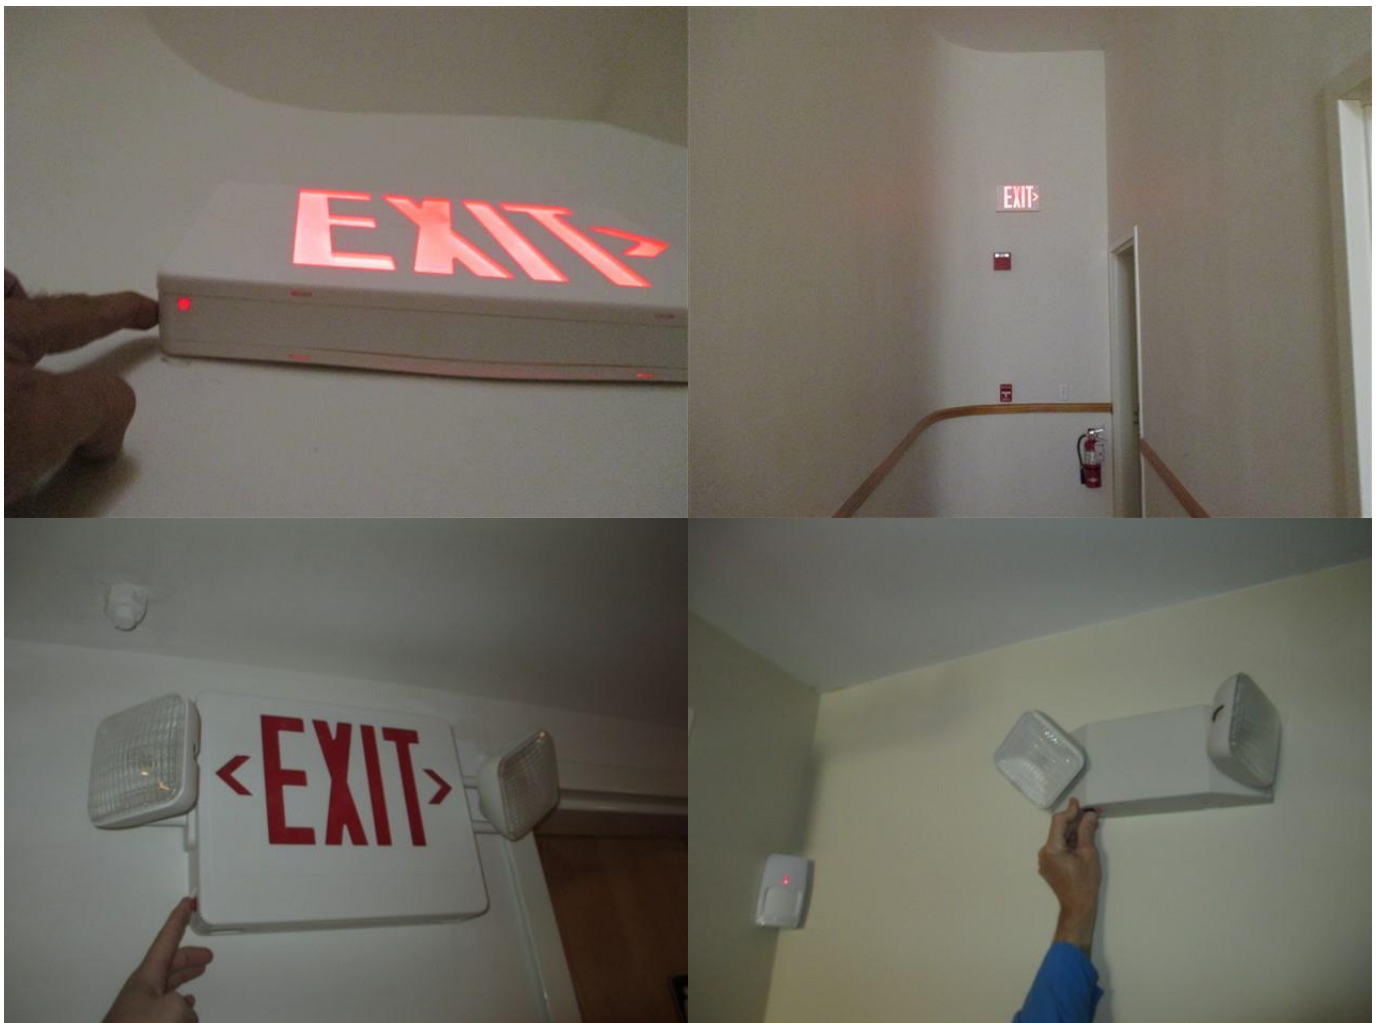
Repair Needed: The emergency lighting for the exit signs throughout the second floor were not operational the time of inspection.

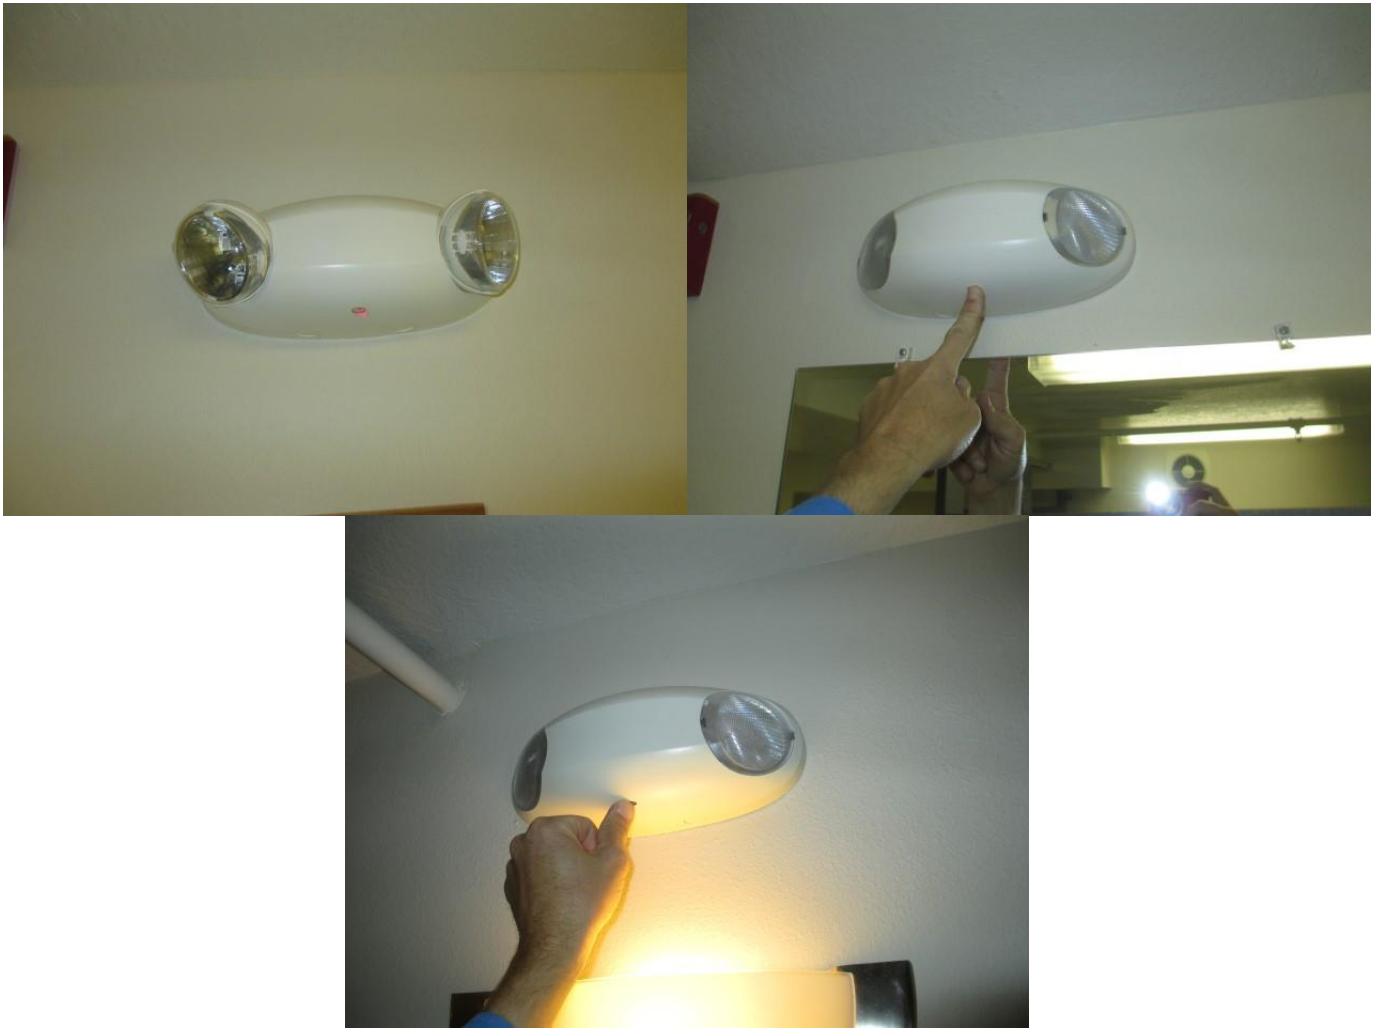
Repair Needed: The emergency lighting for the exit signs in the 1st floor dance studio were not operational the time of inspection.

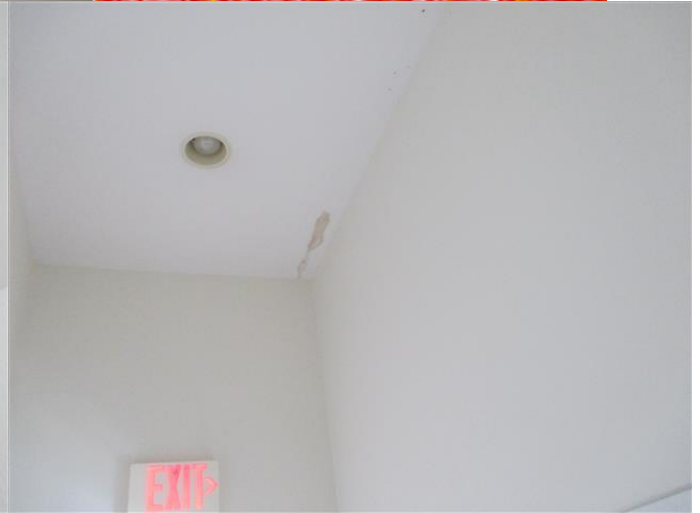
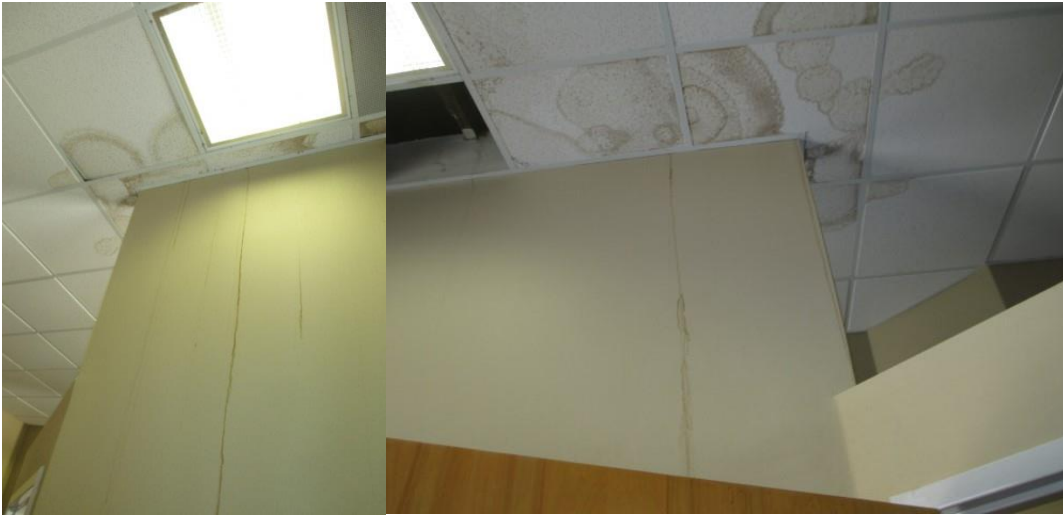
Concern Item: We noted staining to the ceiling and walls at the entry between the mezzanine in the second-floor hallway, and along the west side of the northwest office on the second floor. Most of these areas tested positive for active moisture intrusion at the time of inspection, indicating areas of active roof leakage.

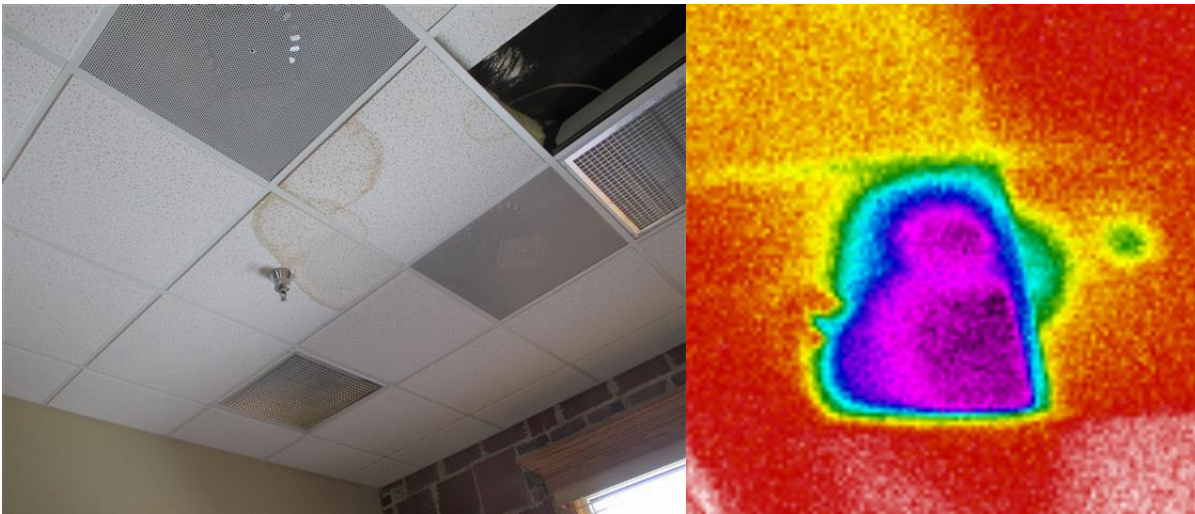
Repair Needed: In the south office in the northwest second-floor suite, we noted staining around the fire suppression nozzle. The area tested positive for active moisture intrusion at the time of inspection, indicating leakage from the supply piping for the fire suppression system (also see Attic notes).

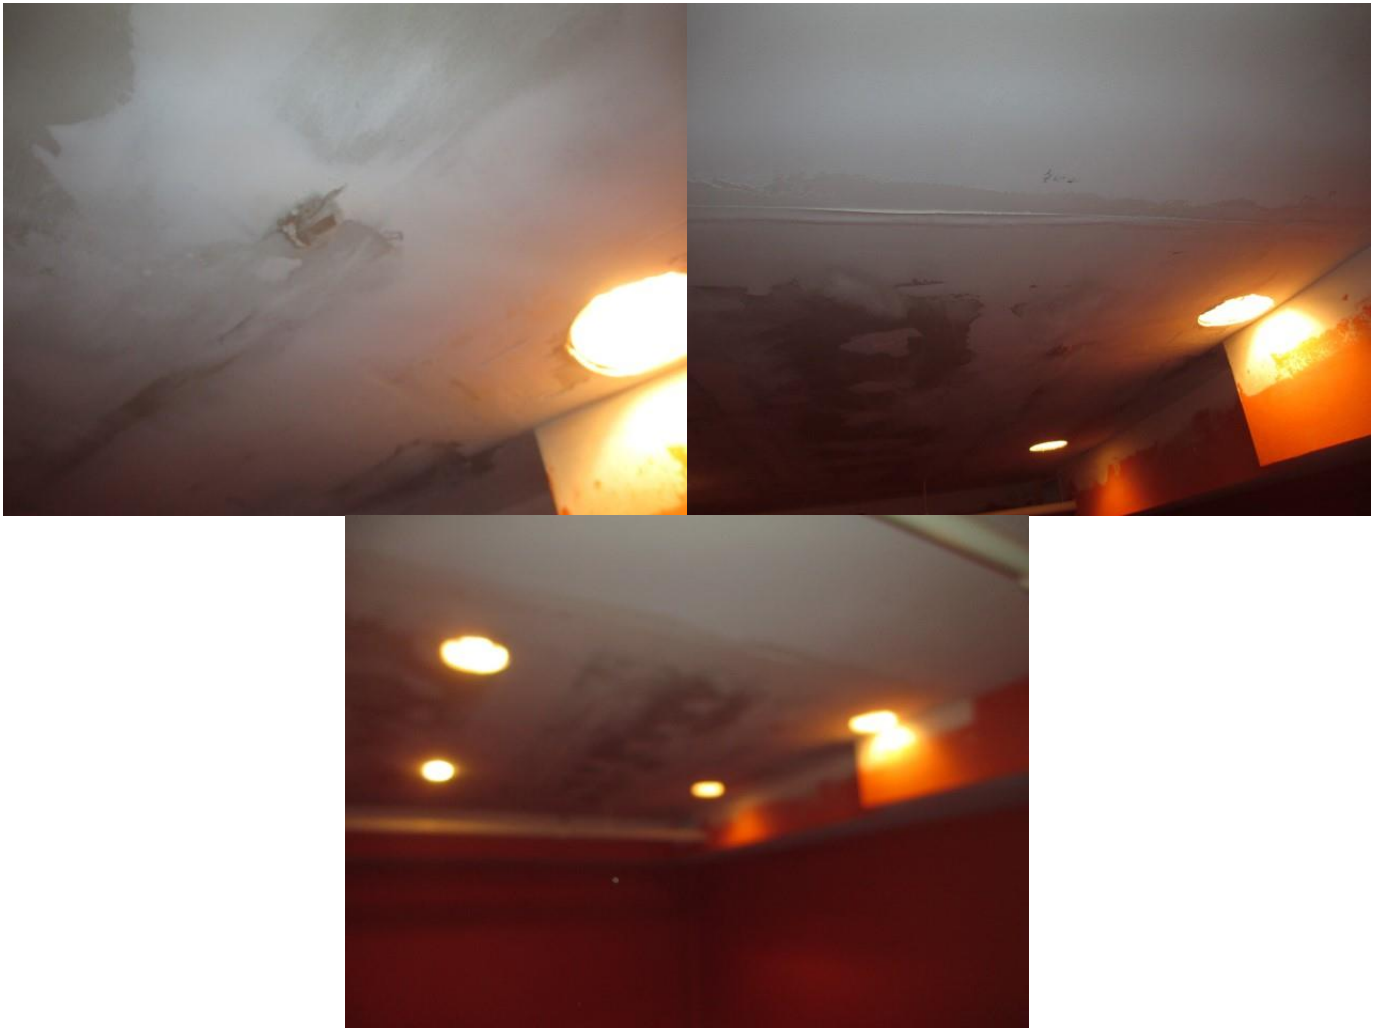
Cosmetic Item: We noted loose tape seams and a stain on the ceiling in the northeast room of the 2nd floor. These areas tested negative for elevated moisture the time of the inspection.

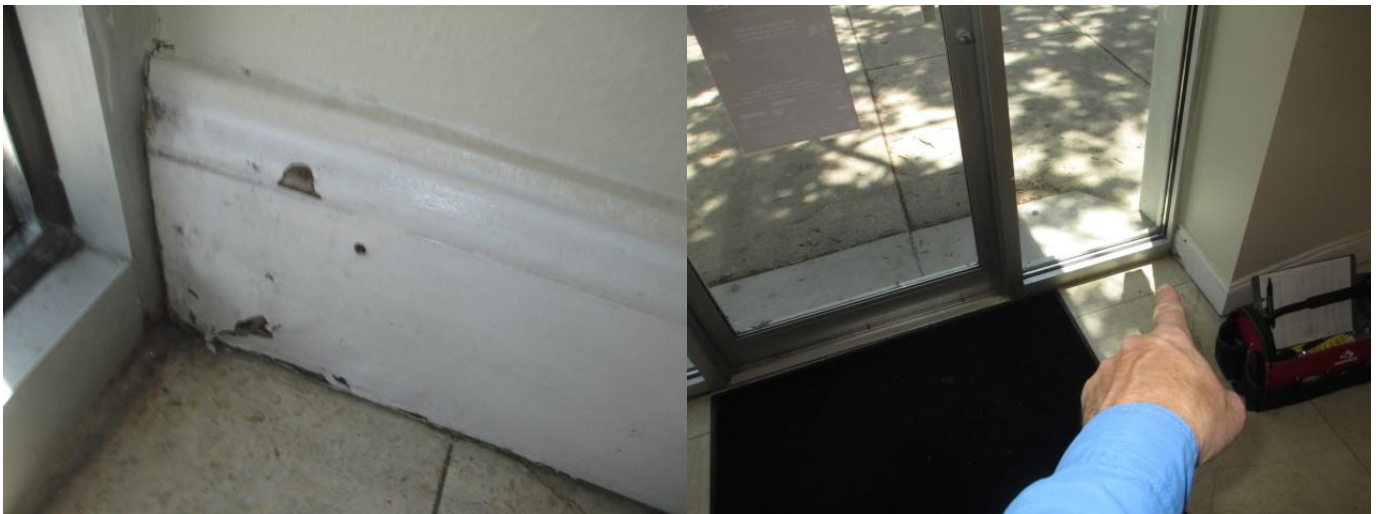
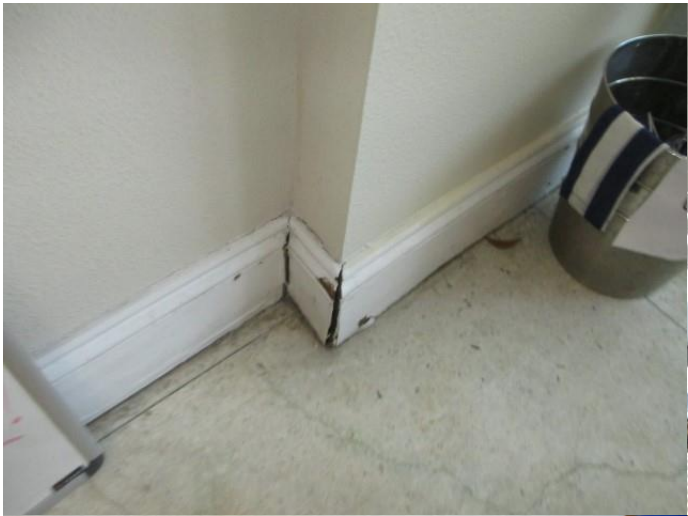
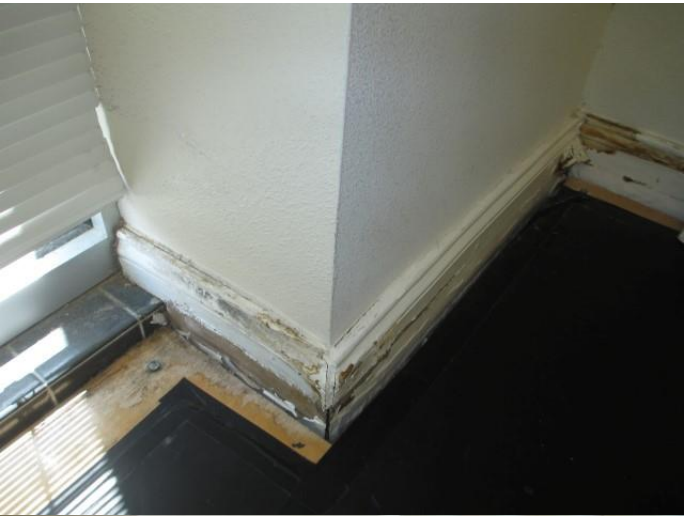
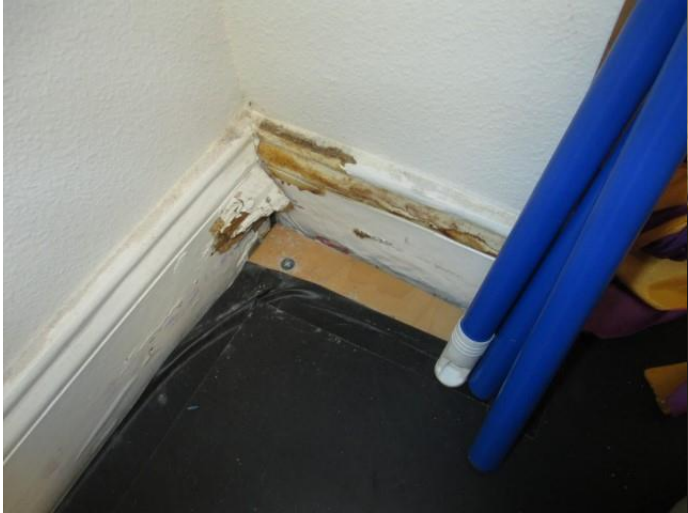
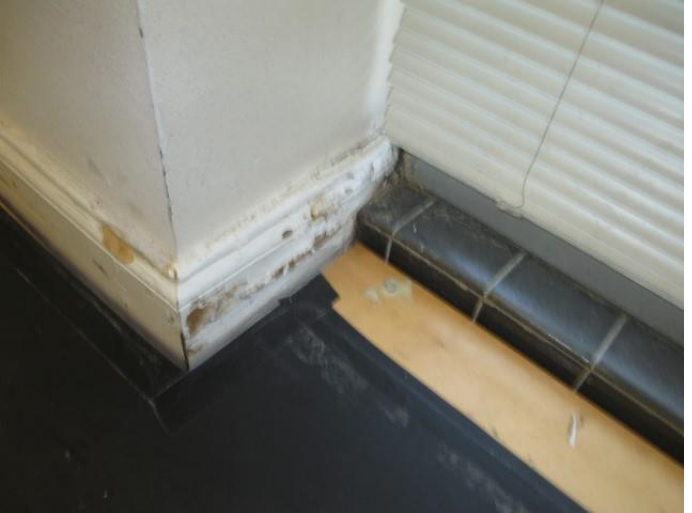
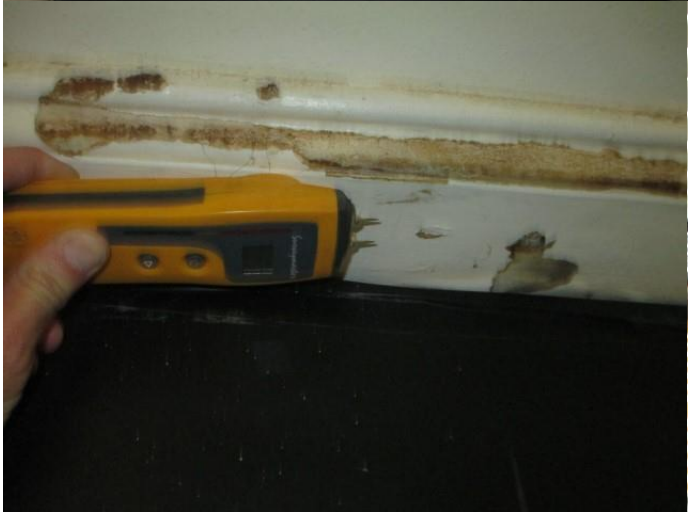
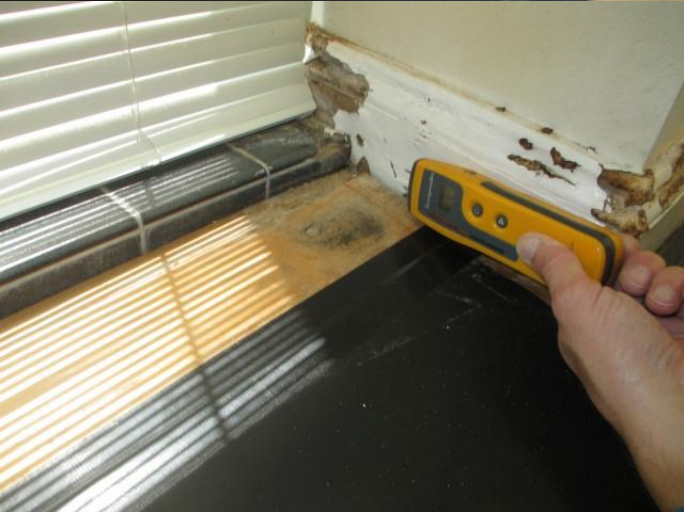
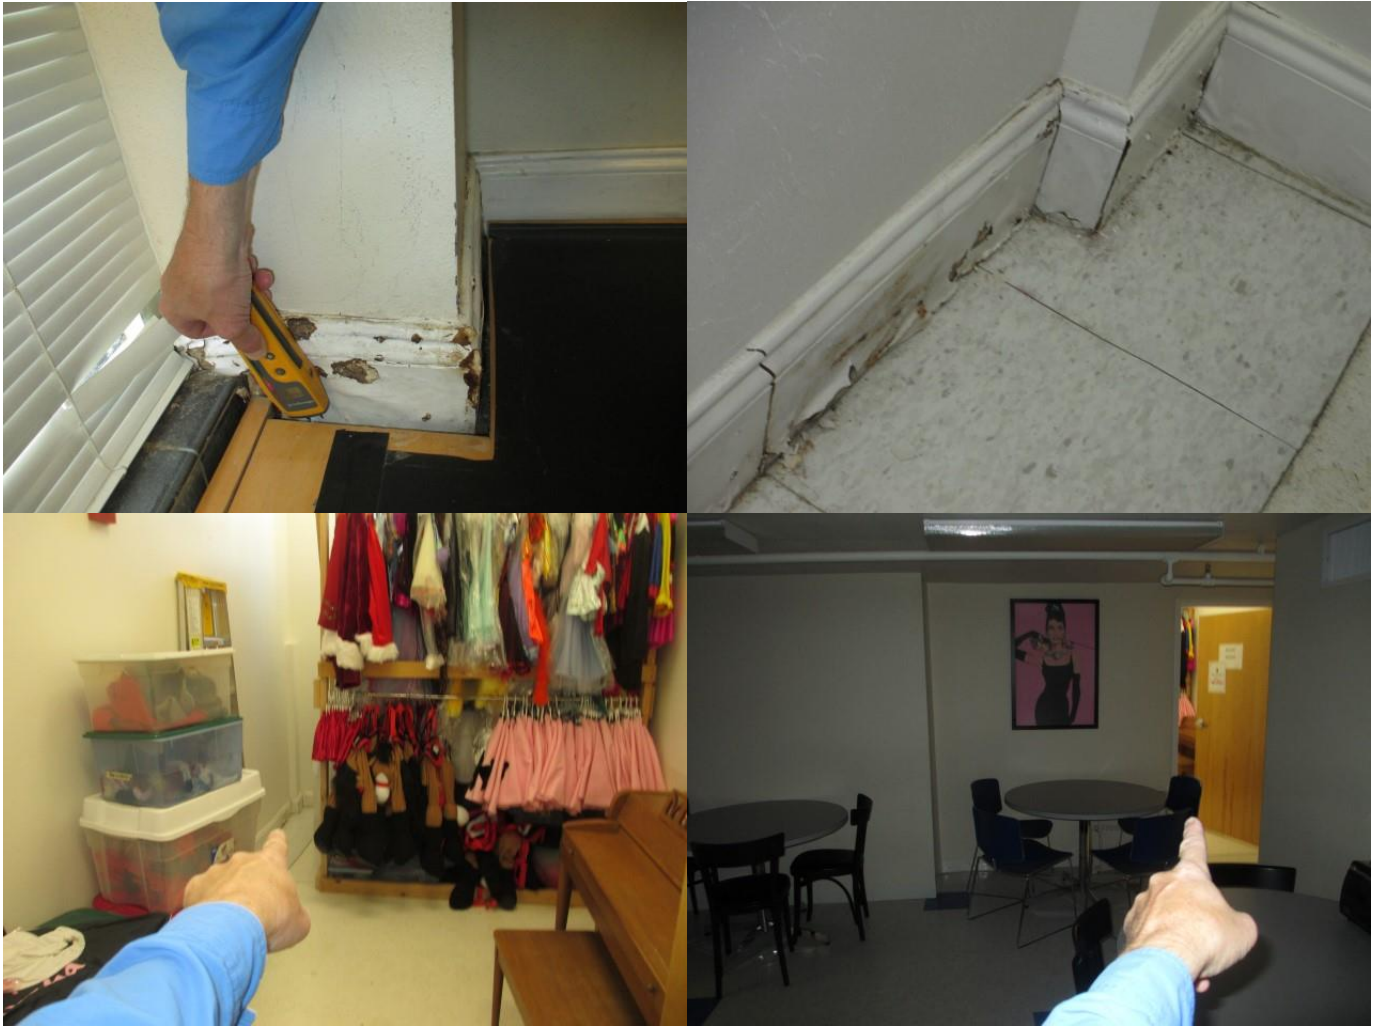
Repair Needed: We noted staining to the baseboards in the north, east and west first-floor dance studios. This was also noted on the baseboards in the north costume room off of the break room area. Many of these areas tested positive for elevated moisture the time of the inspection (see Exterior notes).

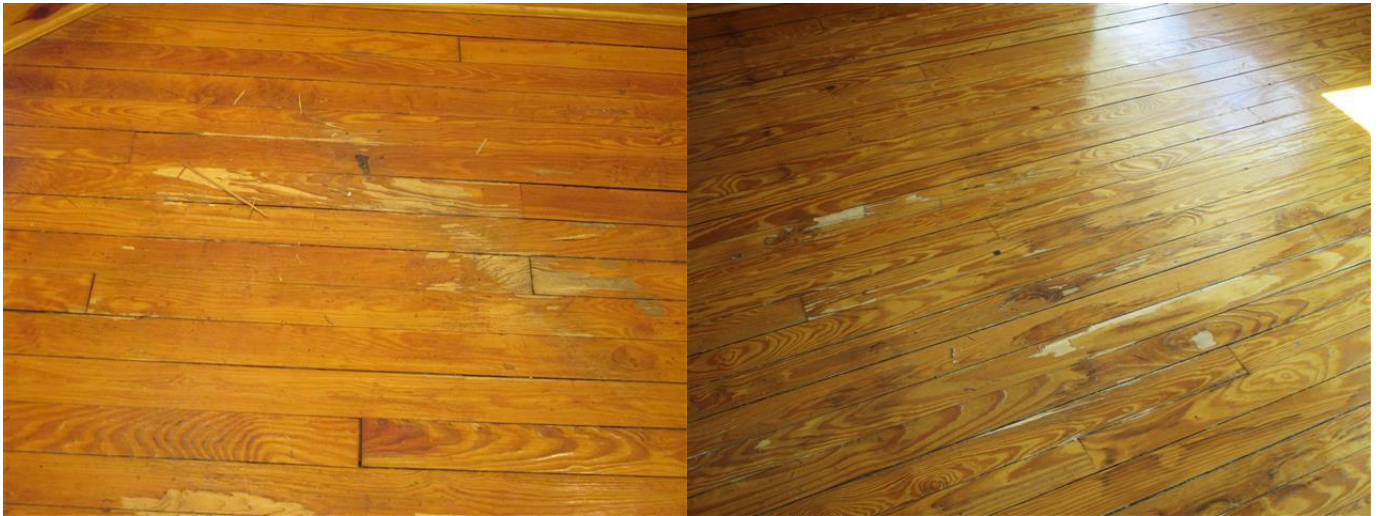
Cosmetic Item: We noted numerous areas of past termite intrusion to the wood flooring throughout the second-floor.

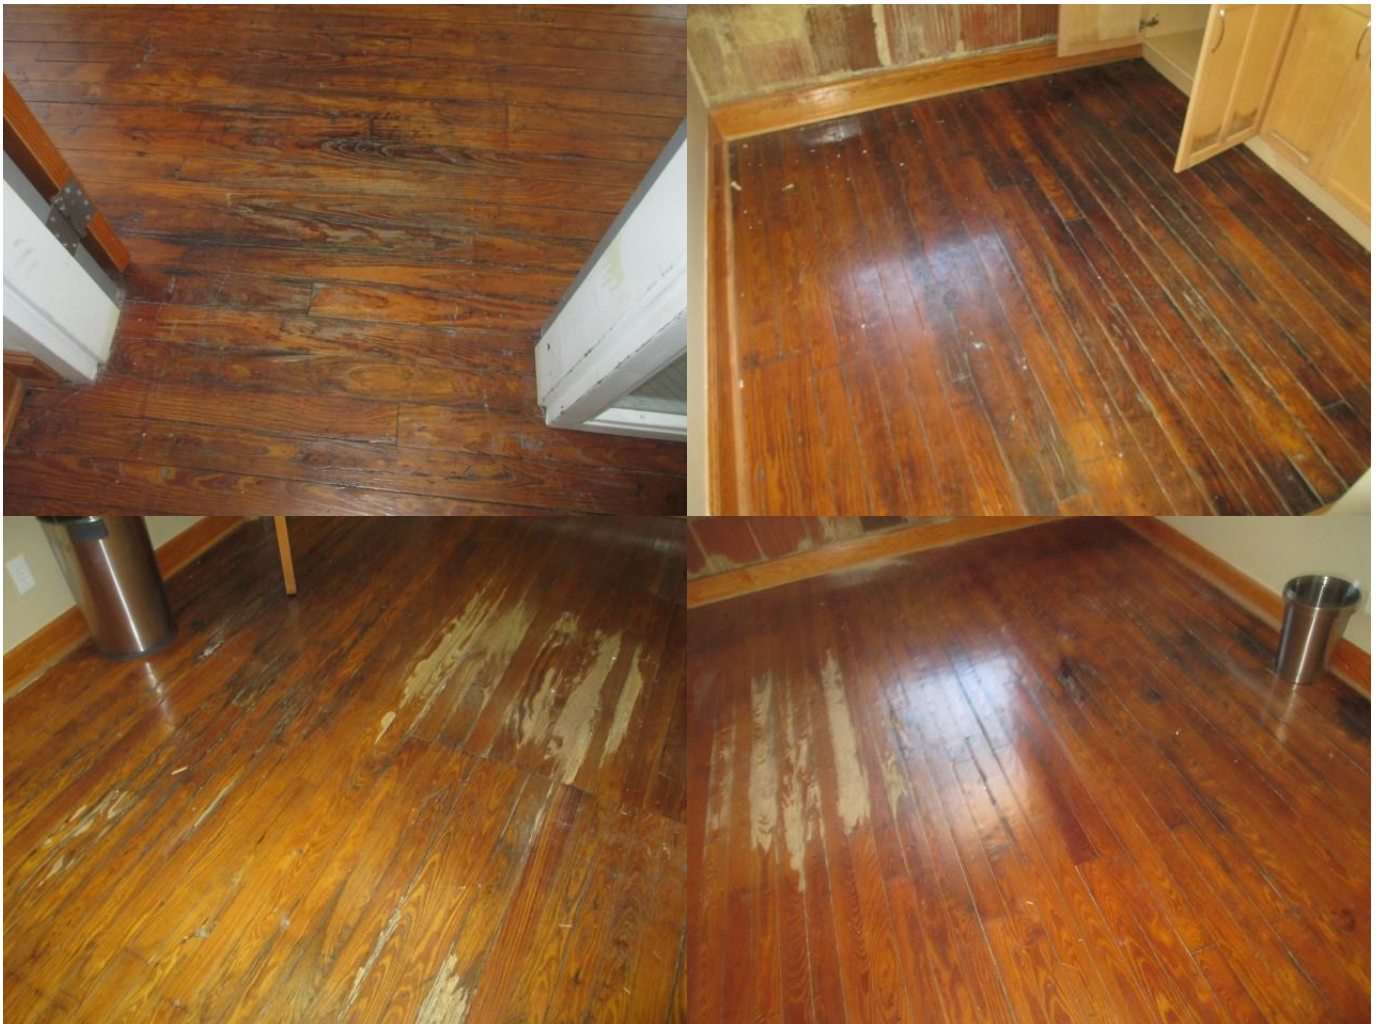
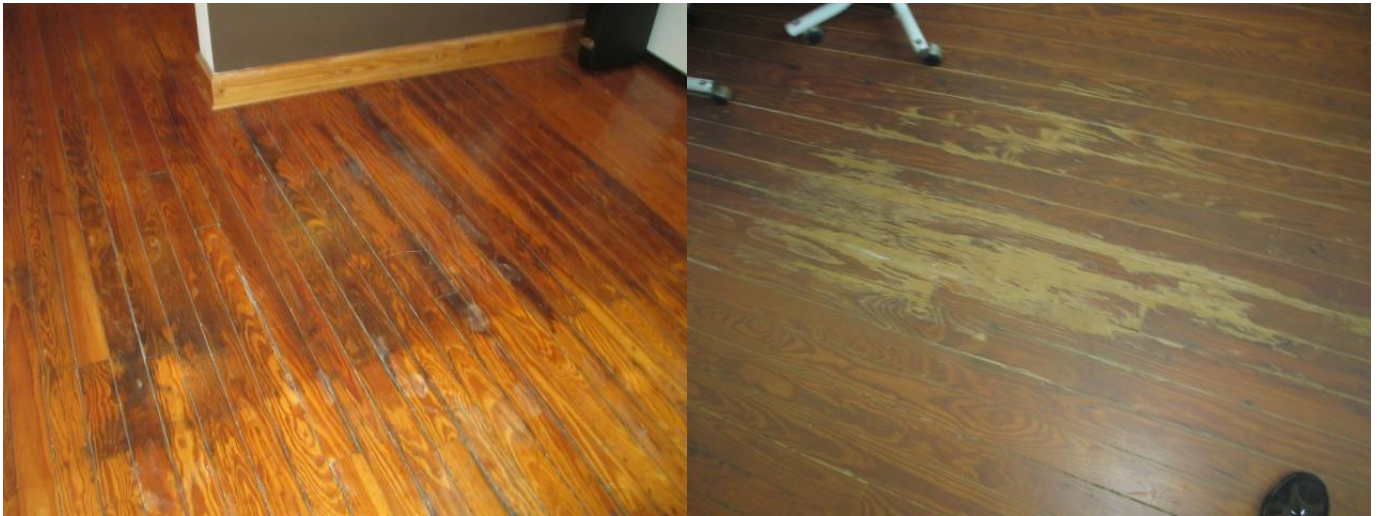
Cosmetic Item: we noted numerous scuffed, warped and stained flooring throughout most of the 3rd floor.

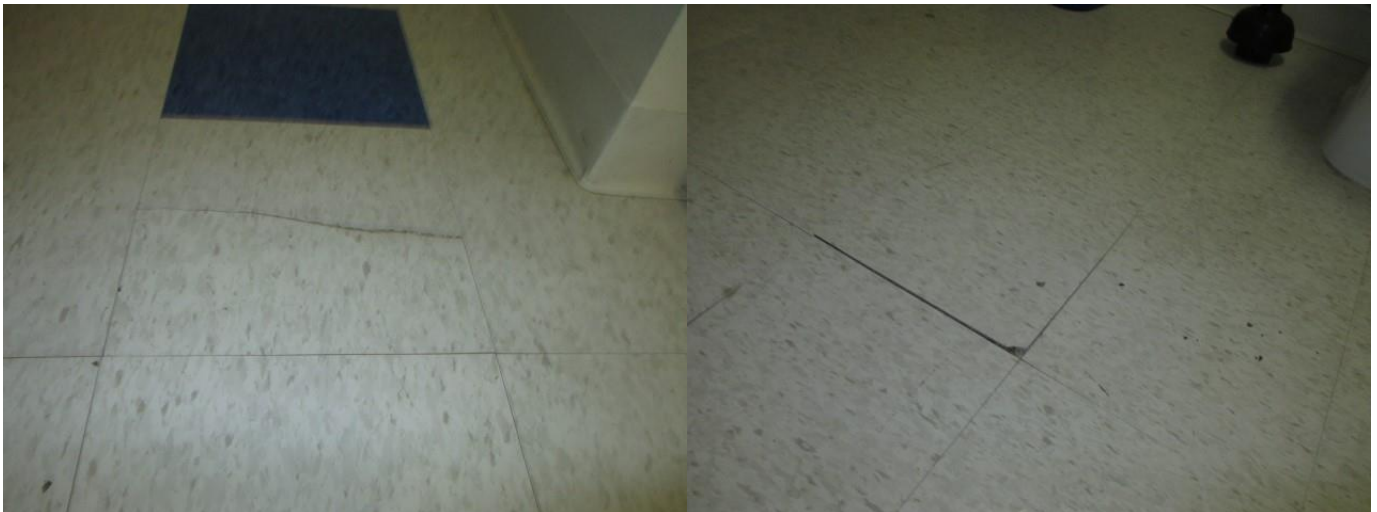
Maintenance Needed: We noted several spots of loose linoleum in the men's restroom in the first-floor dance studio should be secured.
