GENERAL CONDITION OF CONDOMINIUM UNIT

The dwelling is in a three-story block structure on slab with a flat type roof design. The condominium unit was constructed circa 1972.

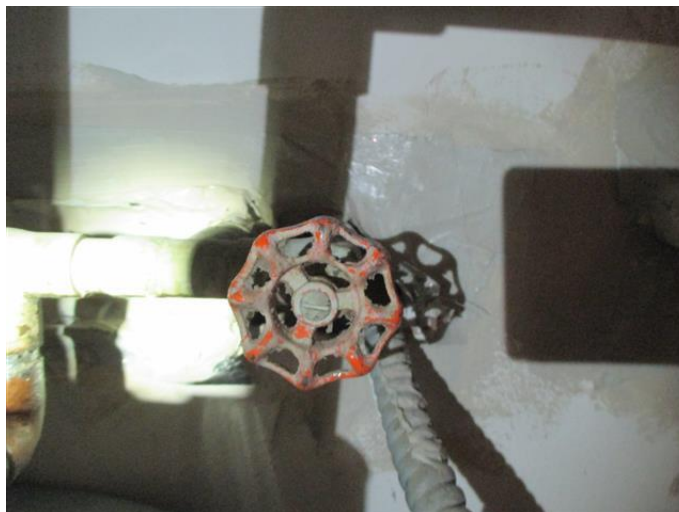
The main water cutoff for the condominium unit was in the closet containing the hot water heater.

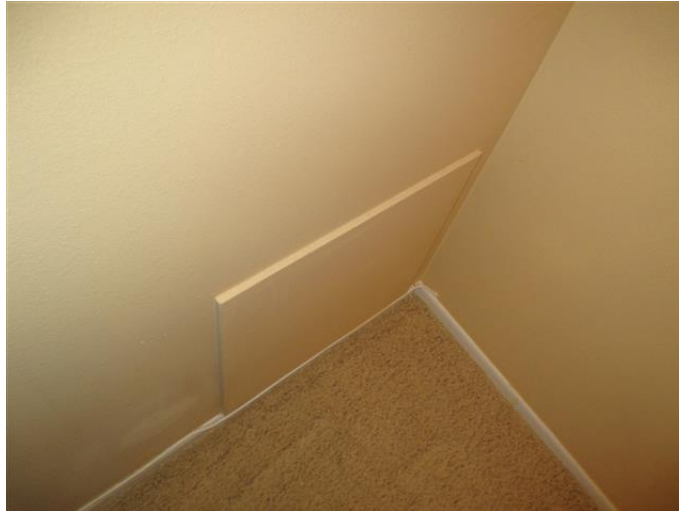
General Information Item: The cover plate for the access opening for the bathtub was painted shut and was not removed during the inspection.

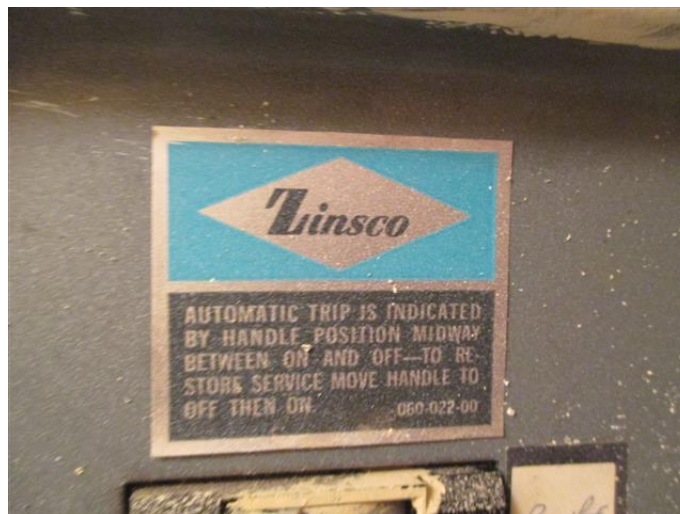
Concern Item: The home is equipped with a Zinsco type main electrical panel and circuit breakers. This brand of electrical equipment has been determined to have a higher than normal failure rate and represents a possible safety concern. Replacement parts can be expensive and difficult to acquire. For further evaluation and information regarding this system, we recommend contacting a licensed electrical contractor.

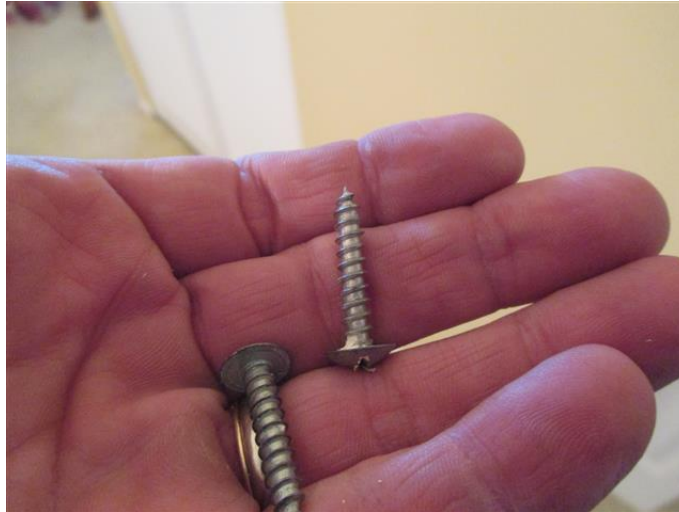
Correction Needed: Some of the fasteners securing the panel cover were improper (wood or sheet metal fasteners) and should be replaced with the proper blunt-tipped screws (safety concern).

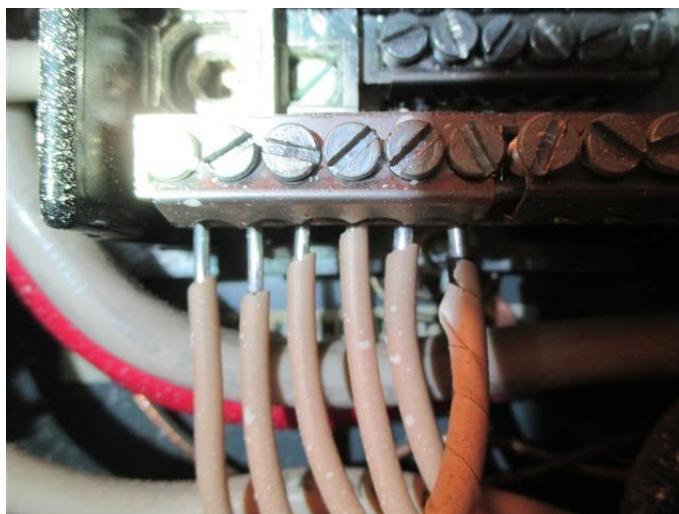
The service entry conductor material is aluminum, which is fed in from underground. The dwelling is equipped with aluminum non-metallic cable type (i.e. Romex) branch wiring.

Concern Item: If more information is desired regarding the possible hazards associated with aluminum branch wiring, along with preventive maintenance measures that can be taken, we recommend contacting a licensed electrician.

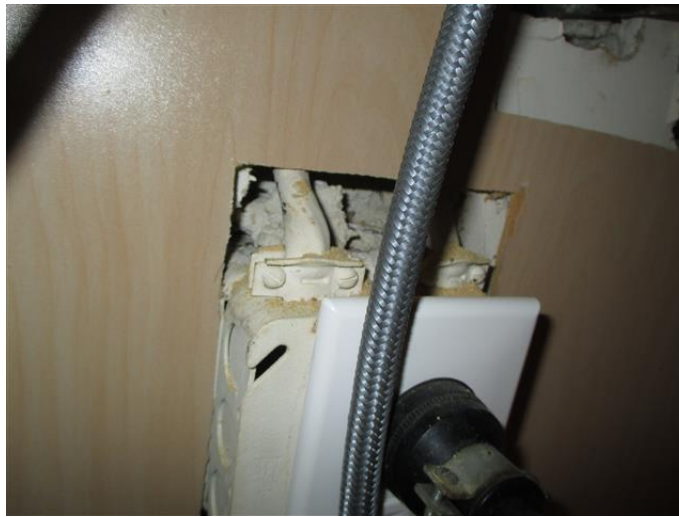
Correction Needed: The exposed electrical cables connected to the outlet box underneath the kitchen sink should be properly covered.

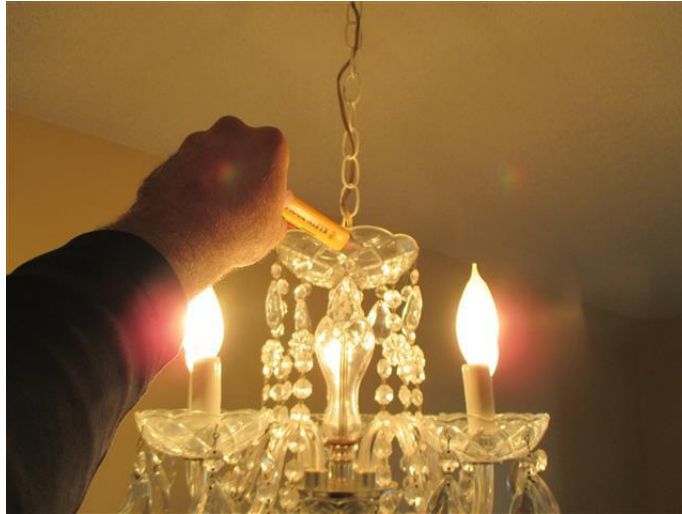
Correction Needed: The chandelier in the dining room area appeared to have an open ground.

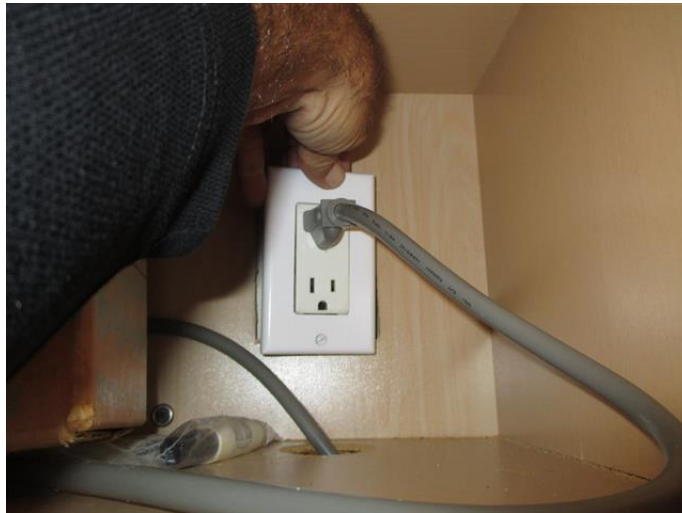
Correction Needed: The receptacle box above the microwave was loose.

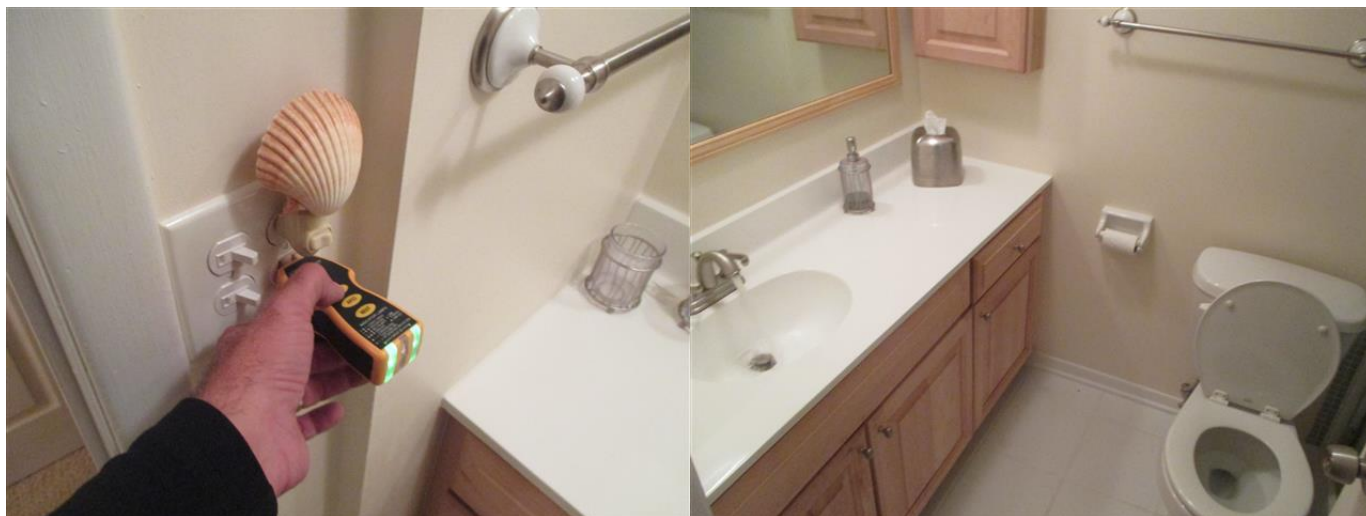
Correction Needed: The receptacle in the upgraded bathroom was not GFCI protected per current standards.

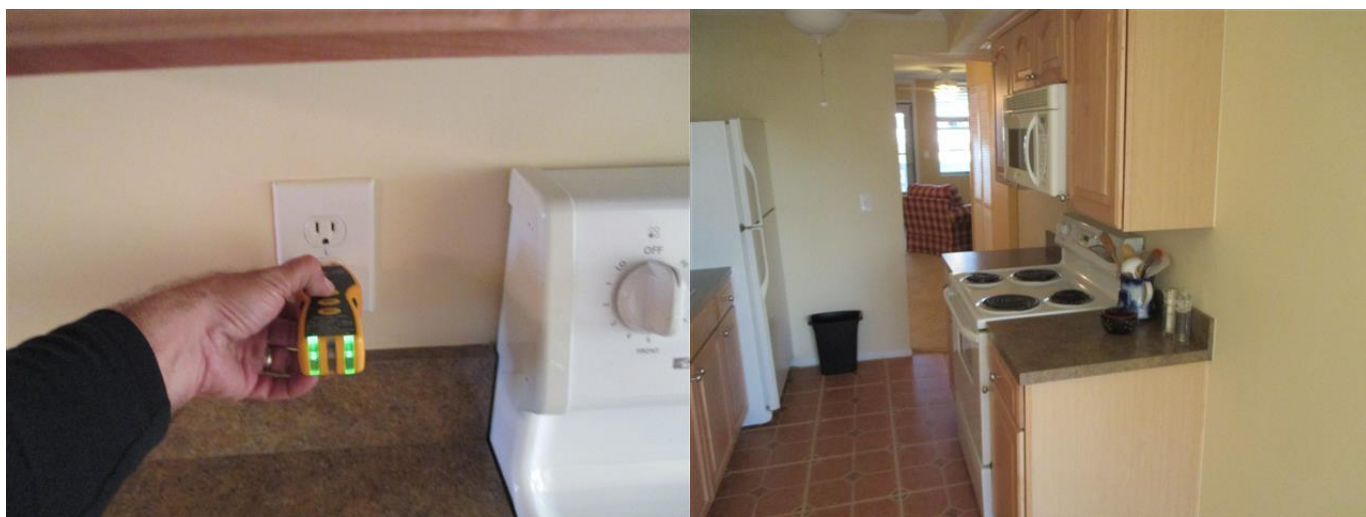
Correction Needed: The receptacle to the left of the stovetop in the upgraded kitchen was not GFCI protected per current standards.

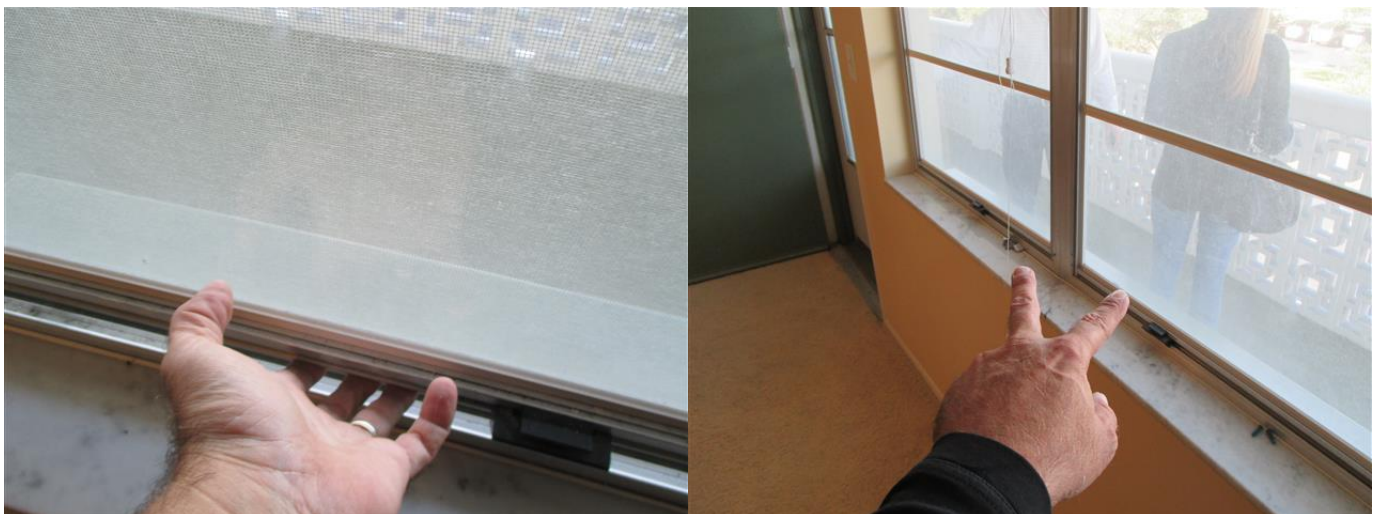
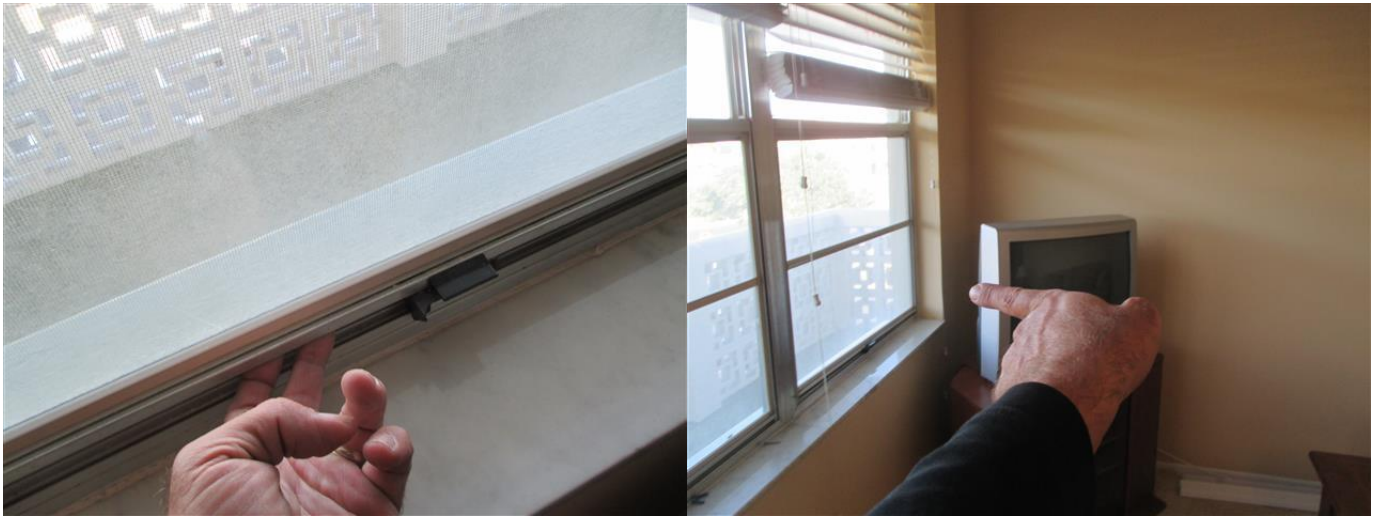
Repair Needed: In the living room, the left side and middle windows would not stay open. The right side window would not open.

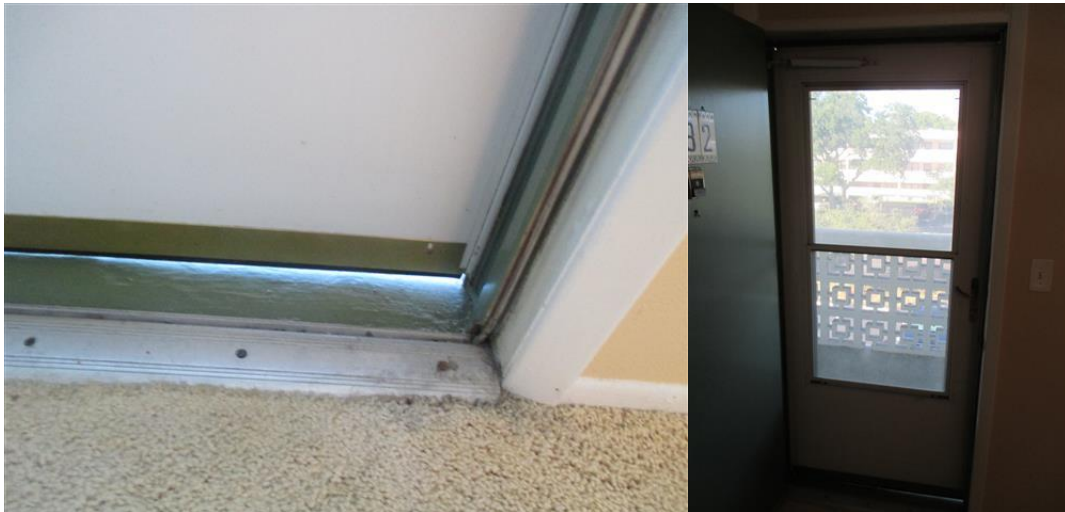
Adjustment Needed: We recommend adjusting the sweep on the base of the storm door on the main entry way so that it will seal fully when closed.

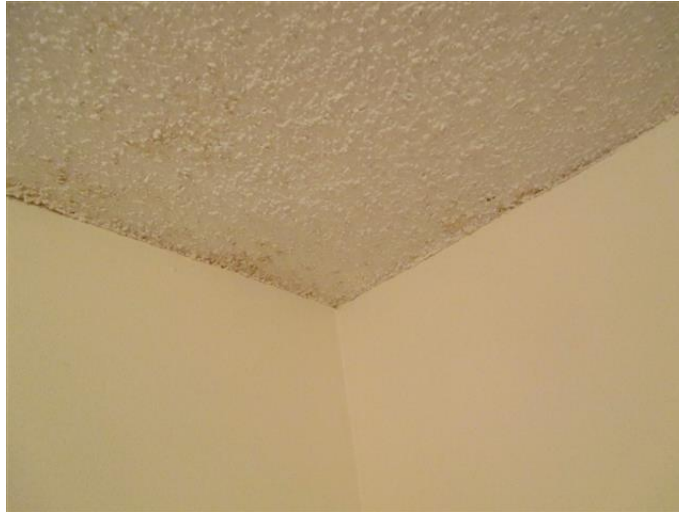
Cosmetic Item: We noted some discoloration to the back left-hand corner of the ceiling in the closet. The area tested negative for active moisture intrusion at the time of inspection.

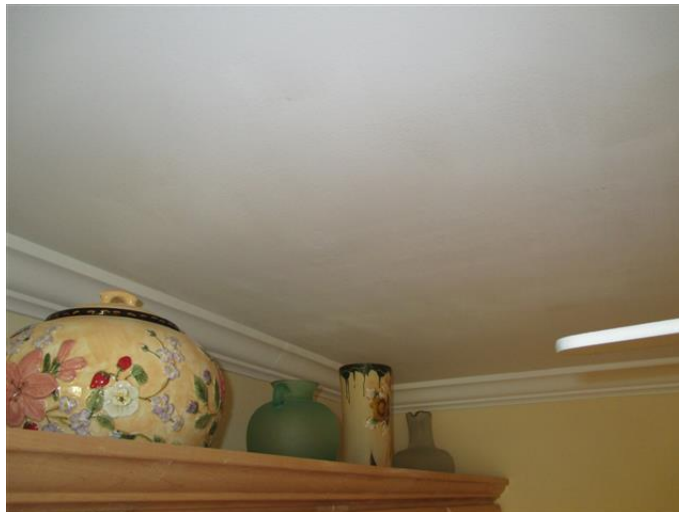
Cosmetic Item: We noted a past repair to the ceiling over the kitchen sink. The area tested negative for active moisture intrusion at the time of inspection.
