INTRODUCTION

GENERAL CONDITION OF DWELLING

The dwelling is a north facing two-story block and framed structure on slab with a hip type roof design. The dwelling was constructed circa 1984.

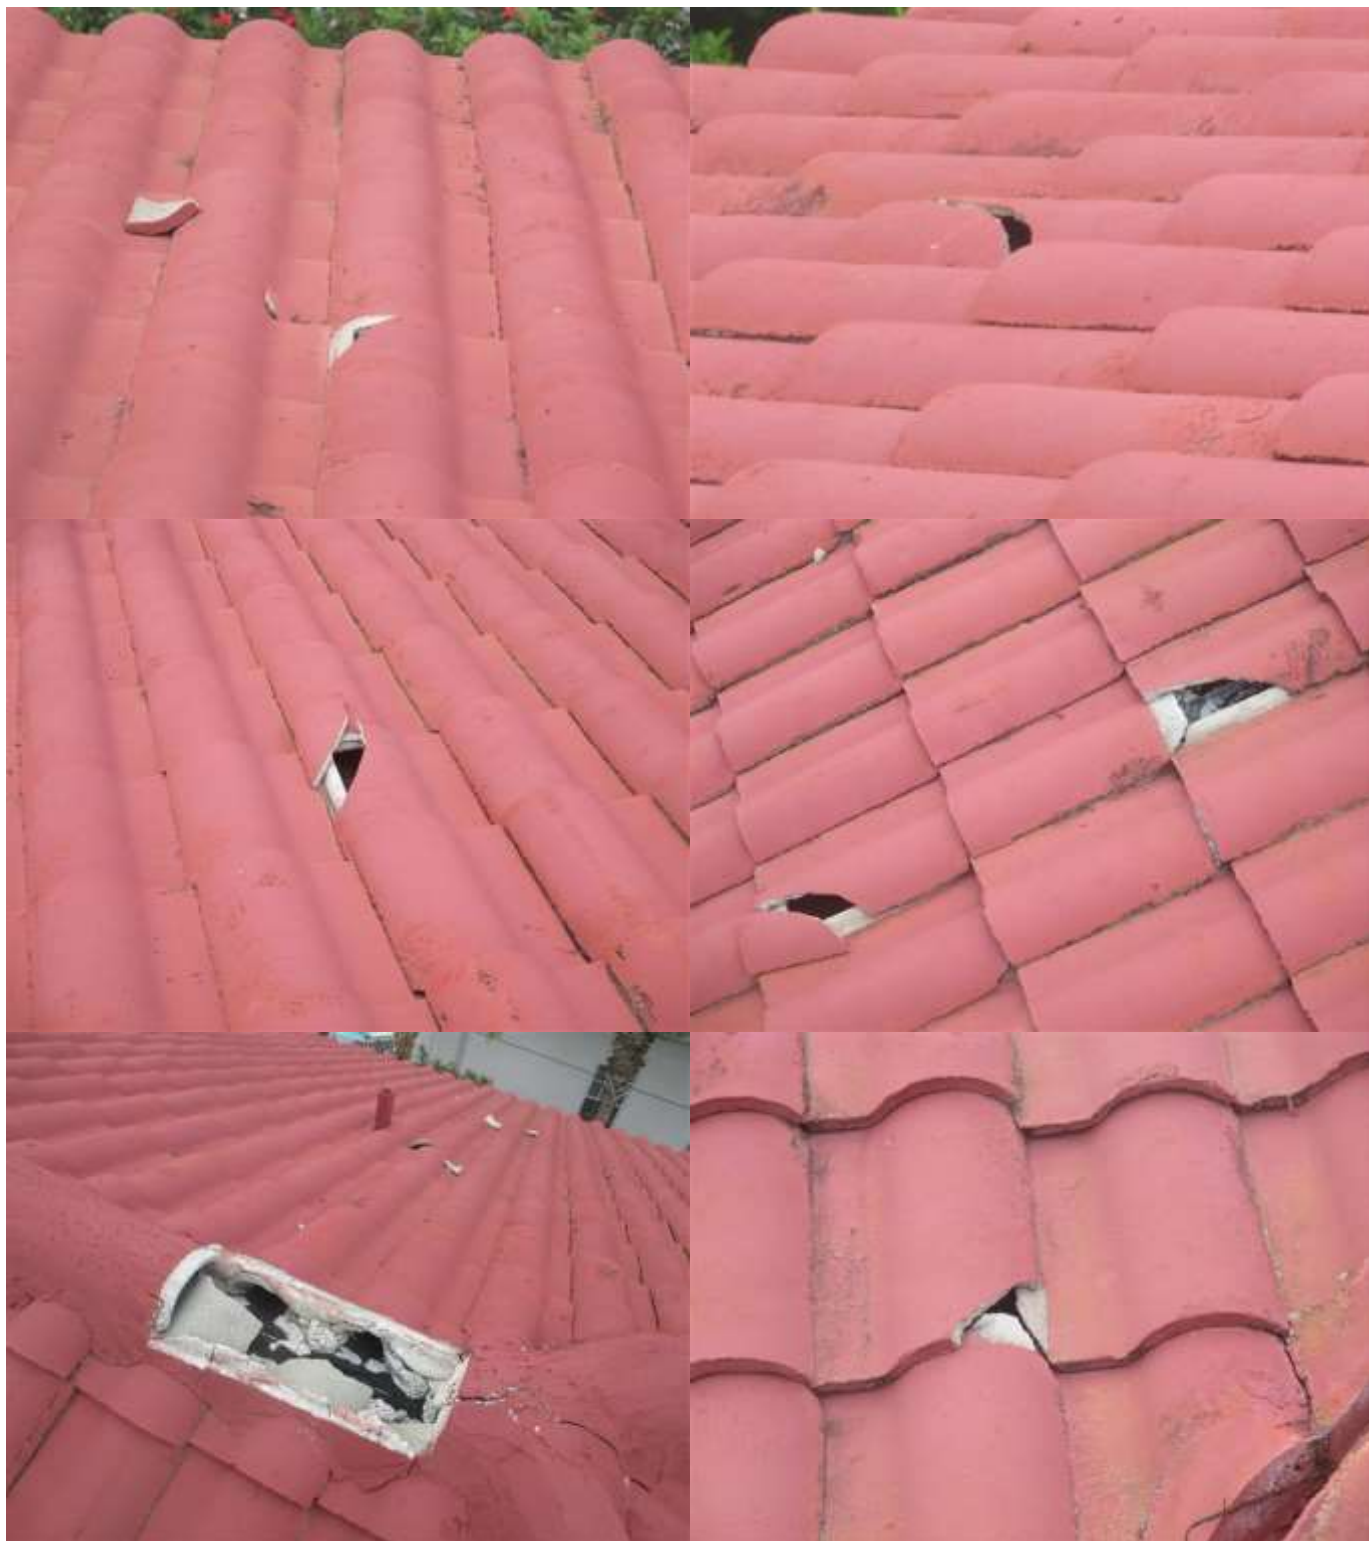
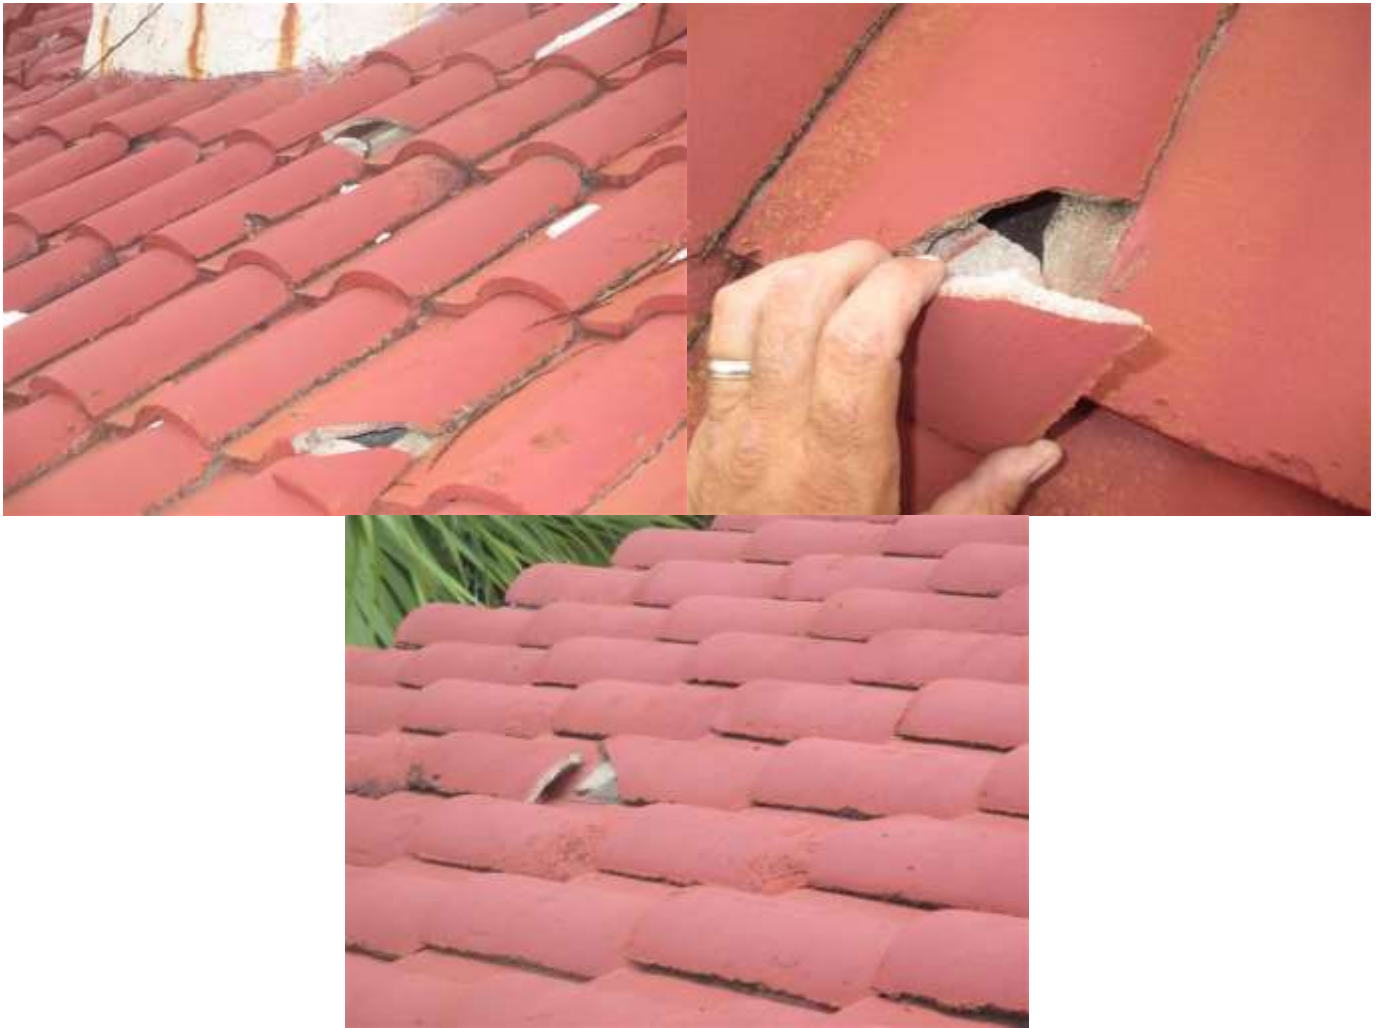
Repair Needed: We noted numerous cracked and damaged tiles that were exposing underlayment.

Repair Needed: some of the exposed underlayment was showing signs of deterioration and will need to be repaired or replaced.

Recommendation: We recommend contacting a licensed roofing contractor regarding replacement of this roof.

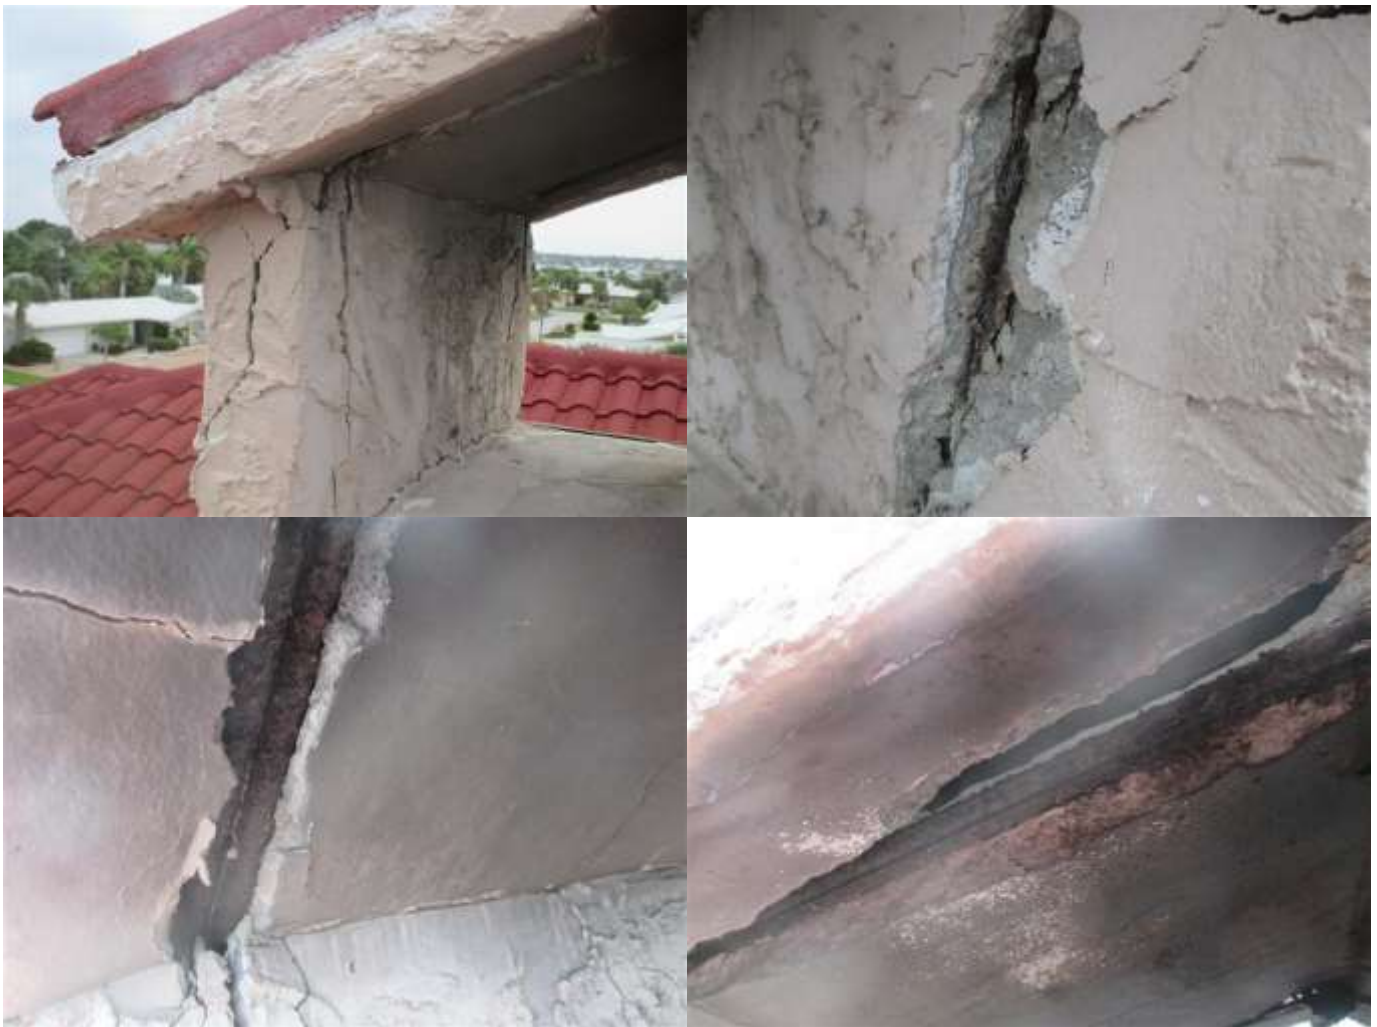
Repair Needed: The masonry crown and cap were heavily deteriorated and will need to be rebuilt or removed.

Replacement Needed: The metal cap for the chimney had corroded away.

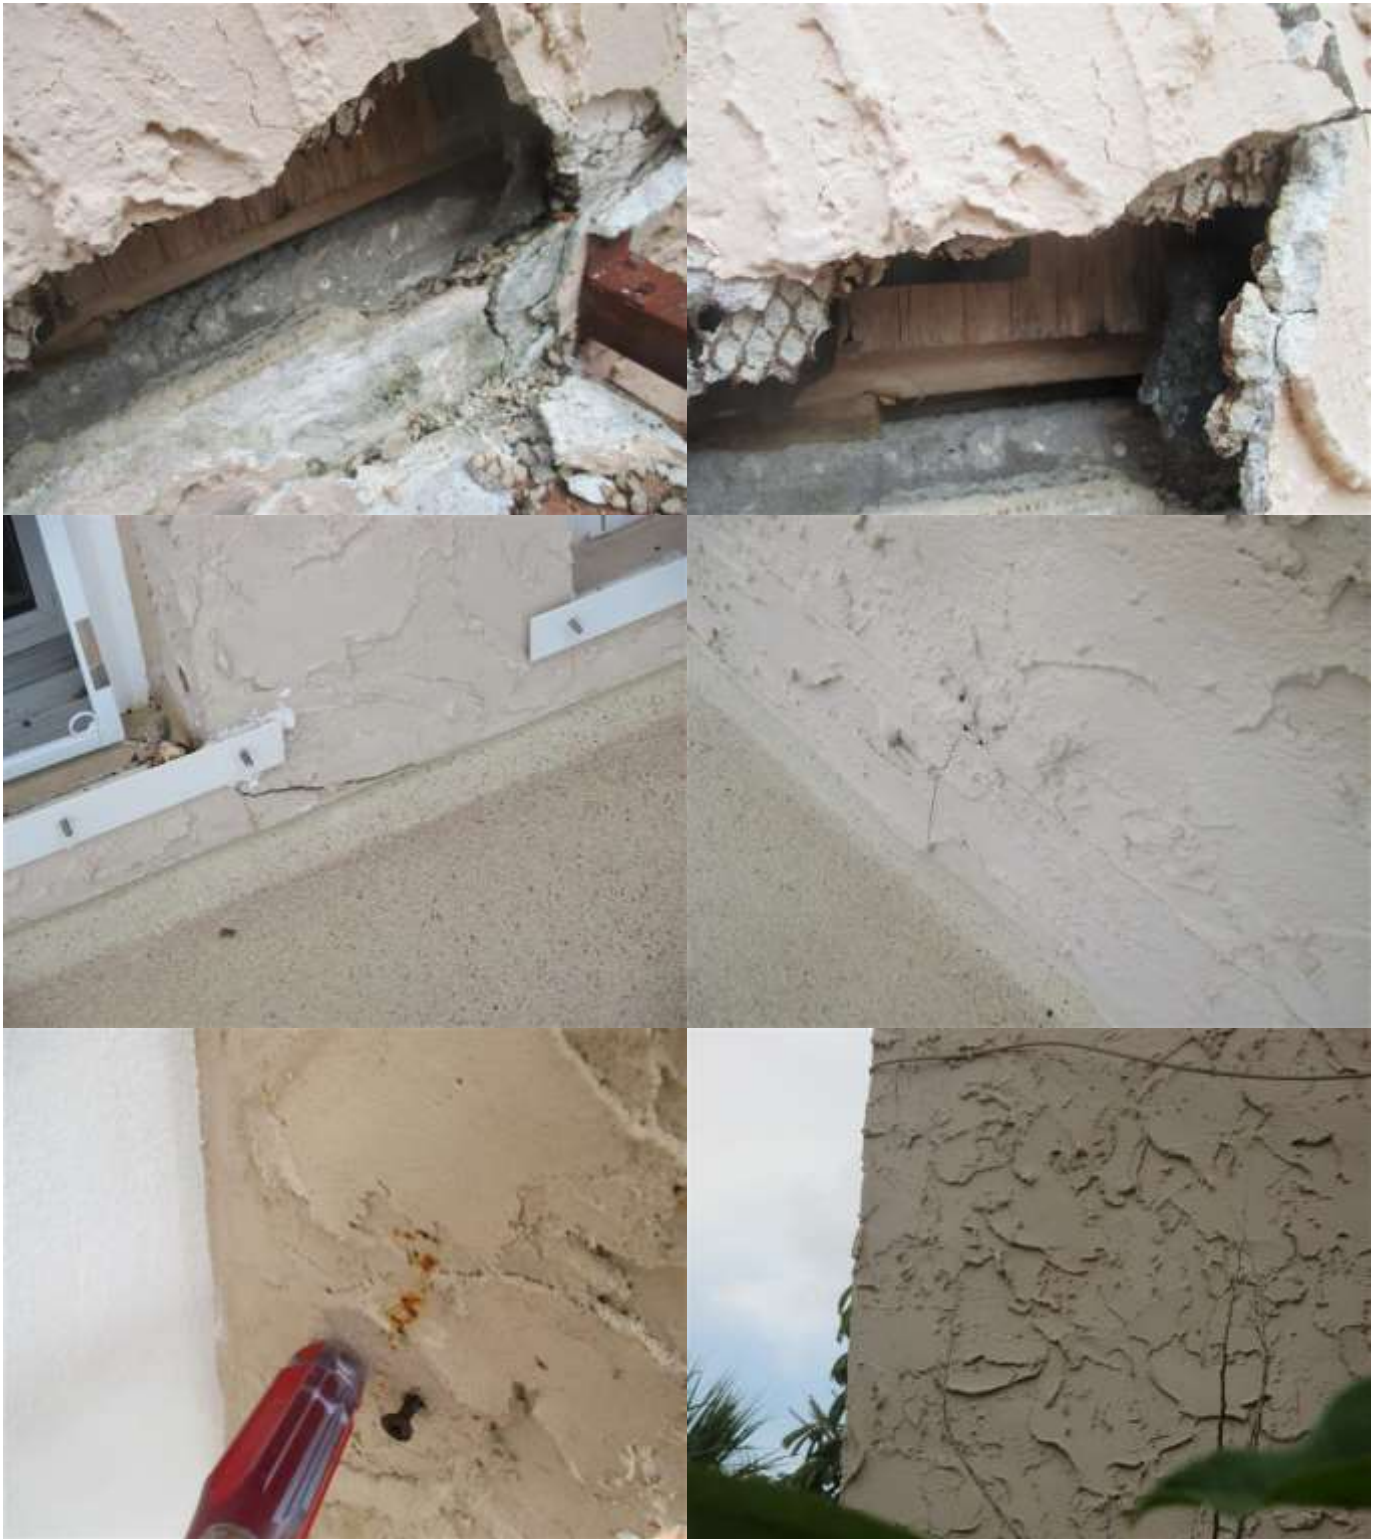
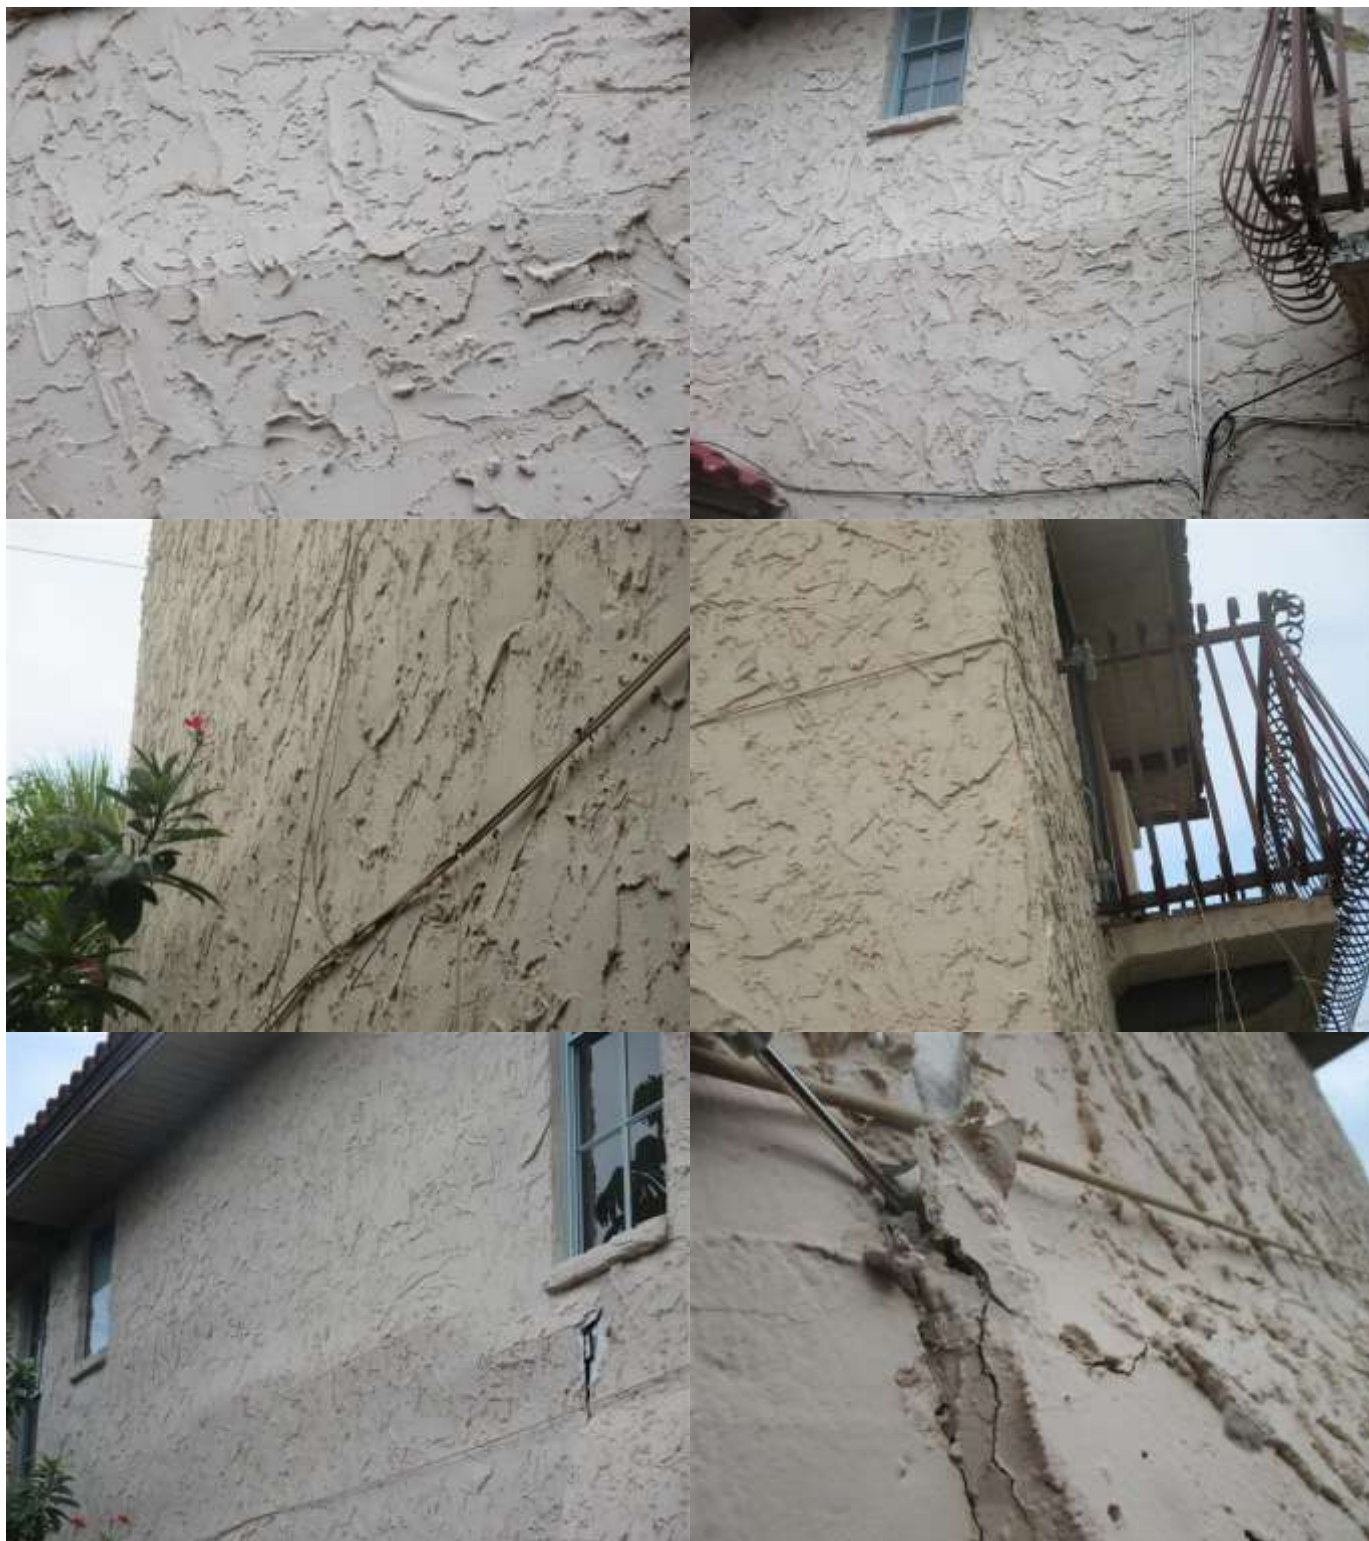
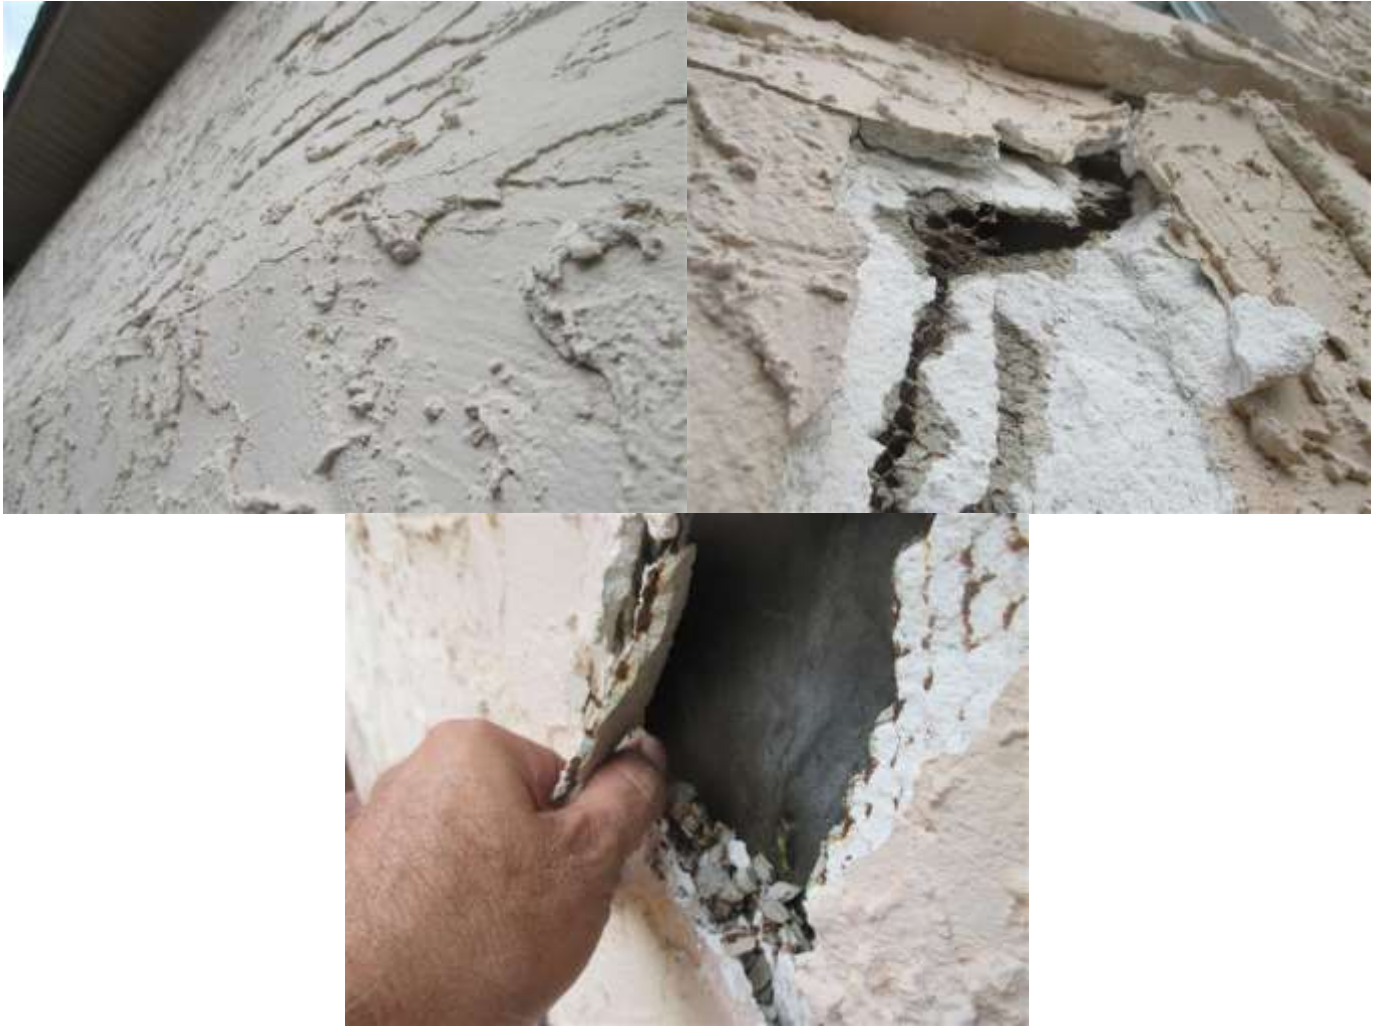
Repair Needed: We noted numerous areas where the stucco siding on the framed portions of the dwelling were heavily cracked and/or buckling. Active moisture intrusion was detected in many of these areas. In some areas the stucco had opened to the point where the sheathing was exposed. We recommend removing all stucco from the framed portions of the dwelling to allow further inspection and, if necessary, repair to the sheathing and framing. Any new stucco should be installed with the appropriate drainage to meet current standards.

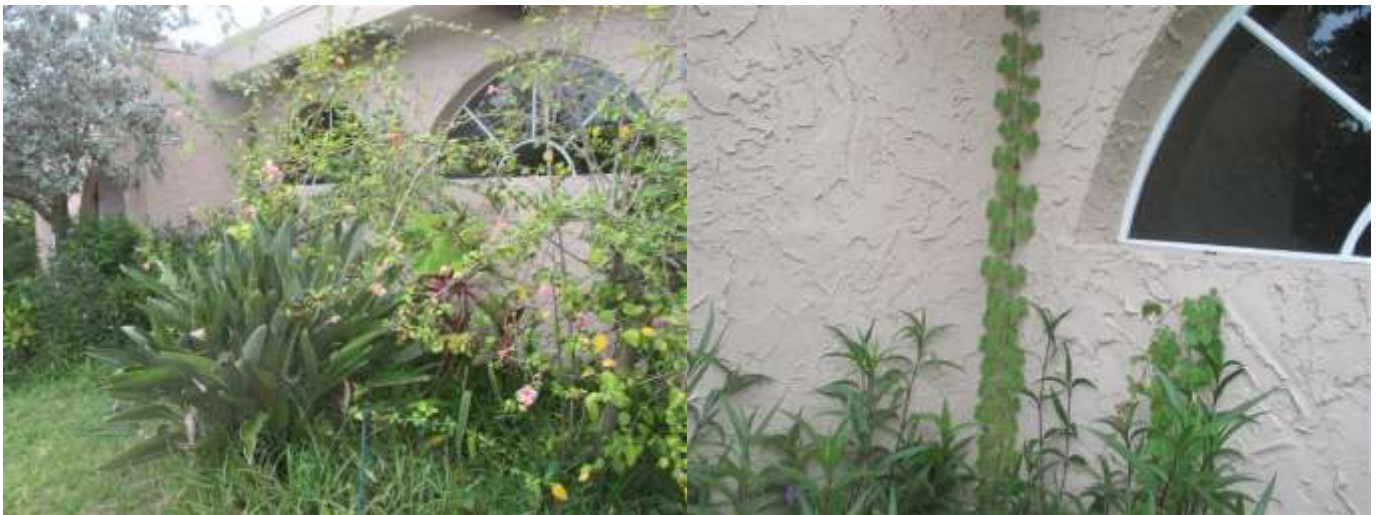
Maintenance Needed: Any vegetation contact with the exterior walls should be trimmed back.

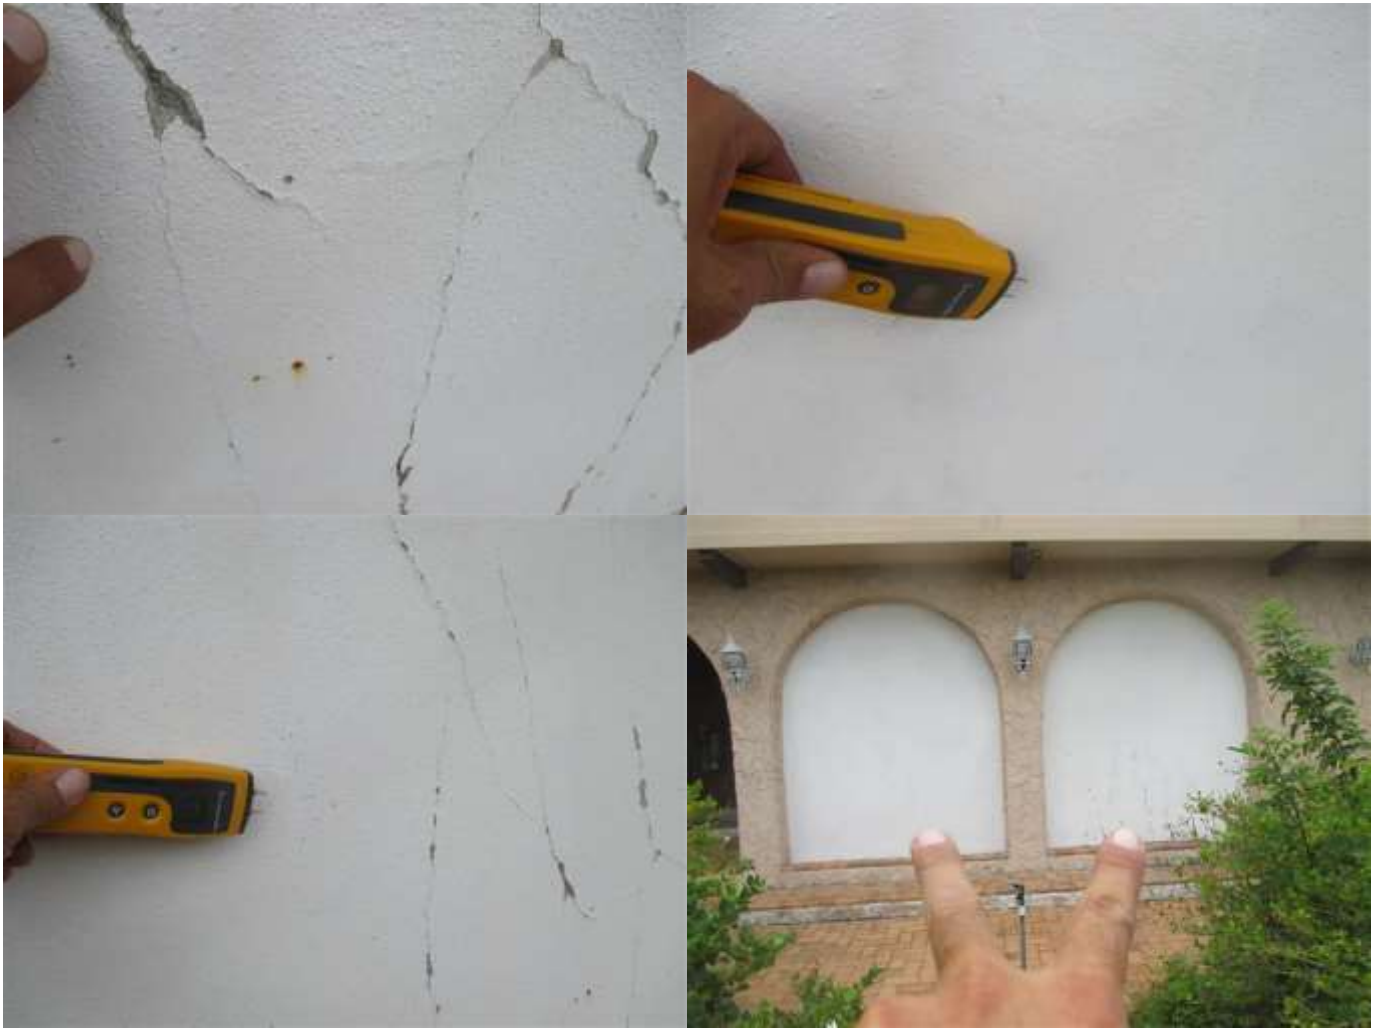
Repair Needed: We noted cracks and detected active moisture intrusion behind the stucco on the walls inside the archways located to the right of the main entry. The stucco siding should be removed to allow further inspection of the sheathing and framing.

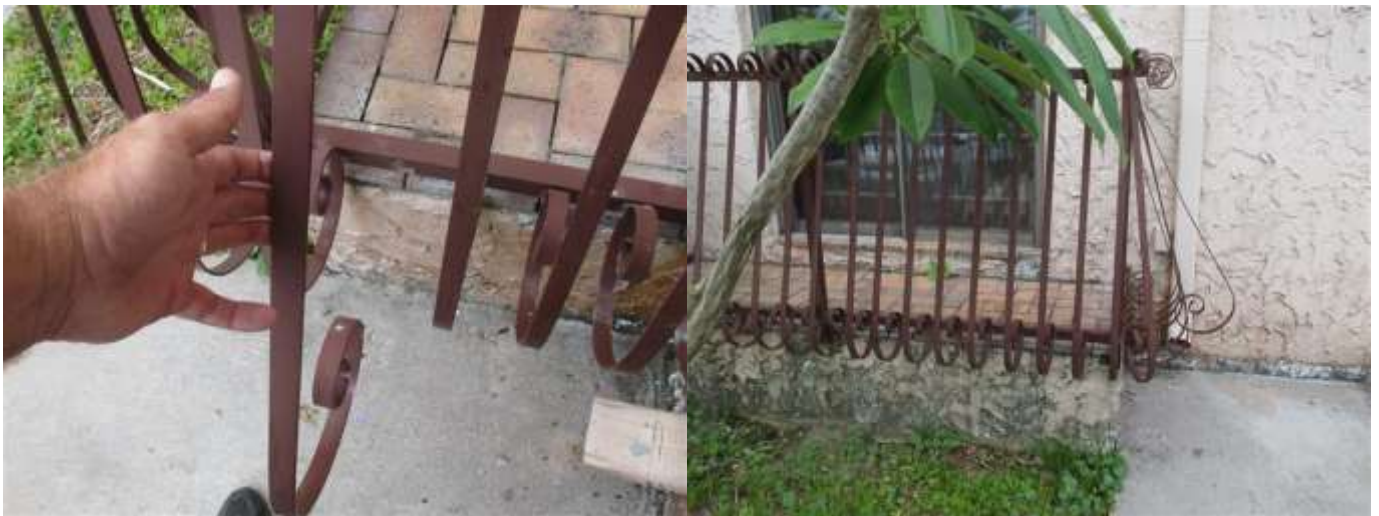
Repair Needed: Some of the balusters for the railing around the lower deck at the northeast corner of the dwelling were coming loose.

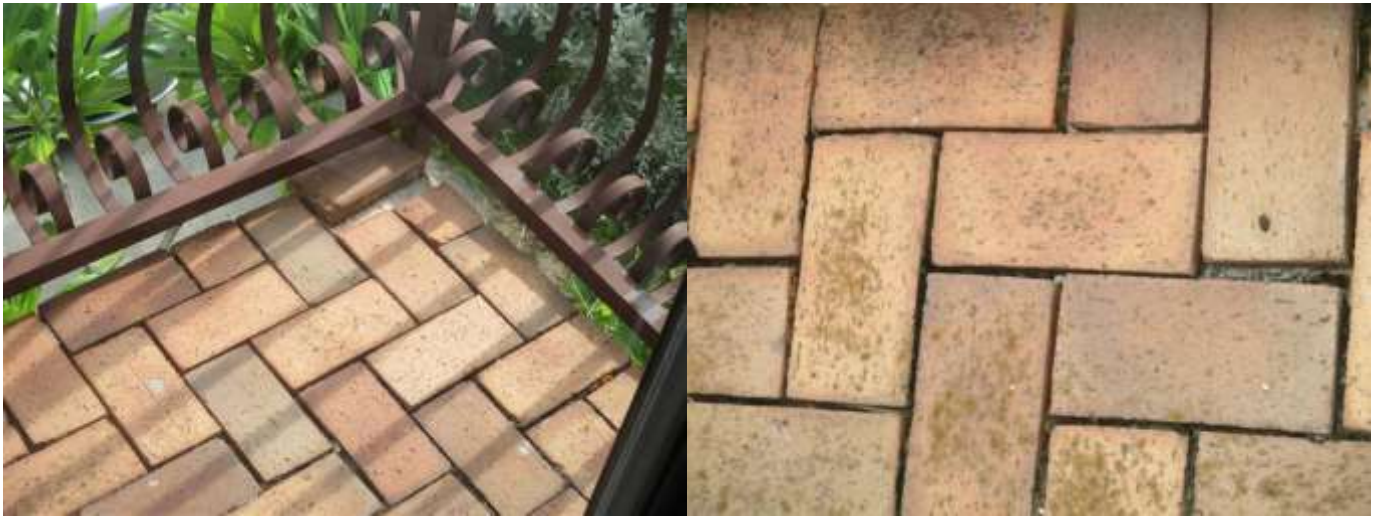
Repair Needed: The pavers on the upper deck at the northeast corner the dwelling should be reset and secured.

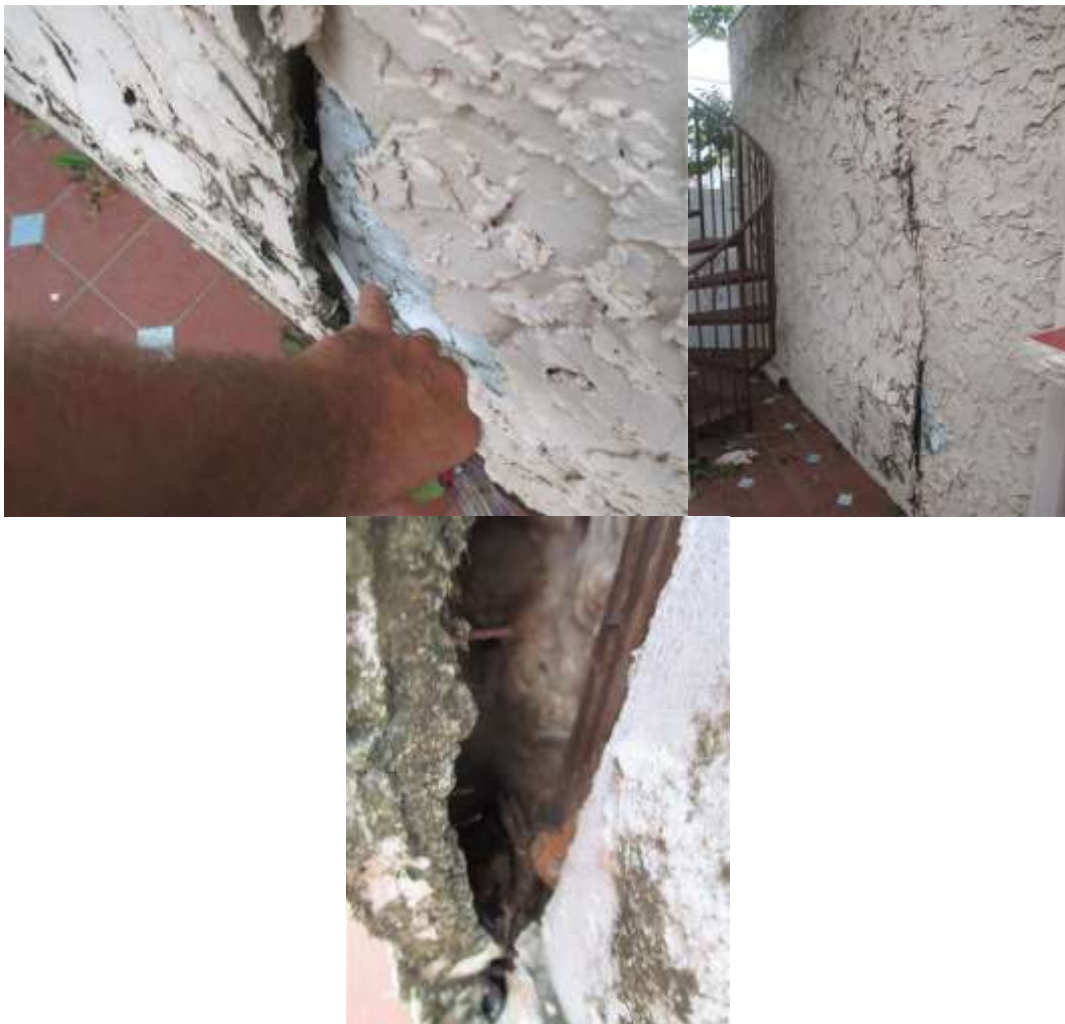
Repair Needed: The stucco siding on the field and archway behind the spiral staircase was heavily cracked and deteriorated. We noted deteriorated framing behind the stucco. The stucco should be removed to allow the area to be properly repaired.

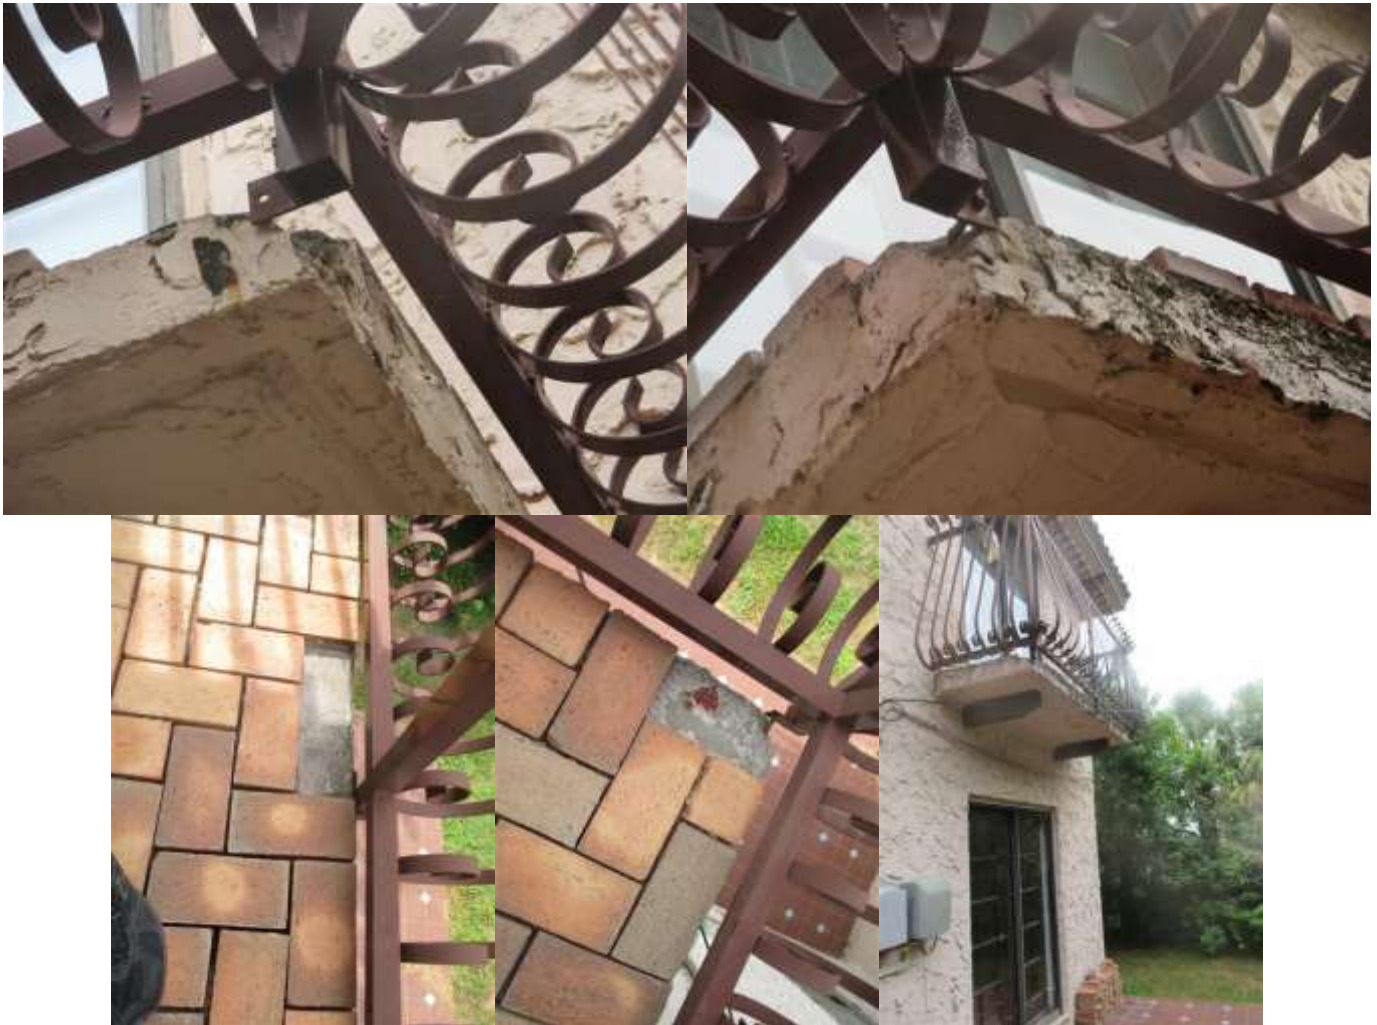
Repair Needed: The corners of the railing around the upper deck at the southeast corner the dwelling were not secured to the deck. The pavers on the deck should be reset and secured.

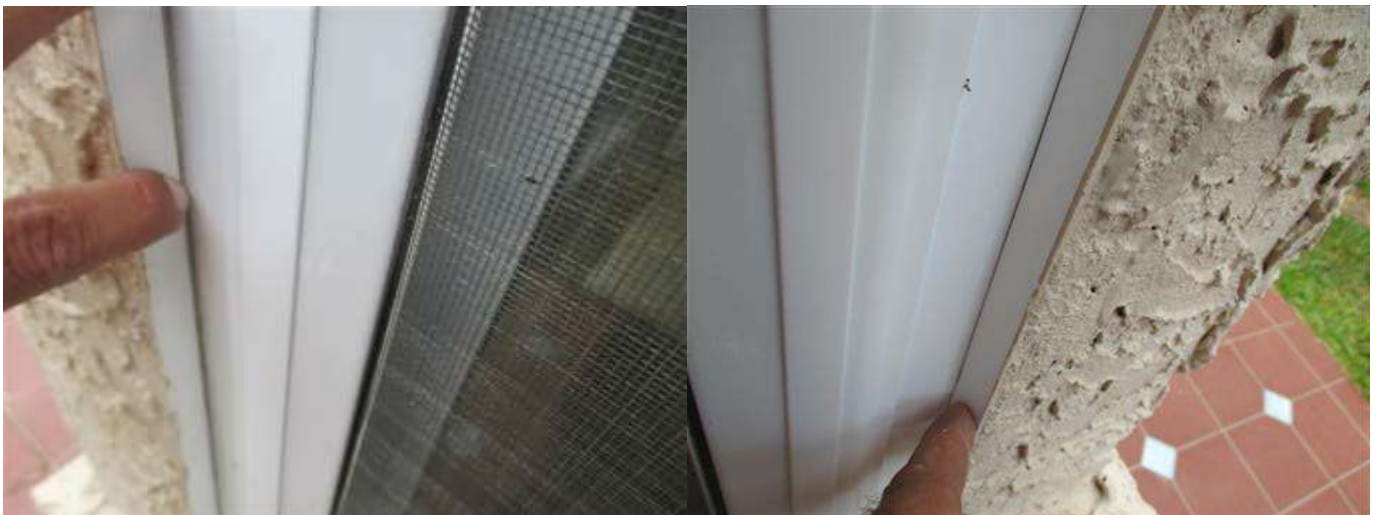
Maintenance Needed: The window openings on the sunroom should be sealed prevent moisture intrusion behind the stucco.

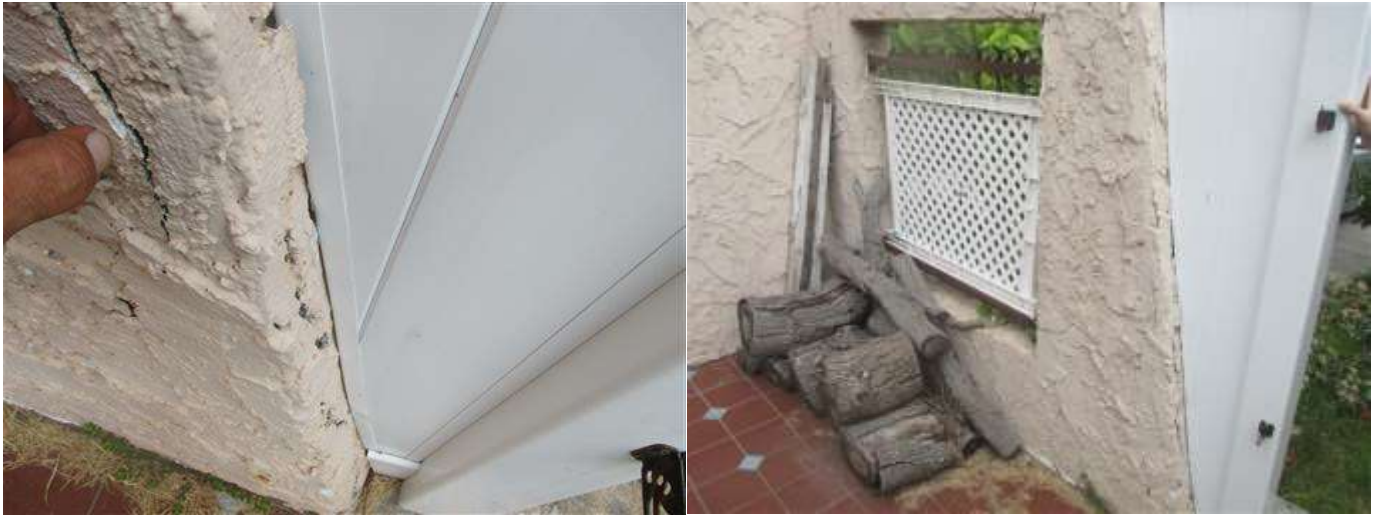
Repair Needed: We noted cracks in the privacy wall at the northeast corner the dwelling. The wall may need to be rebuilt.

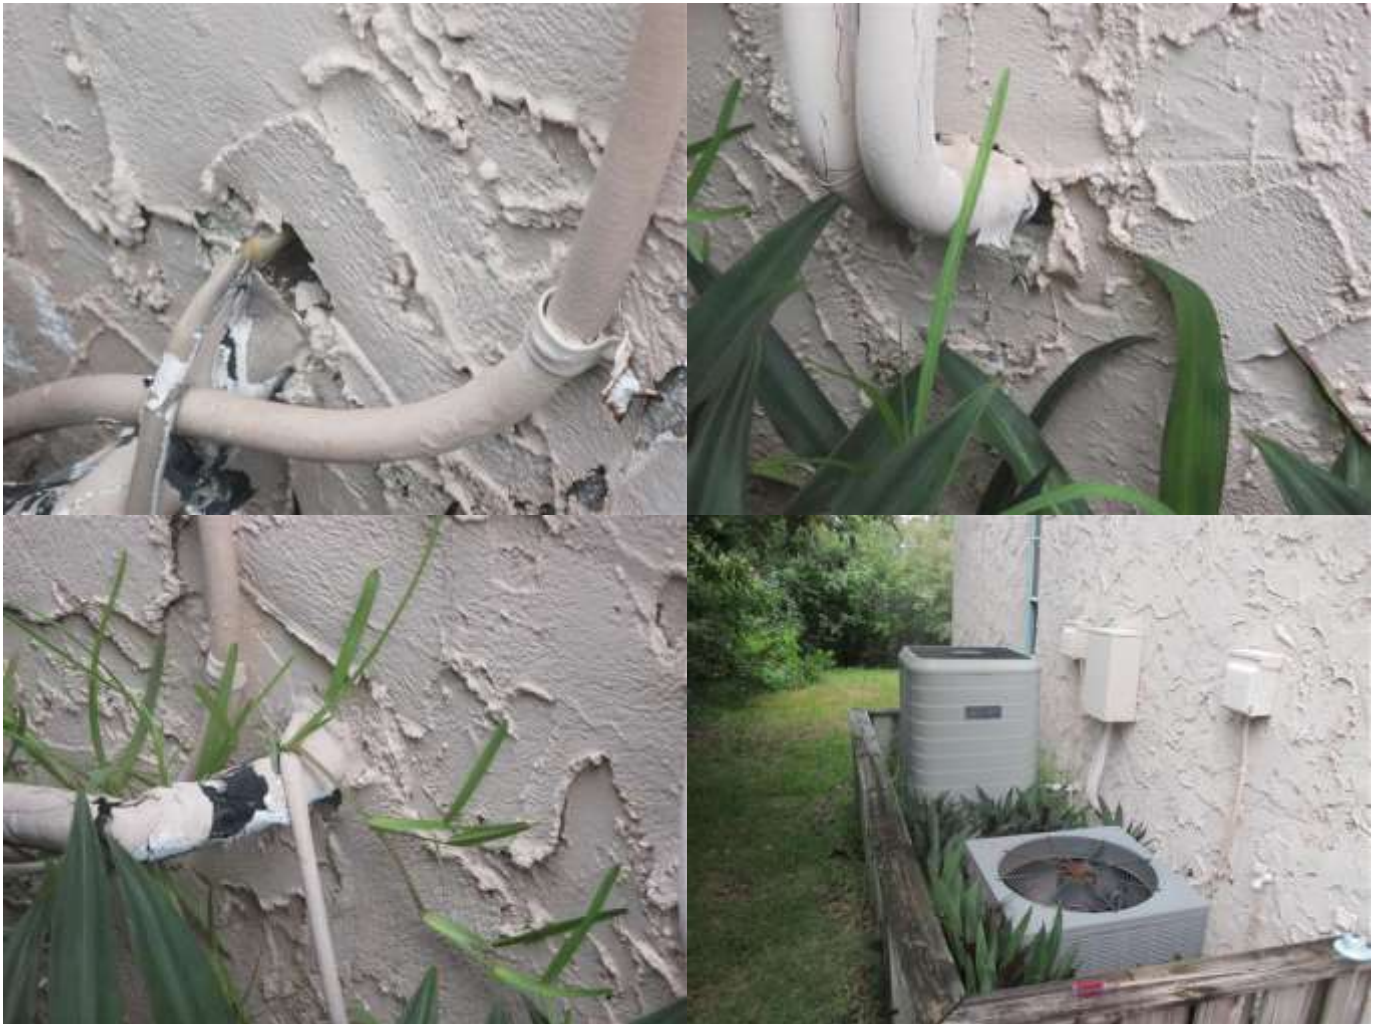
Maintenance Needed: The penetrations through the exterior wall for the air conditioning and electrical piping should be sealed as part of pest and moisture prevention.
