INTRODUCTION

GENERAL CONDITION OF DWELLING

The dwelling is a north facing two-story block and framed structure on slab with a hip type roof design. The dwelling was constructed circa 1984.

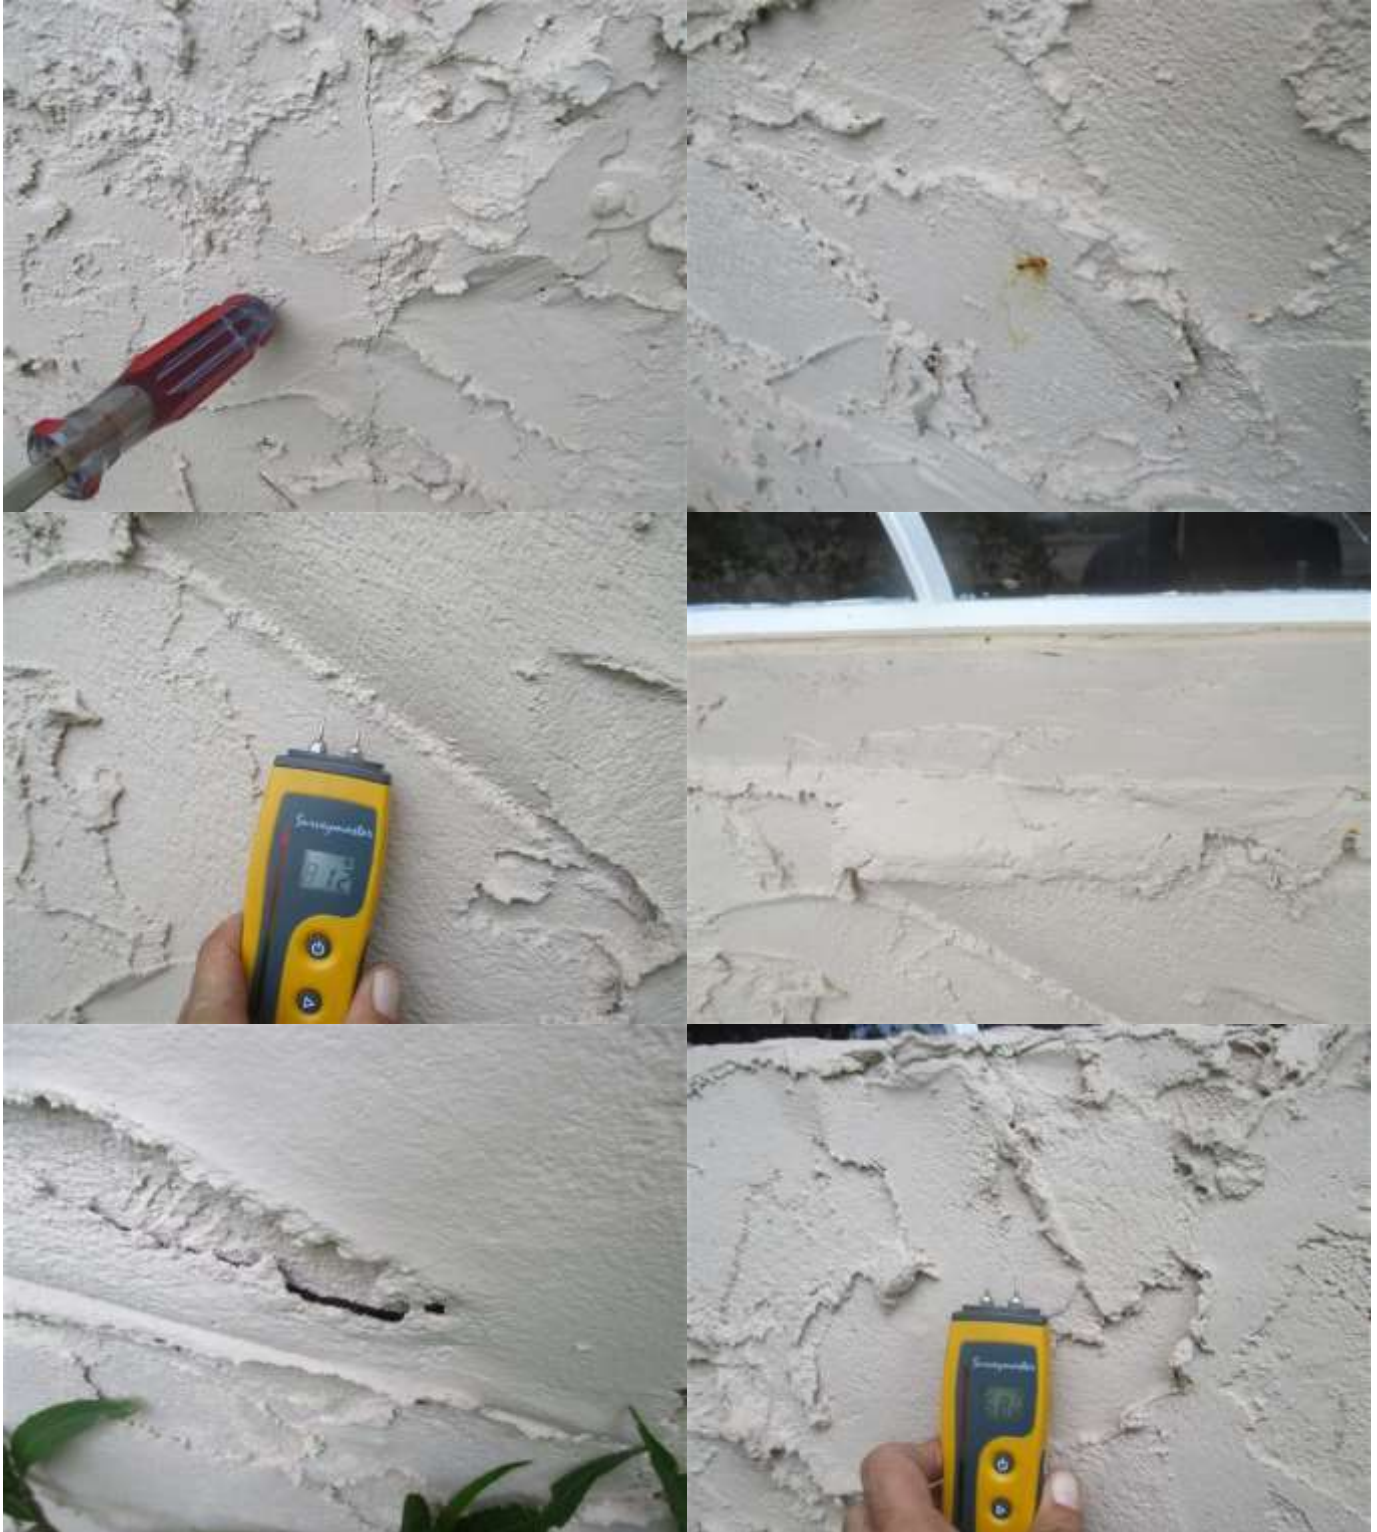
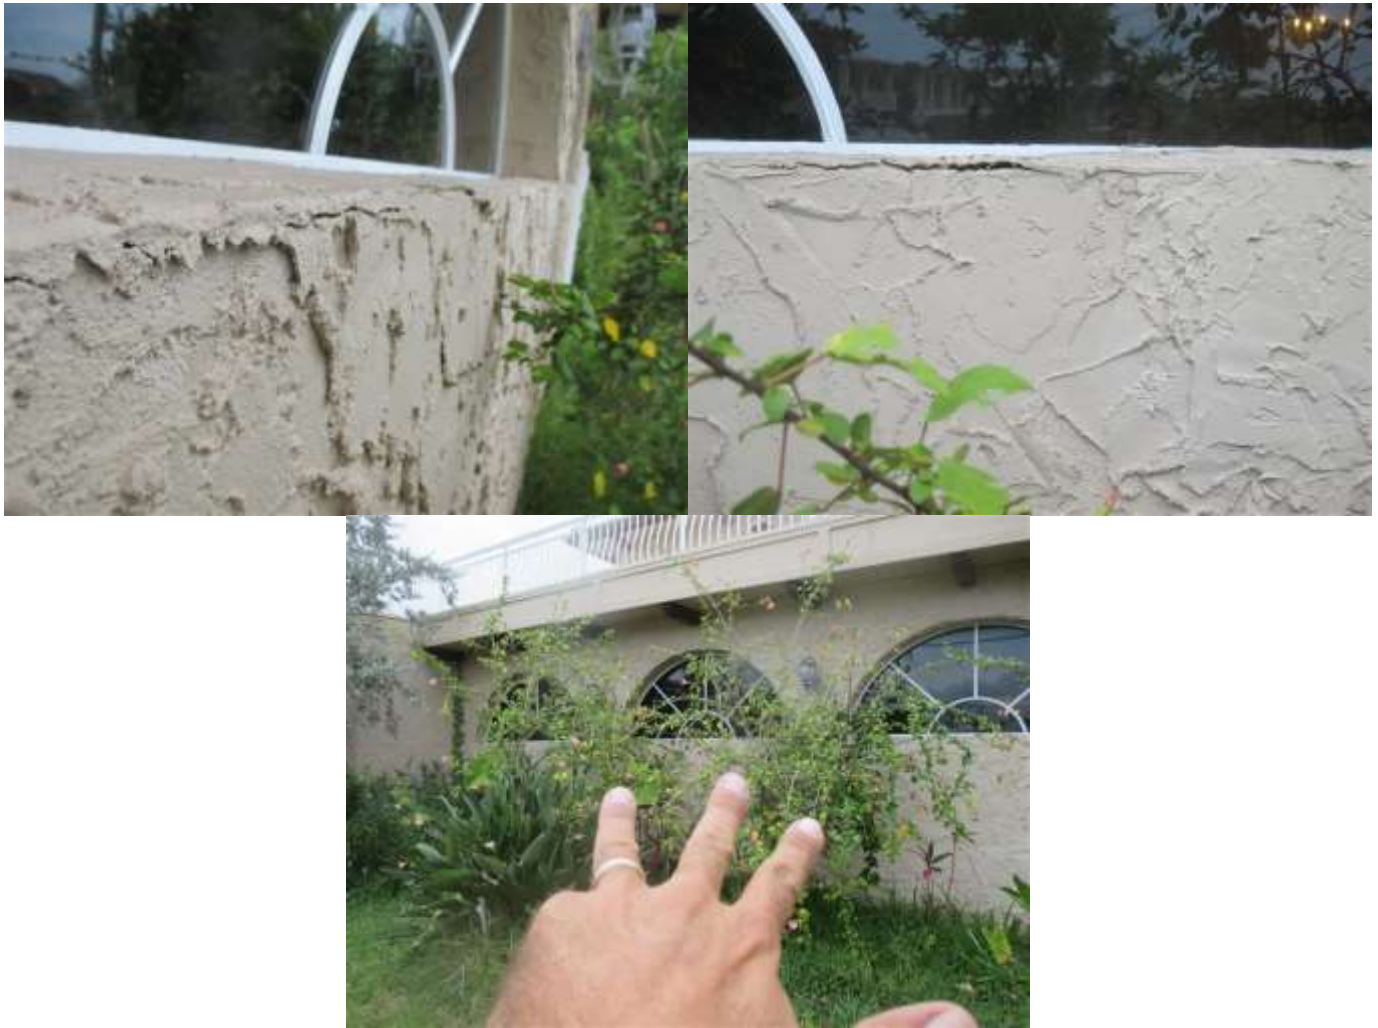
Repair Needed: We noted cracks and detected active moisture intrusion behind the stucco on the walls inside the along the elevation. The stucco siding should be removed to allow further inspection of the sheathing and framing.

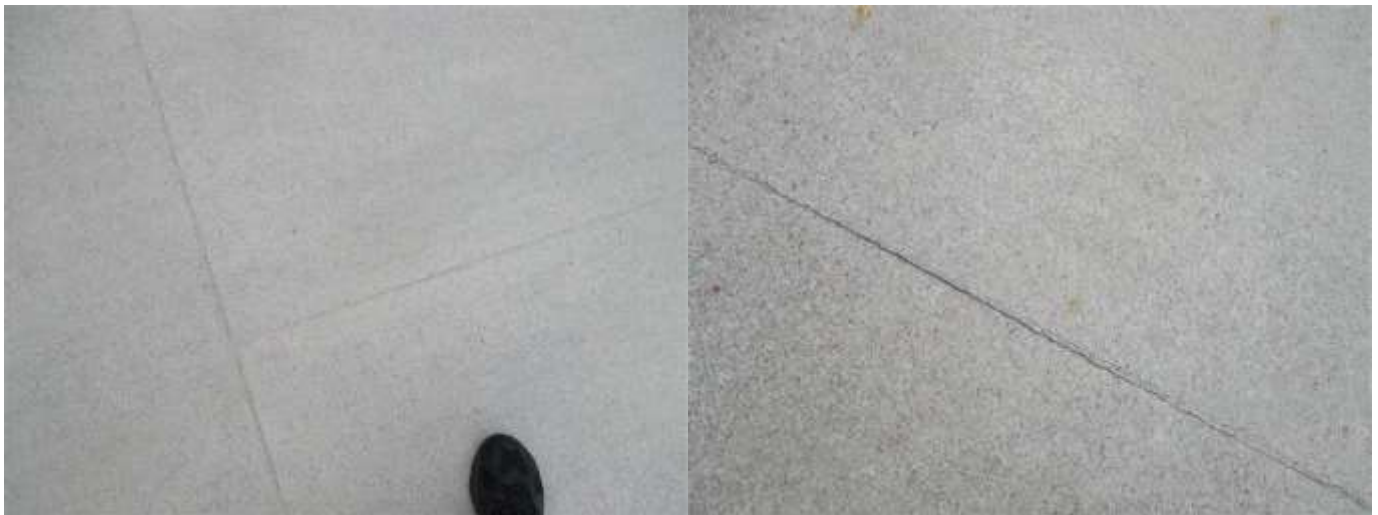
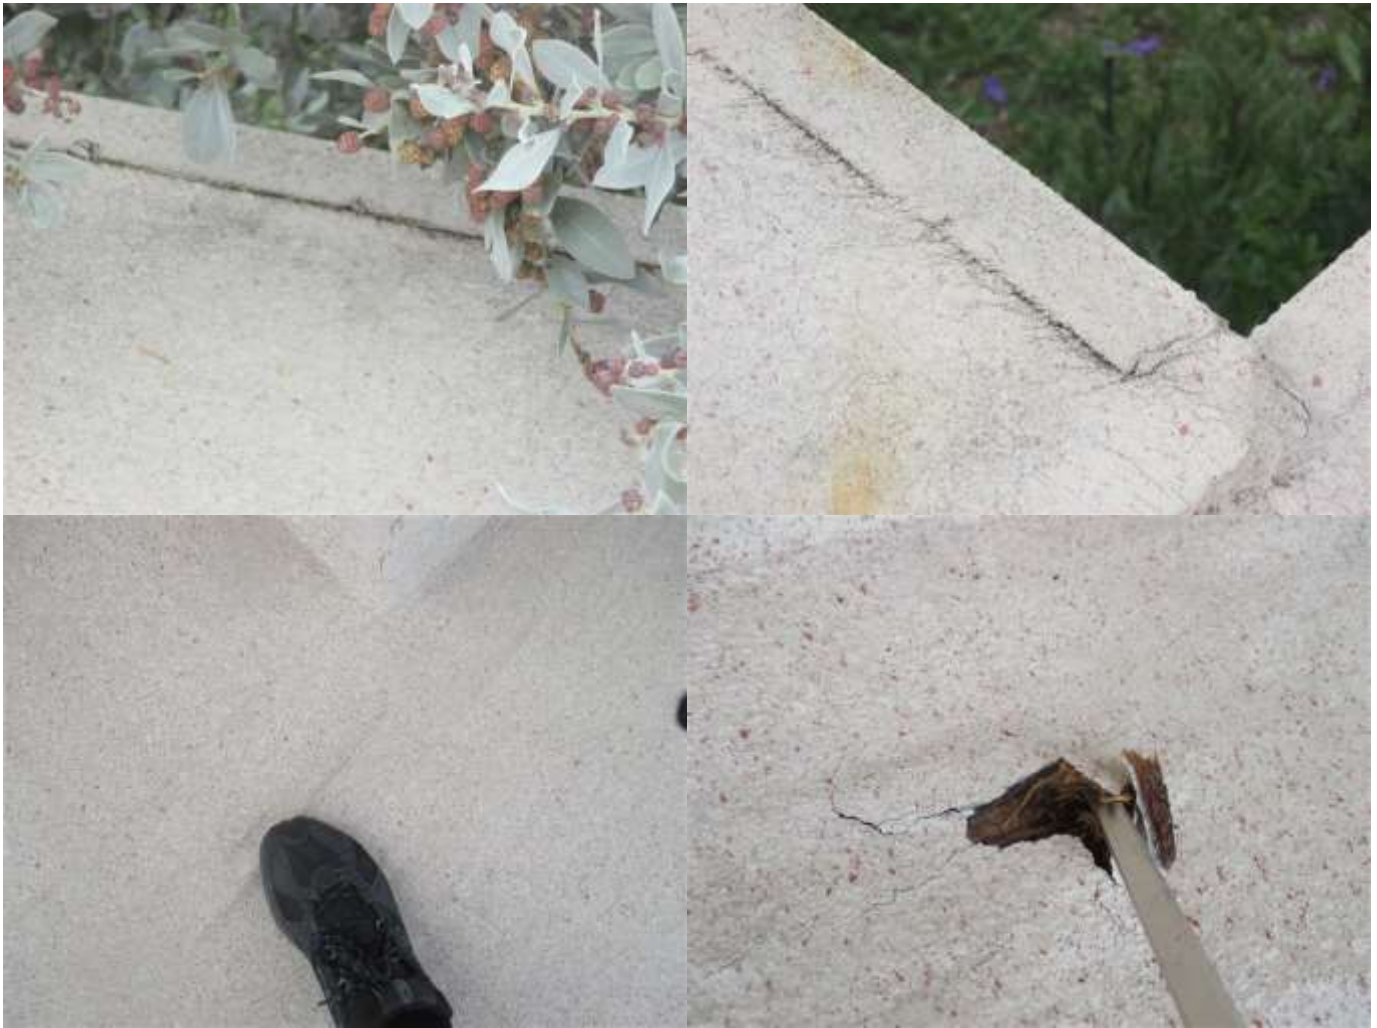
Repair Needed: We noted splits in the seams of the material on the upper deck. We also noted several areas of blistering, including one area where the deck covering had deteriorated to the point where it was allowing moisture to damage the sheathing.

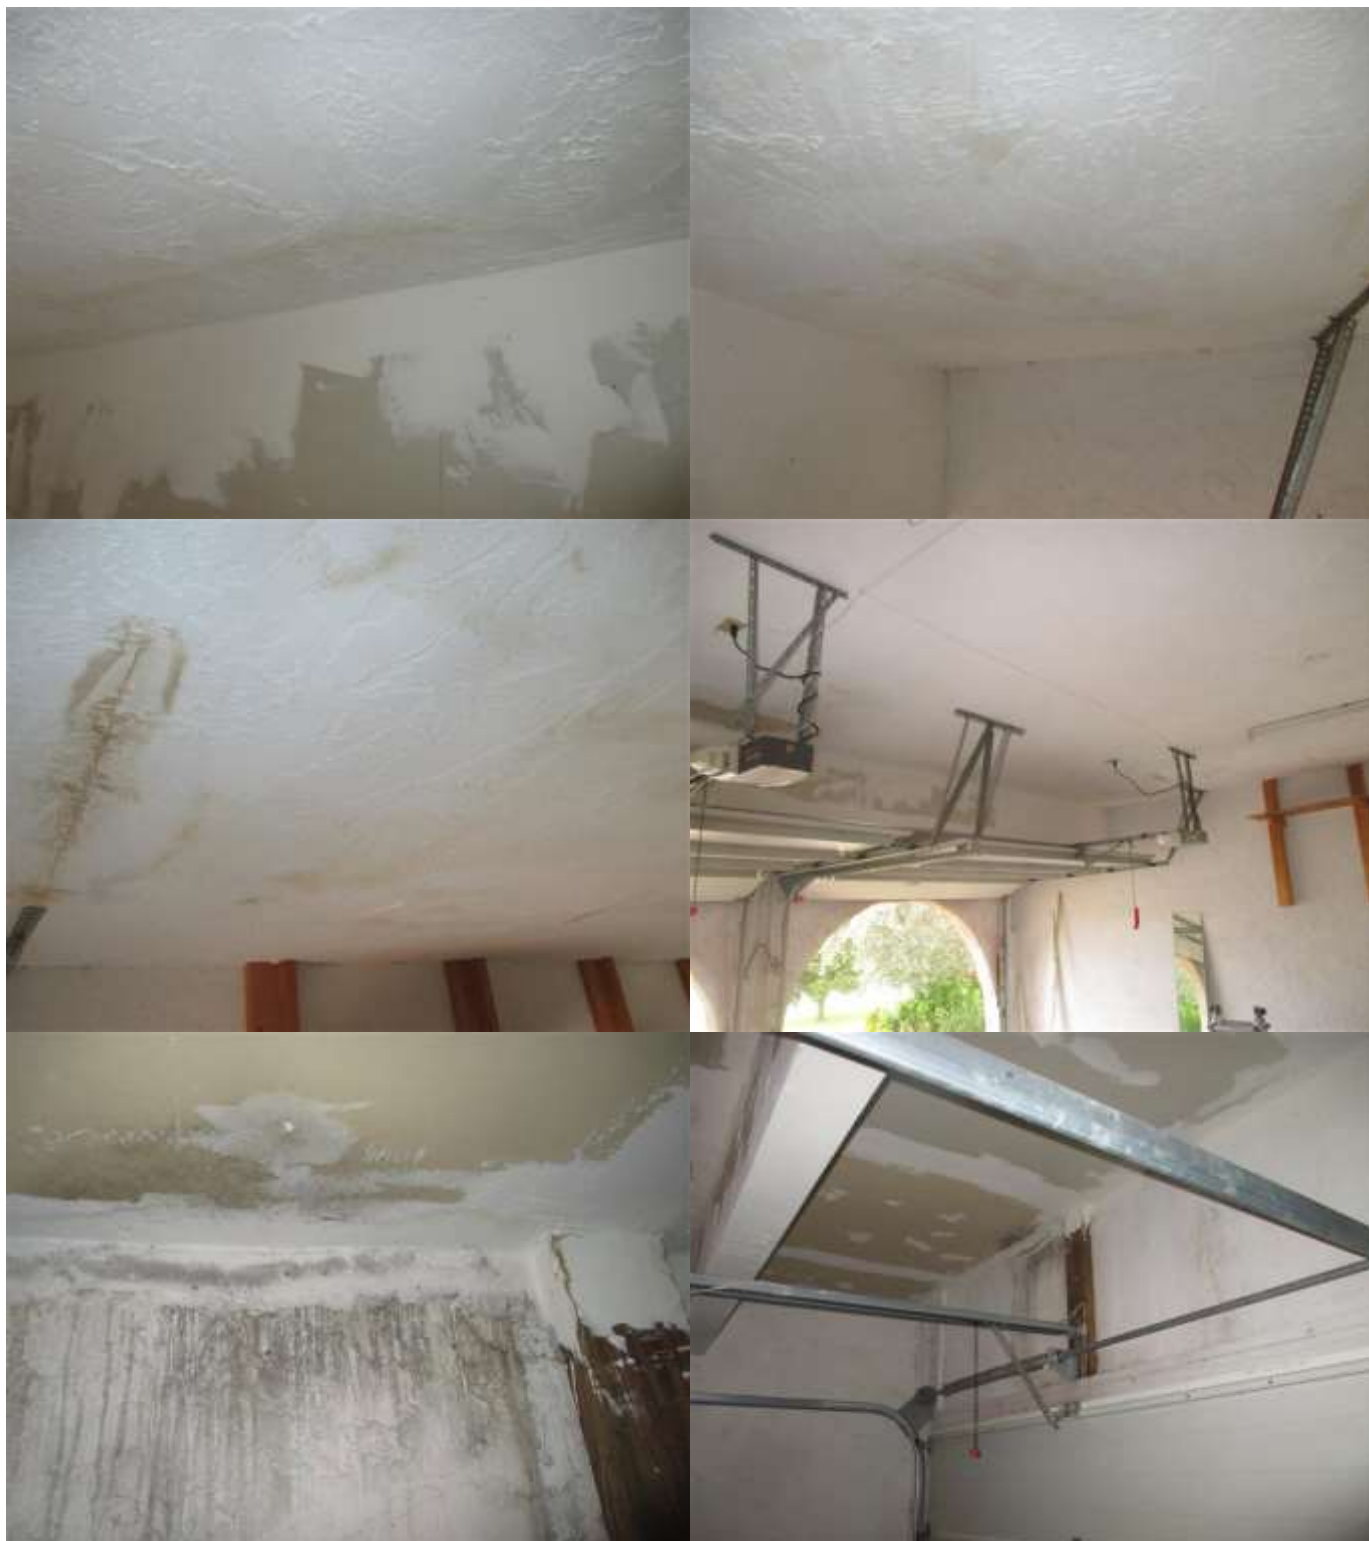
Concern Item (To Be Monitored): We noted numerous areas of staining to the ceiling in the garage, indicating areas of past moisture intrusion. Although these areas tested negative for active moisture intrusion at the time of inspection, they should be monitored.

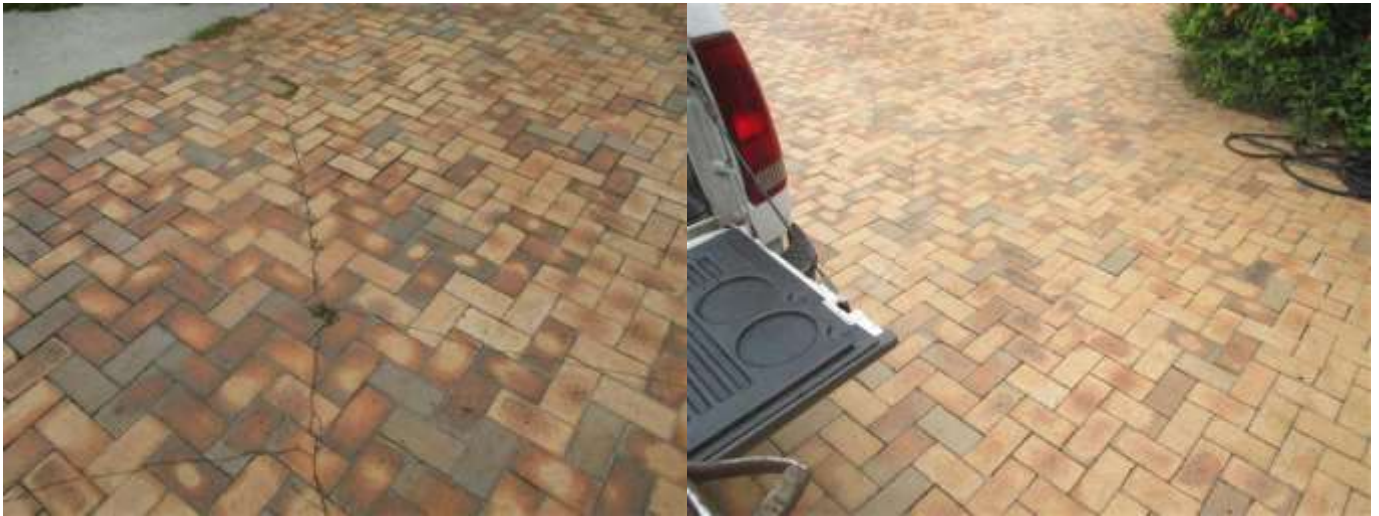
Repair Needed: We noted crack in the concrete patio on the south elevation.

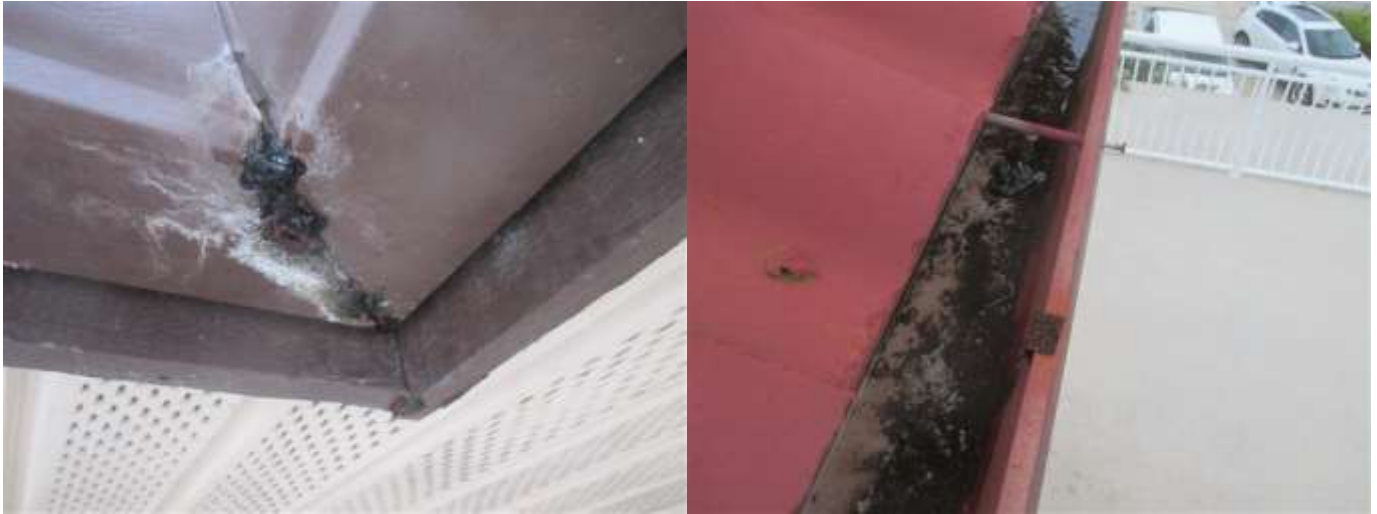
Correction Needed: The gutters along the upper roof were holding water and should be adjusted so that water will flow towards the downspout. We also noted leaking from the gutters.

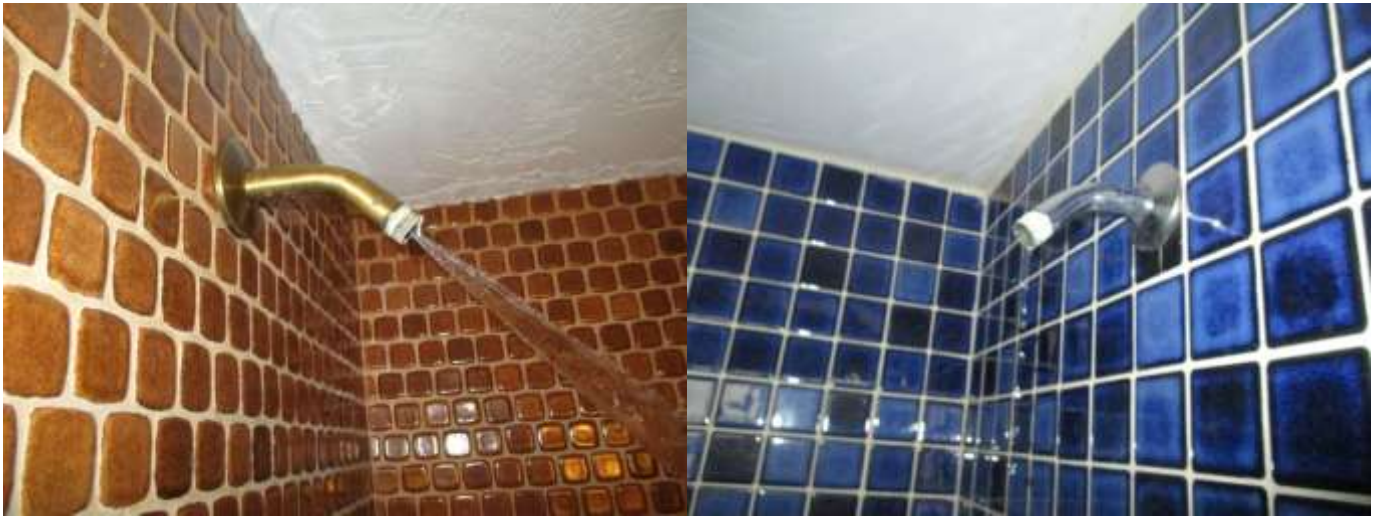
Correction Needed: The showerhead was not installed in the south hall and southeast second-floor bathroom shower and should be replaced.

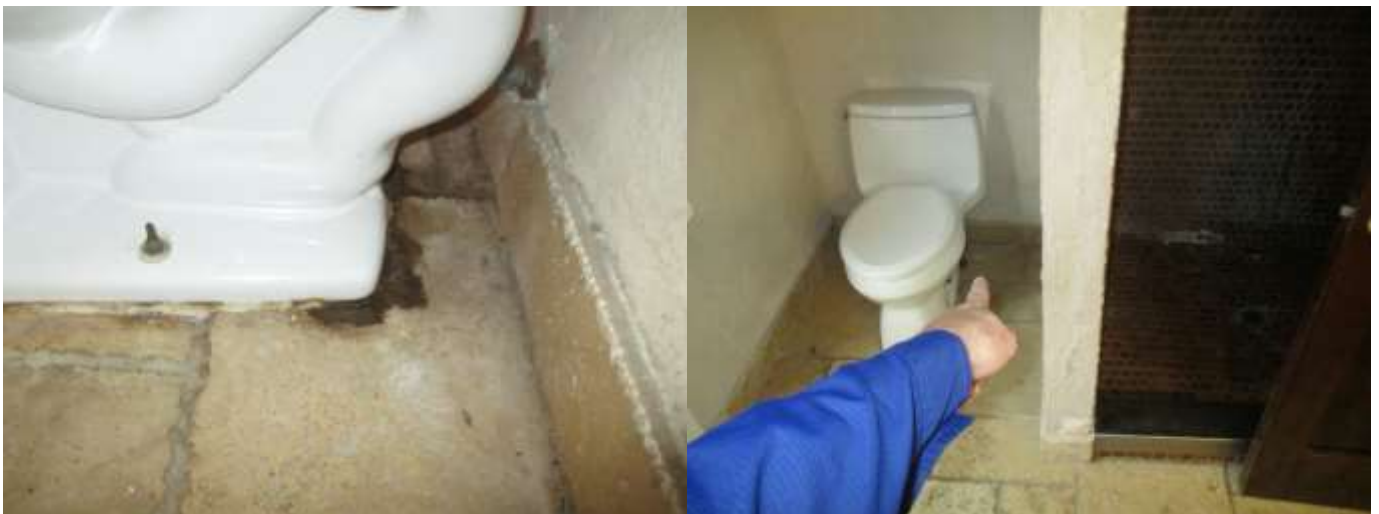
Repair Needed: Commode was leaking at the base in the south hall bathroom and the wax ring should be replaced.

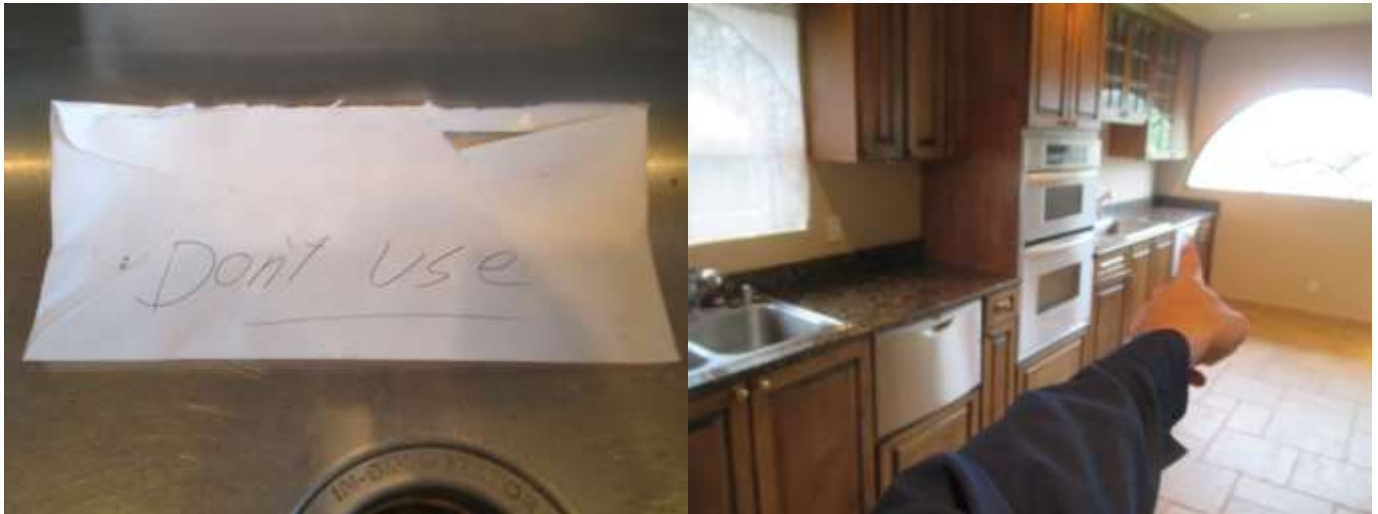
Repair Needed: The right kitchen sink could not be operated time of the inspection. It was stated that the sink backs up and recommend having this operational at final walk-through.

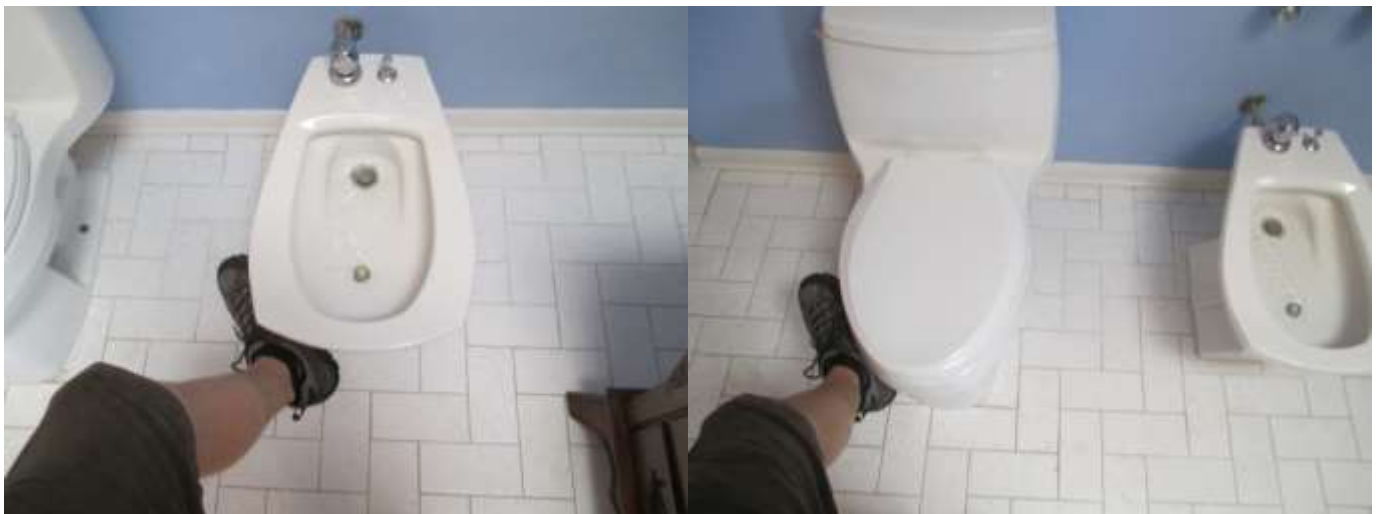
Correction Needed: The master bathroom commode and bidet were loose the base and should be secured.

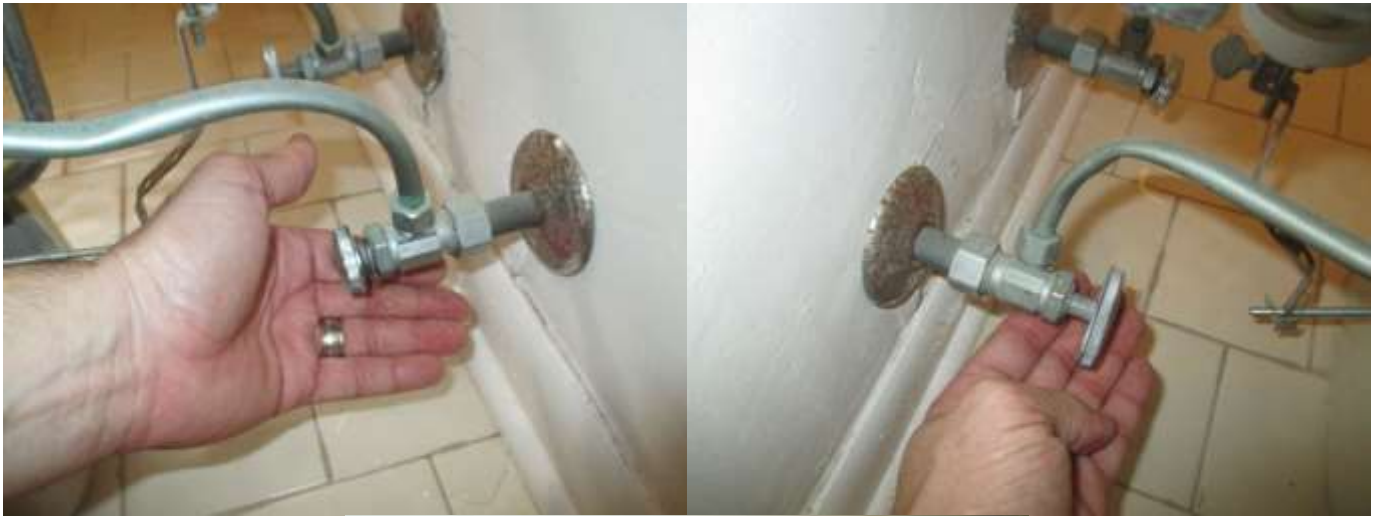
Repair Needed: The cutoff valve for the commode in the southeast second-floor bathroom and both cutoff valves for the bidet in the second-floor hall bathroom were leaking and likely needs the packing replaced.

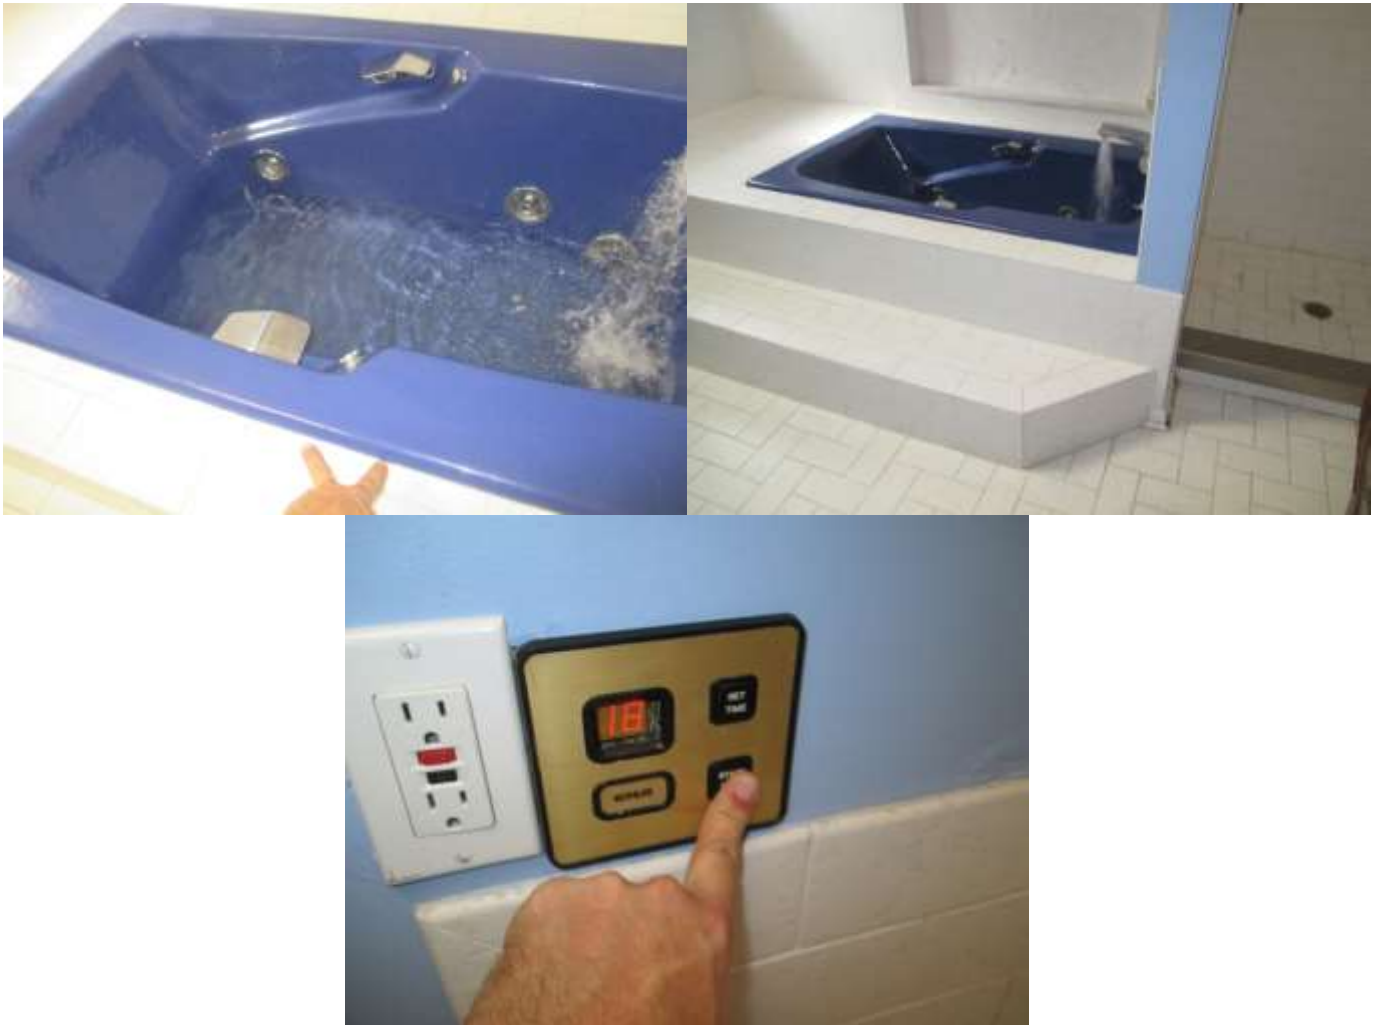
Repair Needed: The whirlpool tub was not operational the time of the inspection. A plumbing and motor access was not present at the time of the inspection and could not determine if a dedicated GFCI receptacle was present. We recommend verifying that it is GFCI protected prior to use.

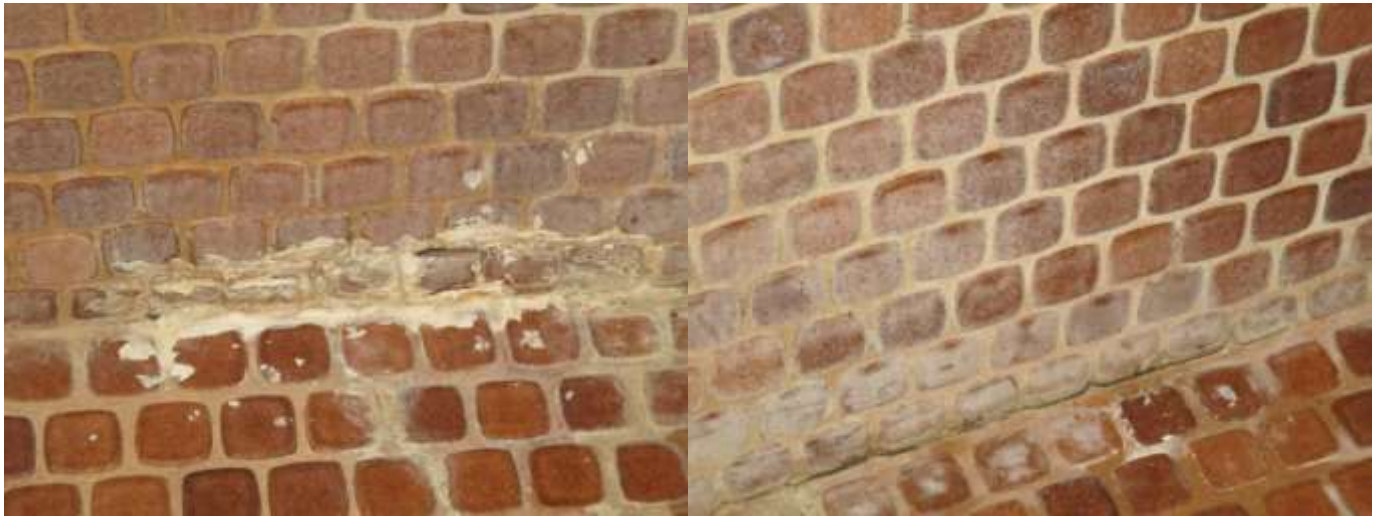
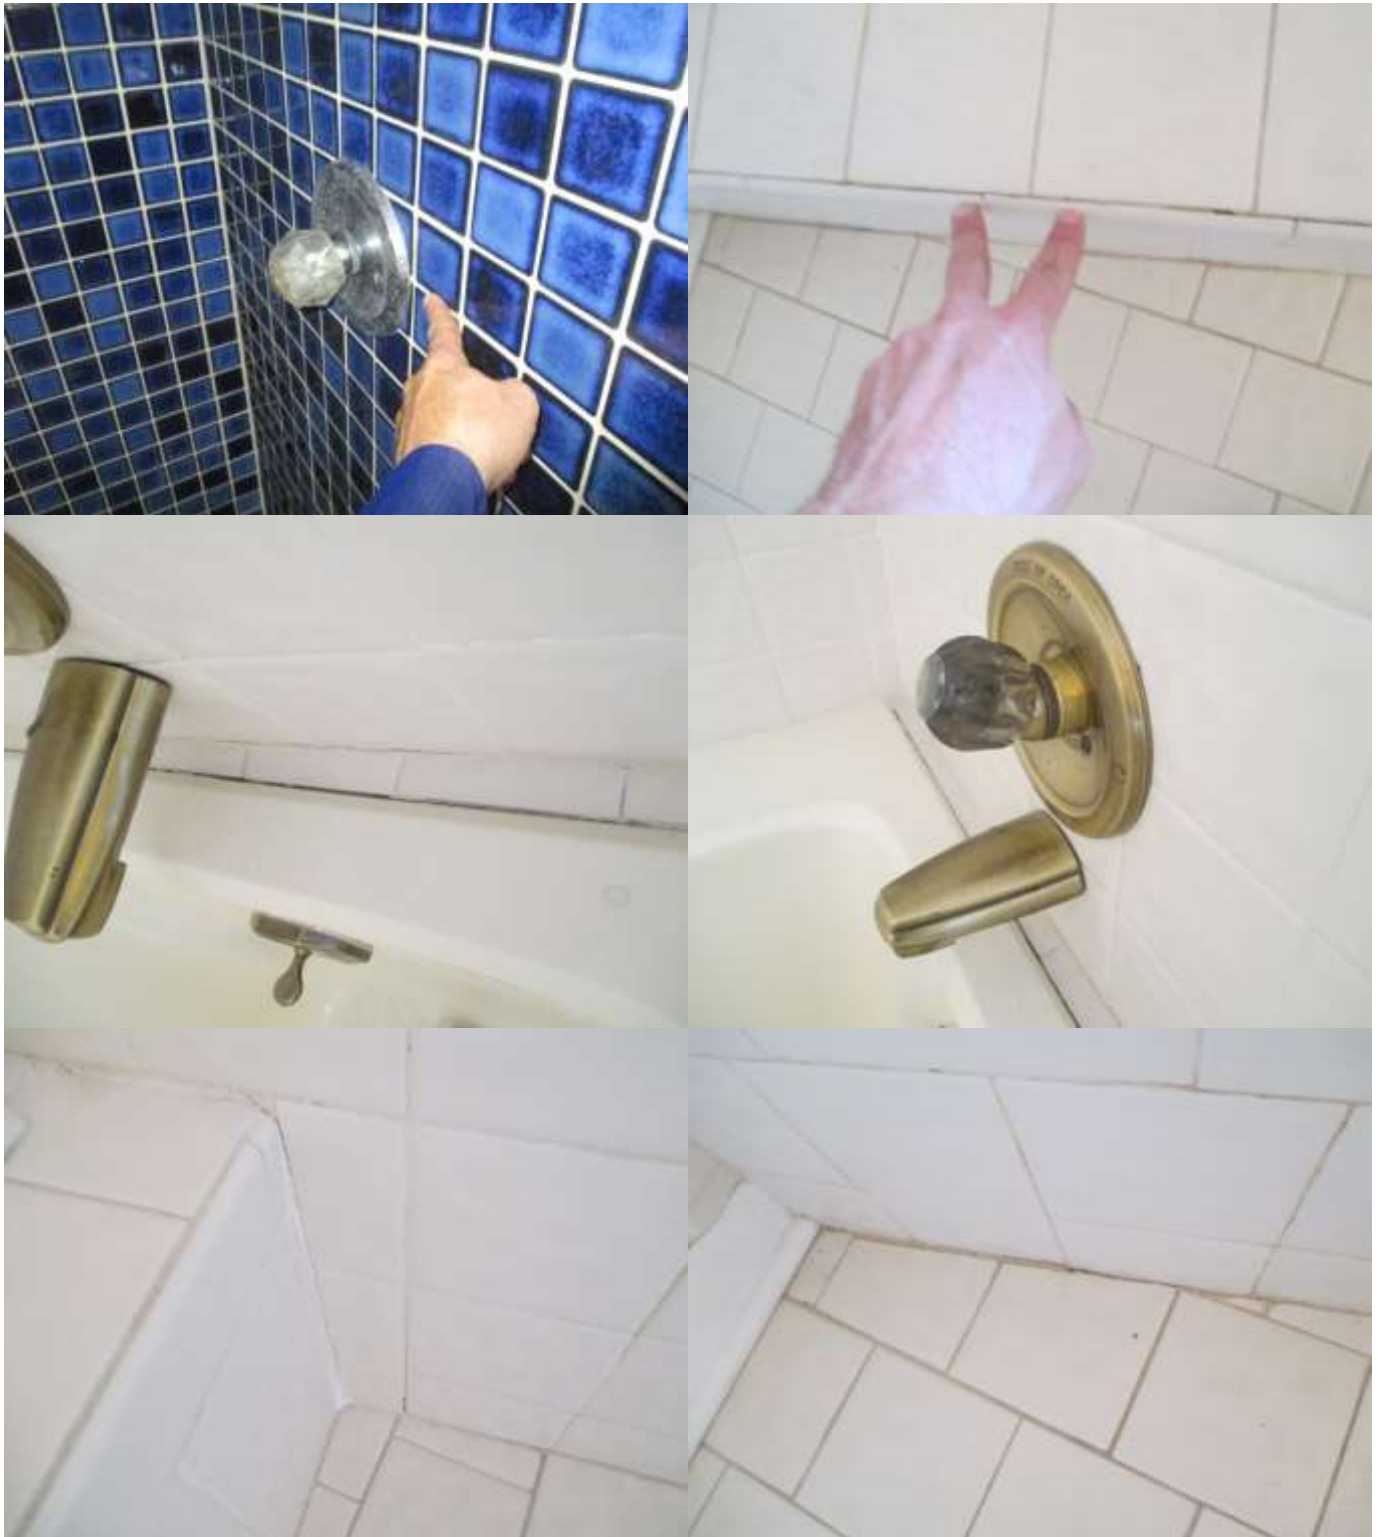
Maintenance Needed: The cracked grout, control plate, downspout in the bathroom tub and shower areas should be resealed with a bathroom rated silicone caulk to prevent moisture intrusion by the tile.

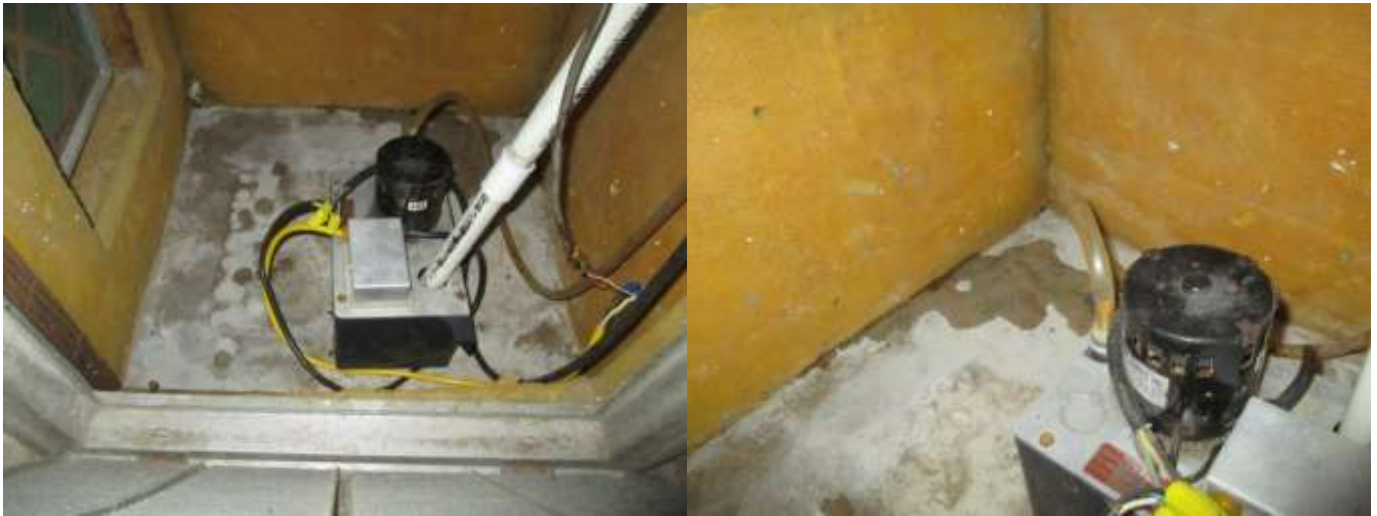
Concern Item: We noted a small amount of moisture underneath the air handler unit (1st floor) and recommend having the unit serviced by a licensed HVAC contractor.

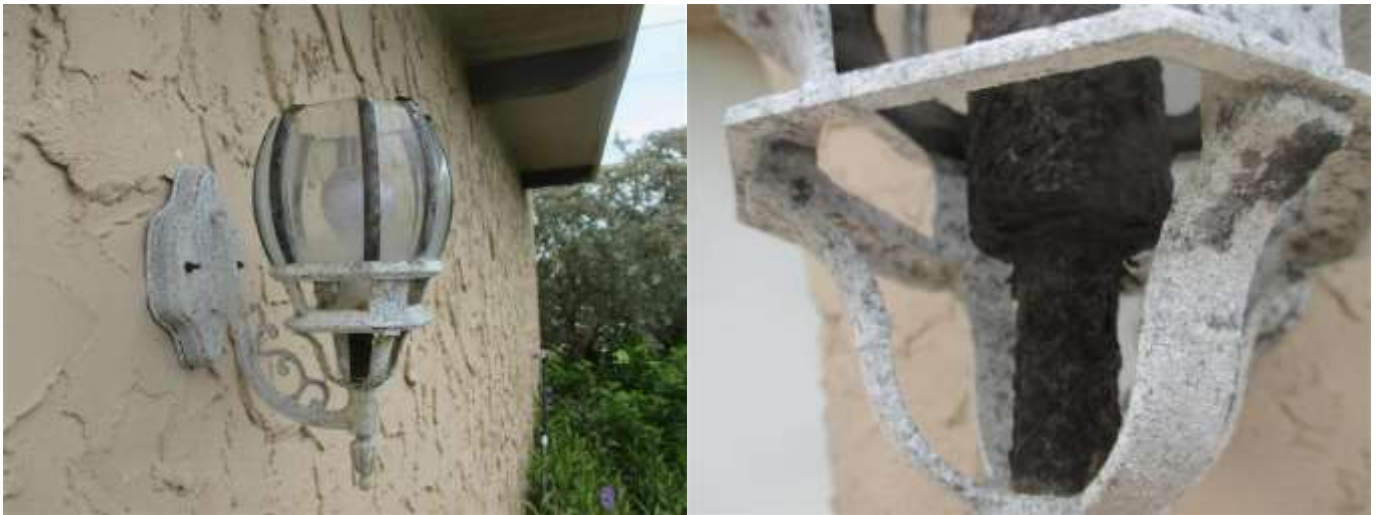
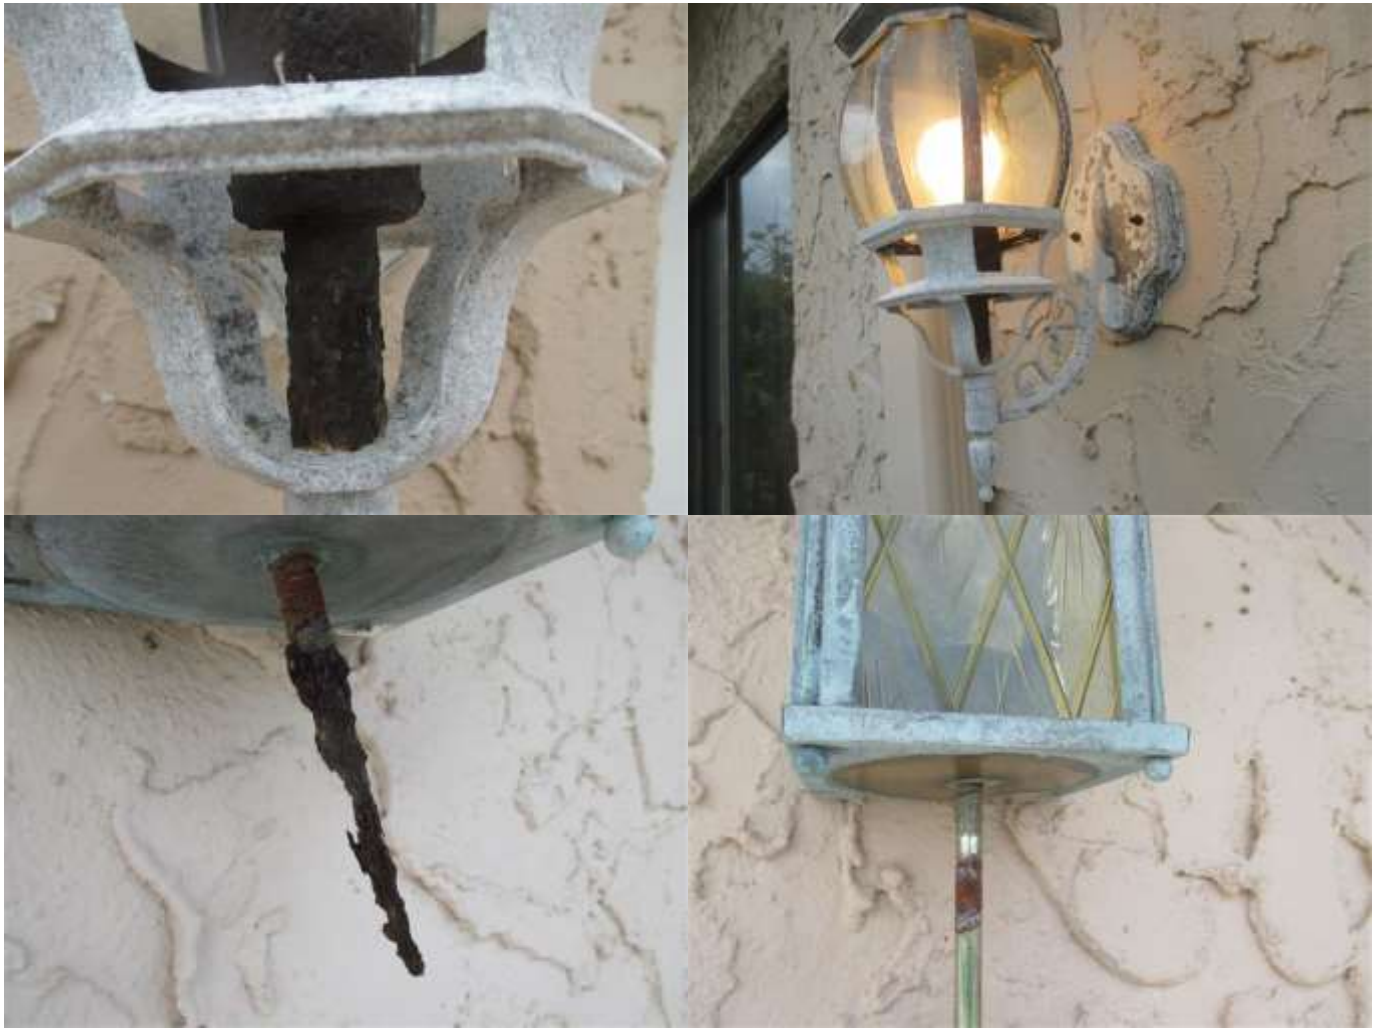
Replacement Needed: Many of the exterior light fixtures were heavily corroded and will need to be replaced.
