INTRODUCTION

GENERAL CONDITION OF DWELLING

The dwelling is a north facing two-story block and framed structure on slab with a hip type roof design. The dwelling was constructed circa 1984.

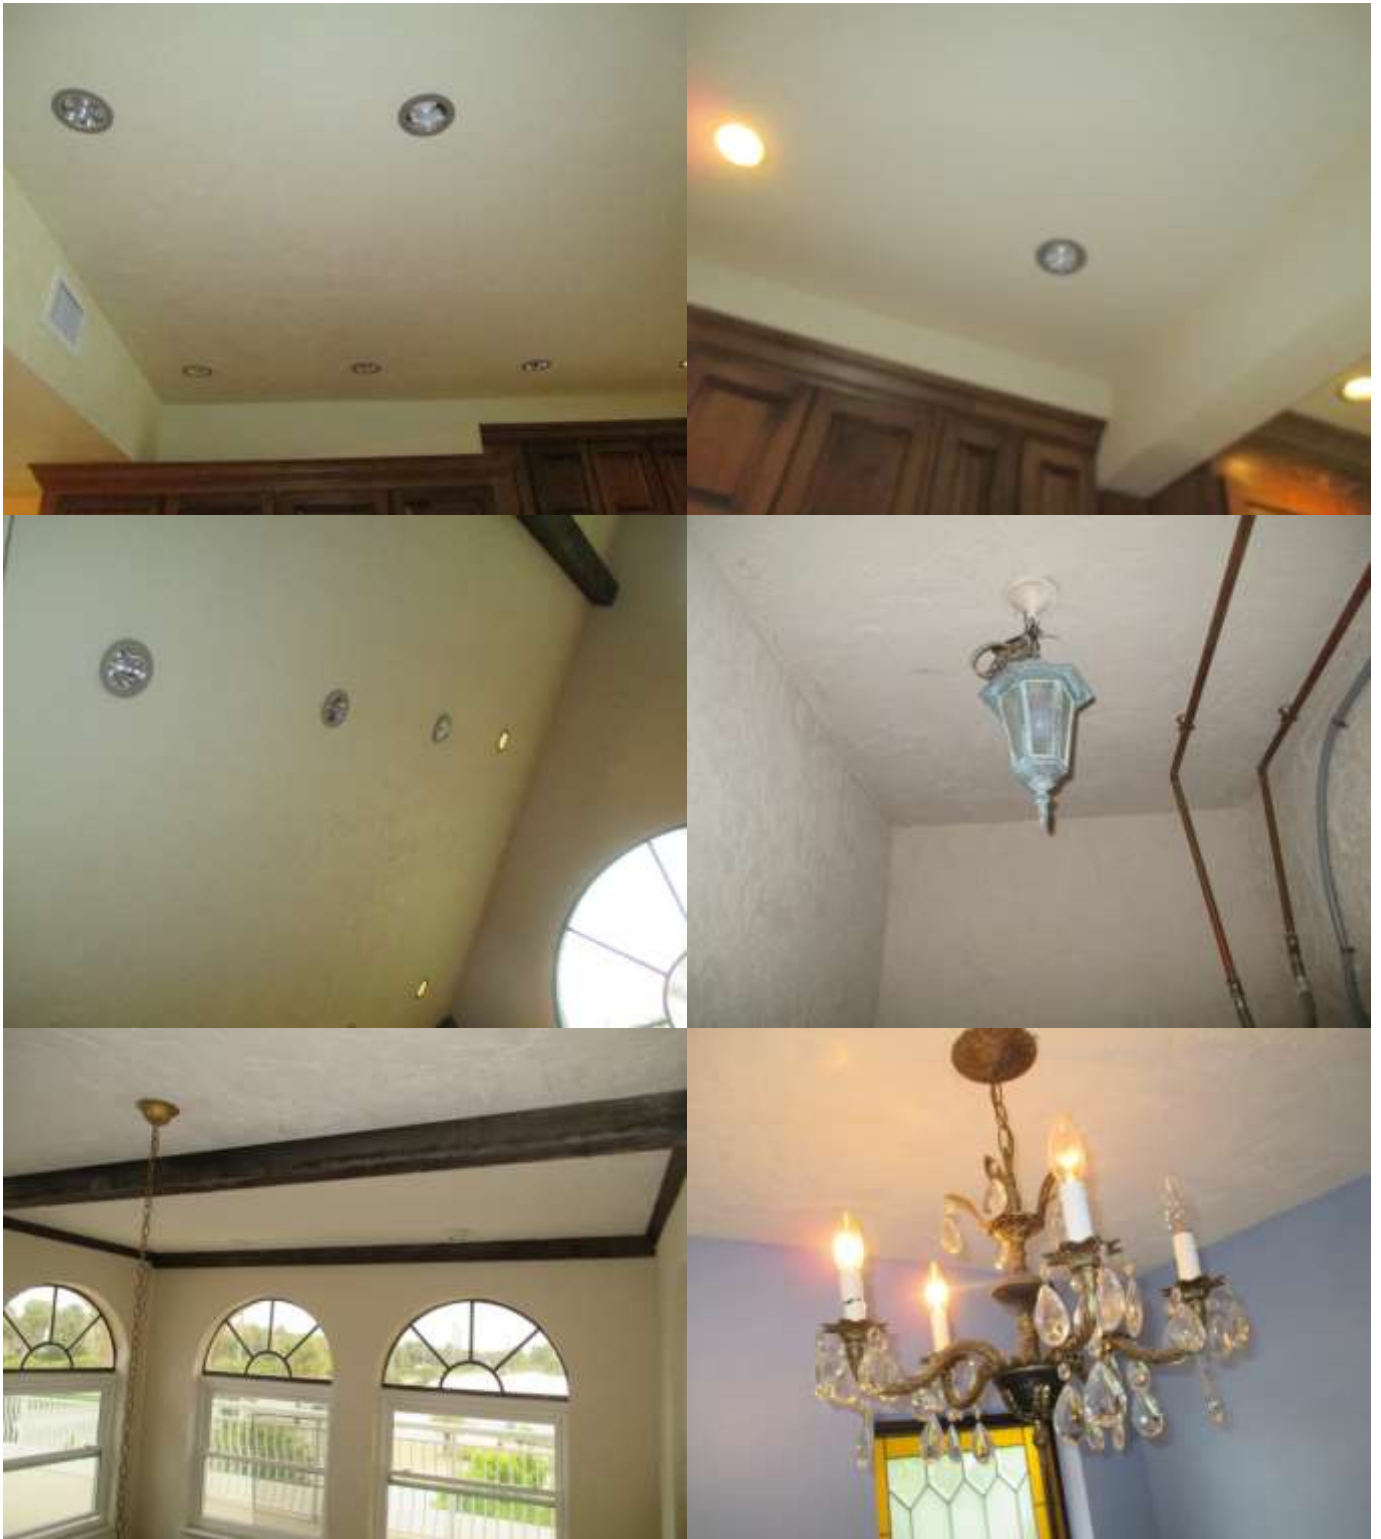
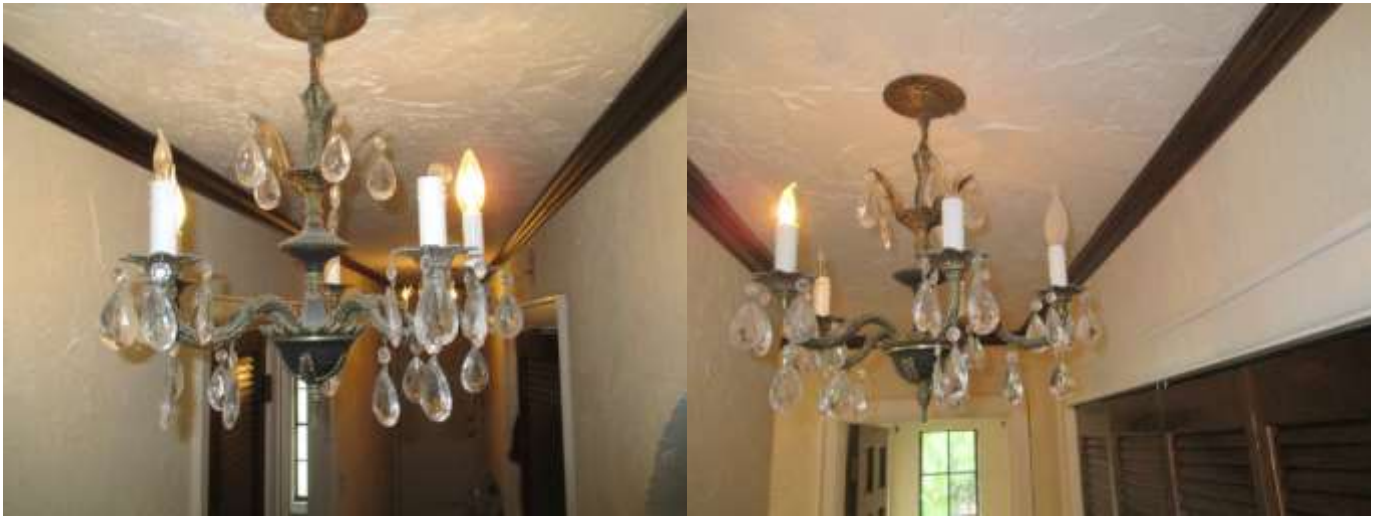
Repair Needed: We noticed numerous light bulbs were not working in and/or not installed throughout the dwelling and likely need the light bulbs replaced.

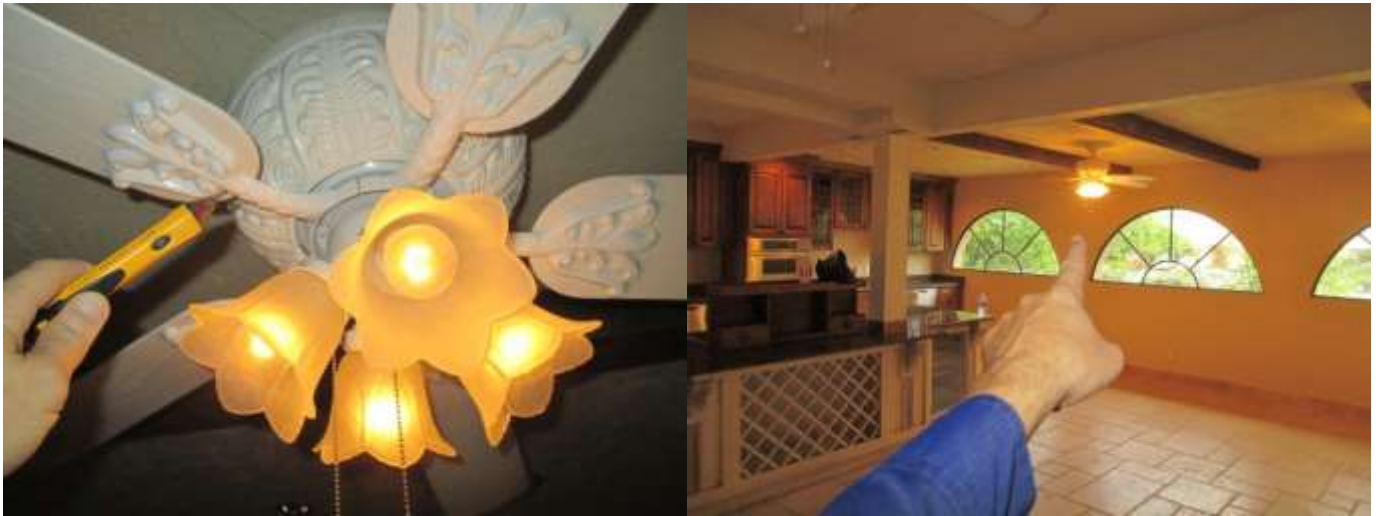
Correction Needed: Ceiling fan northwest side of family room area was not grounded time the inspection.

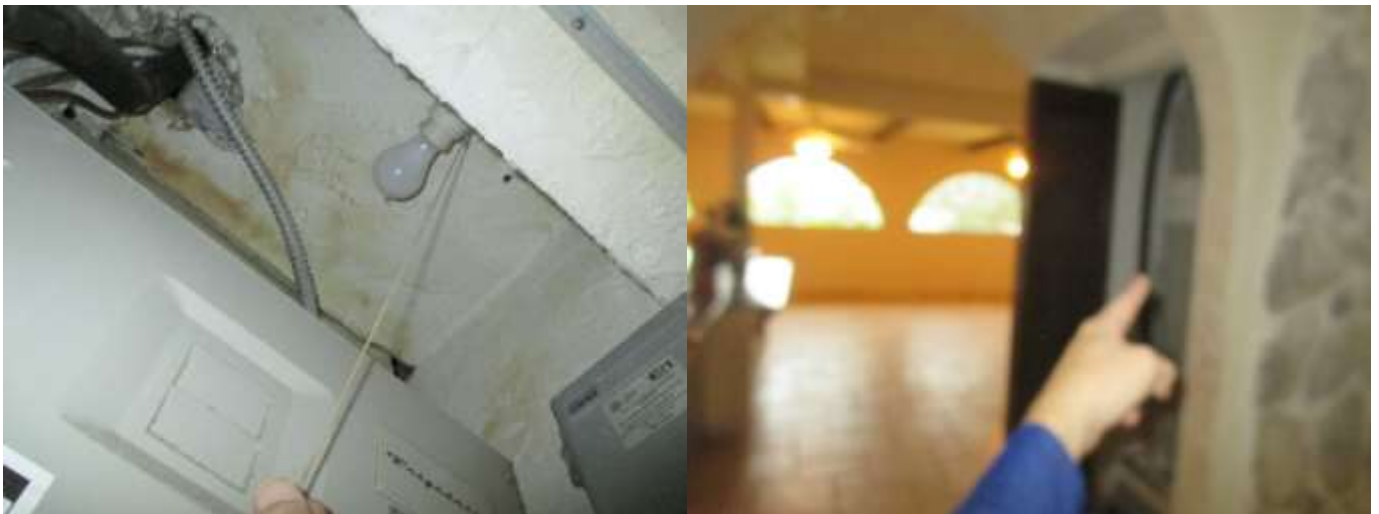
Repair Needed: The pull cord for the air handler closet light fixture was not operational at the time of the inspection may need to be replaced.

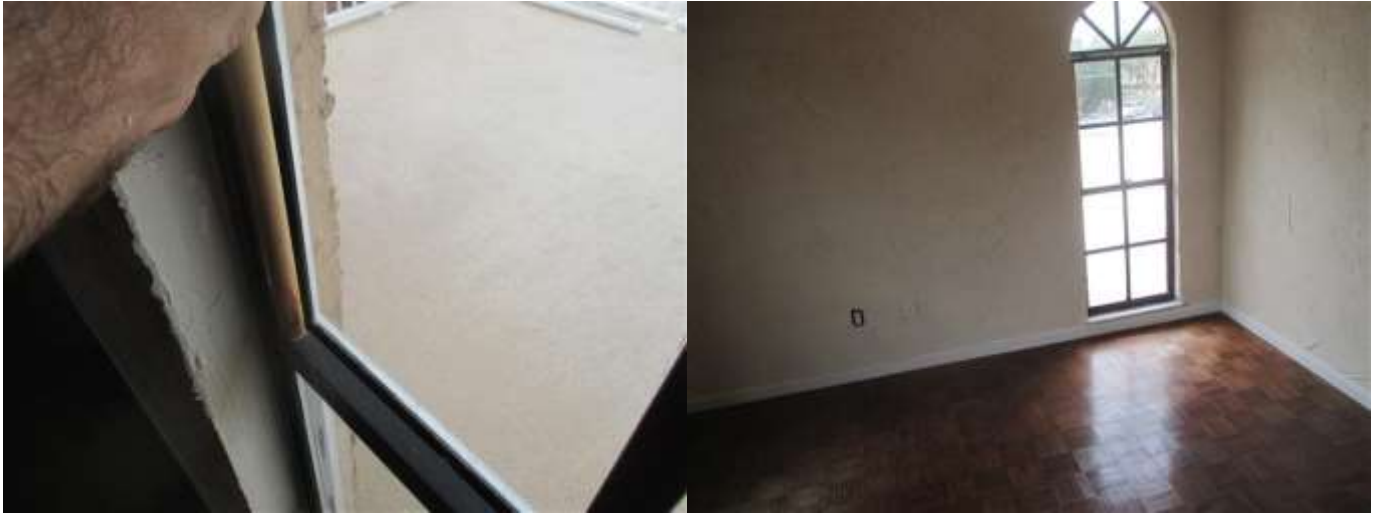
General Information Item: The window in the southwest bedroom had a wood dowel installed that we could not remove. As such the window could not be opened.

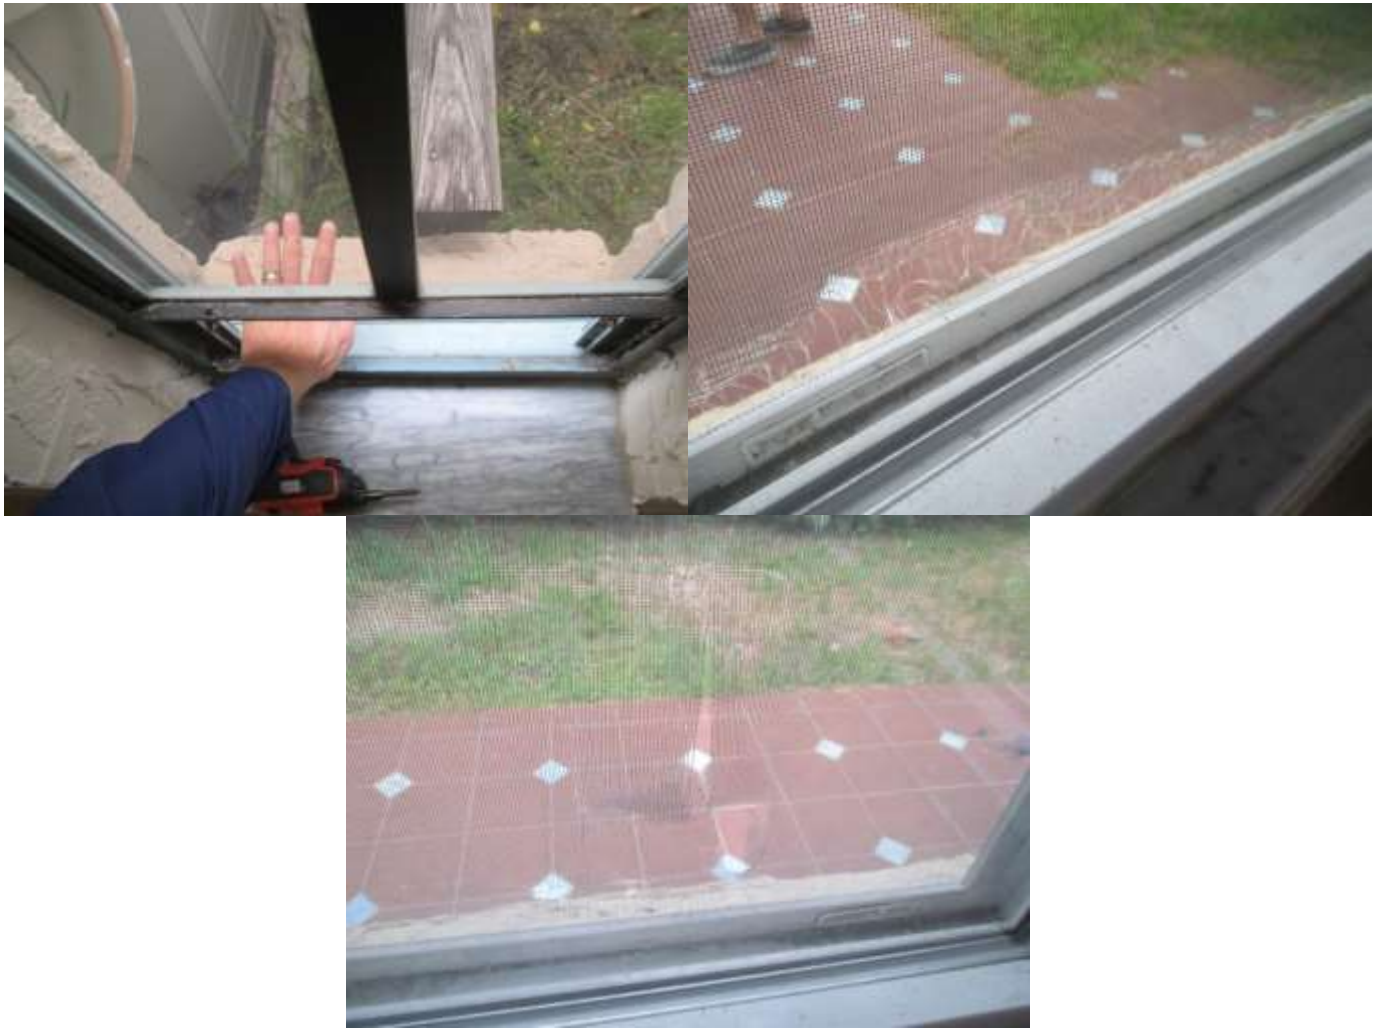
Correction Needed: Some of the window screens were not installed or damaged randomly throughout the dwelling and should be replaced.

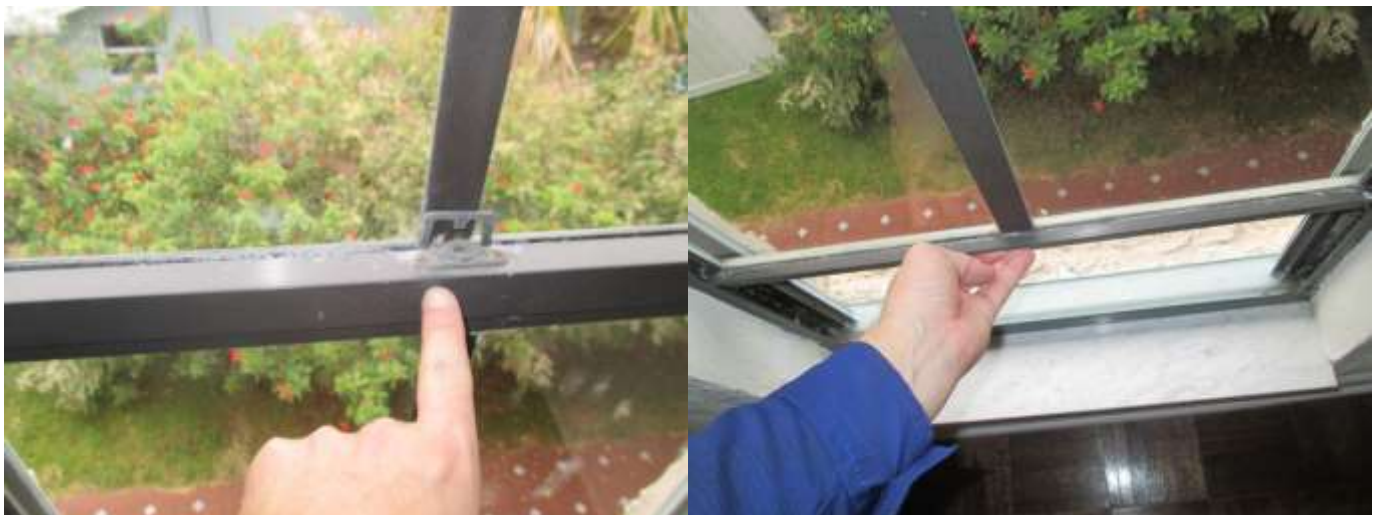
Repair Needed: The latch was not installed, the control springs were detached in the window would not stay open during operation (east window) in the master bedroom.

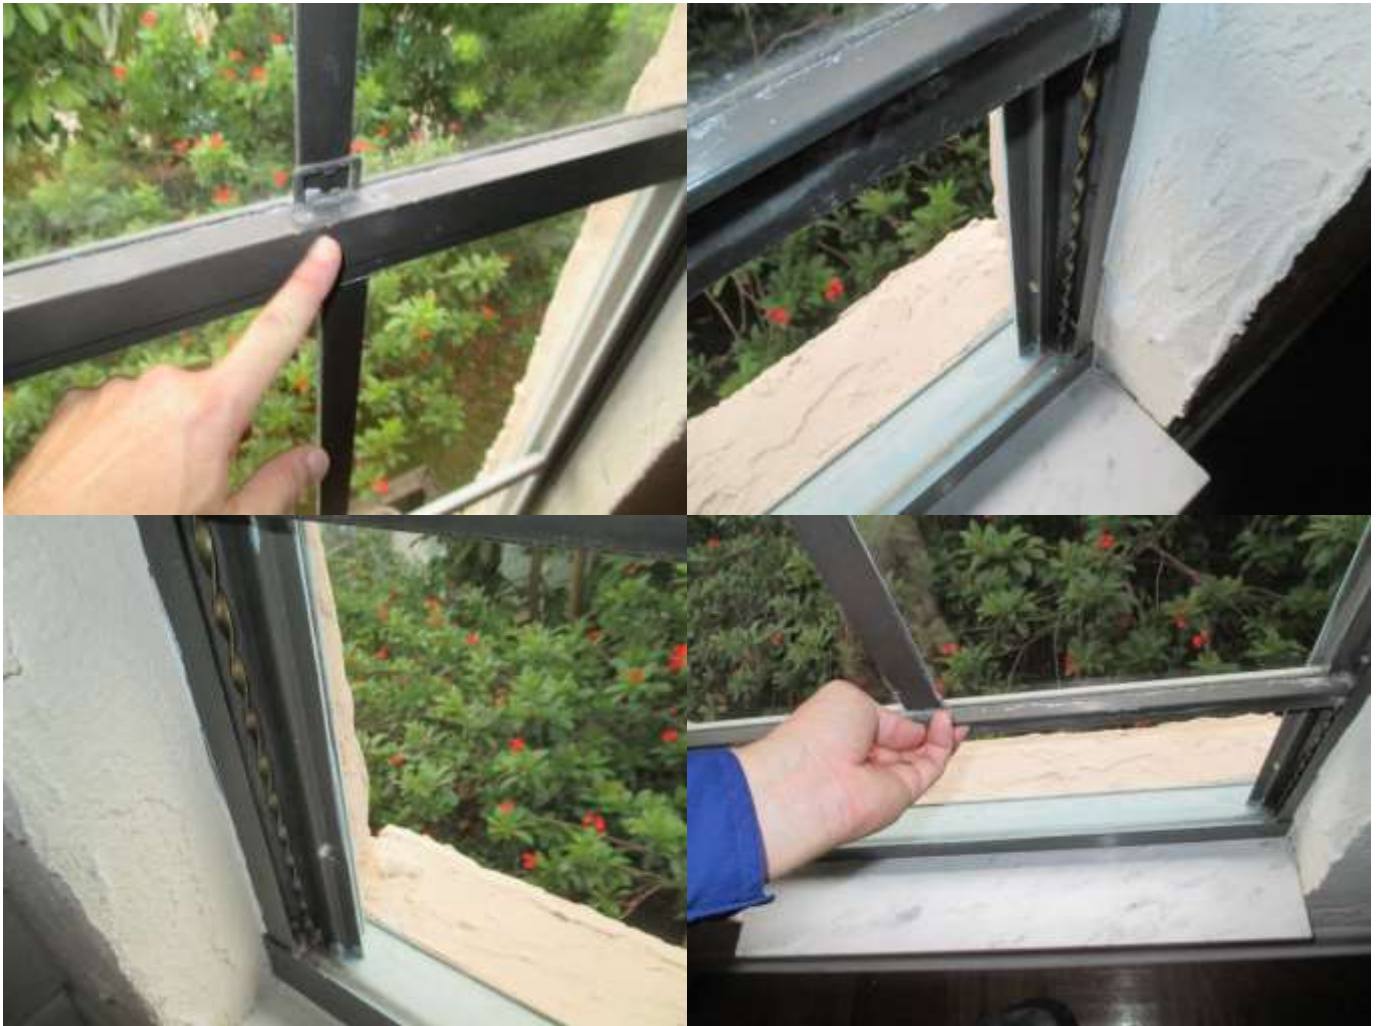
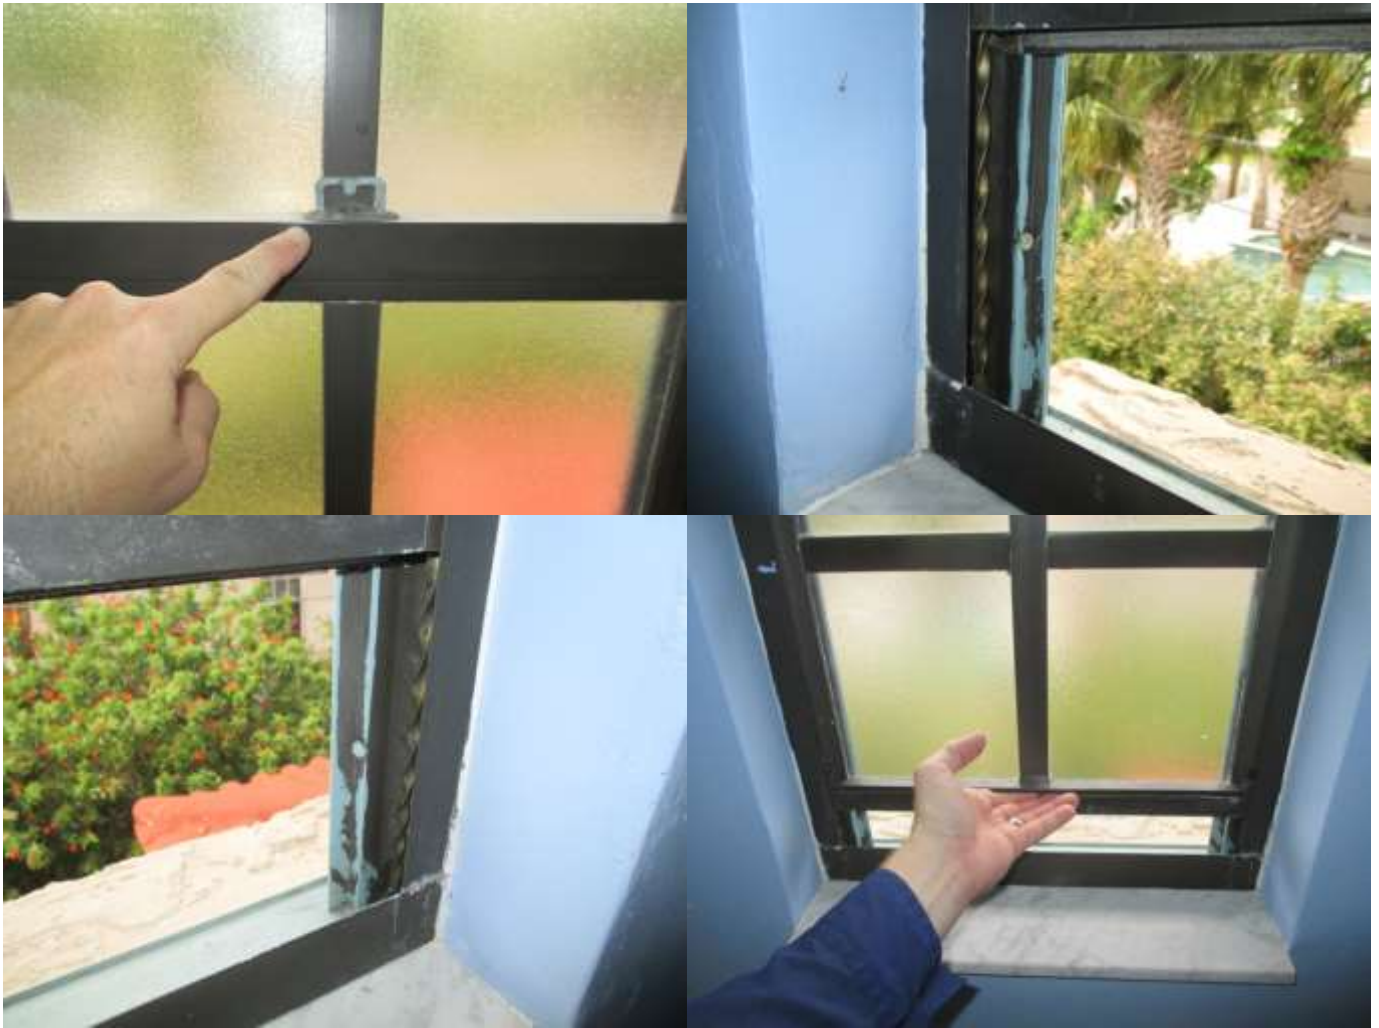
Repair Needed: The latch was not installed, the control springs were detached in the window would not stay open during operation in the southeast second-floor bedroom and bathroom.

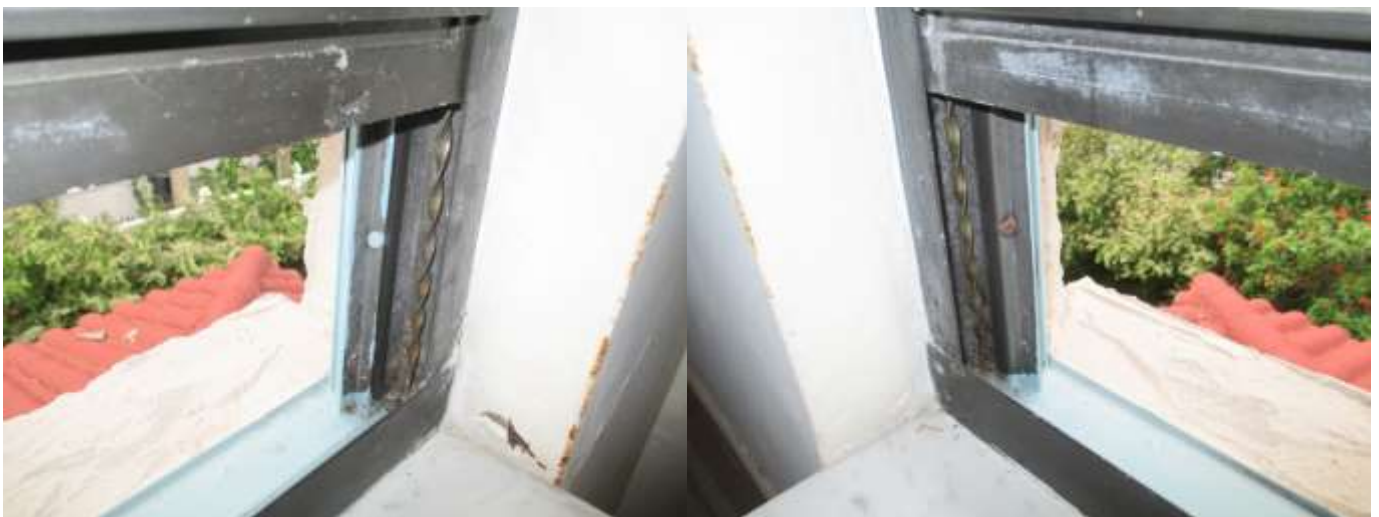
Repair Needed: The control springs were detached in the window would not stay open in the second-floor hall bathroom.

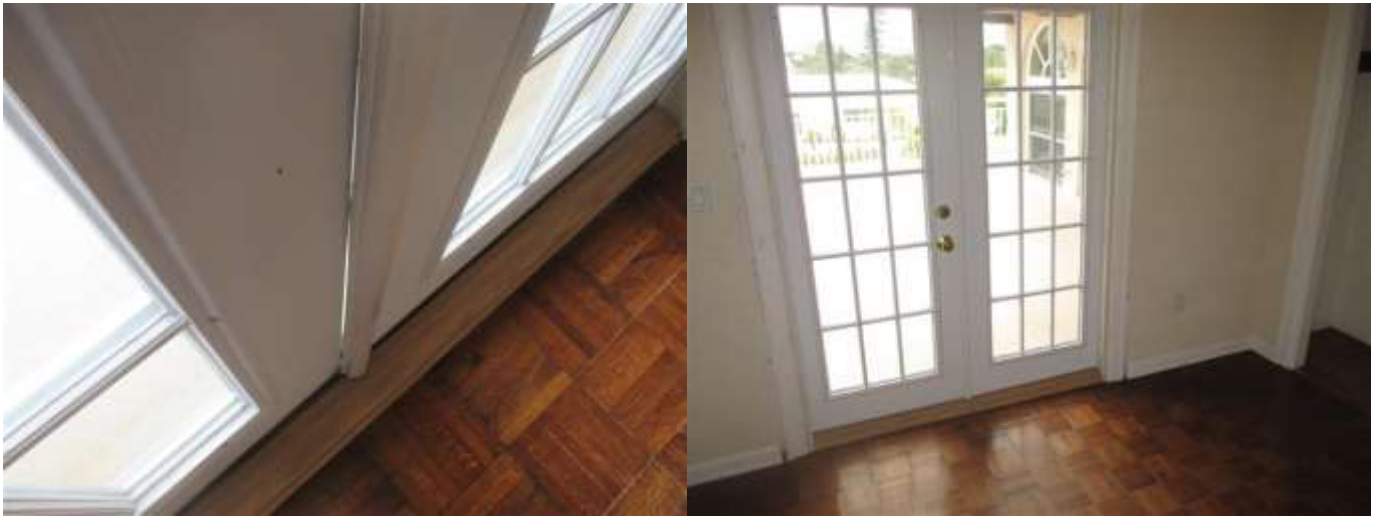
Correction Needed: The exterior doors in the northwest bedroom needed adjustment to seal fully when closed.

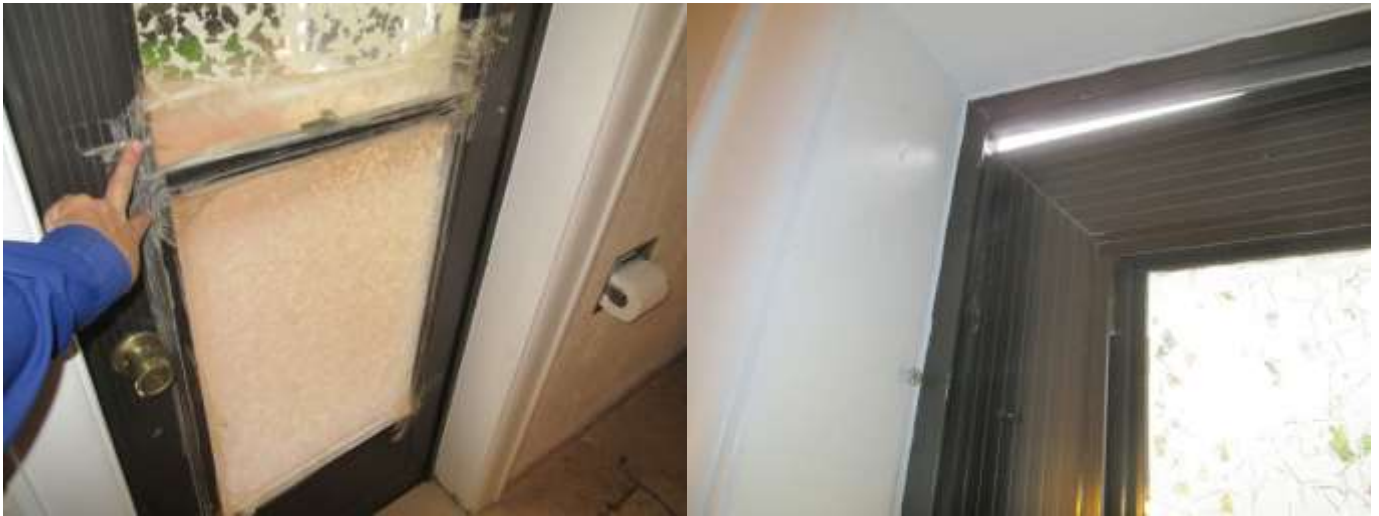
Repair Needed: The glazing in the south hall bathroom had been taped over on the exterior door should be properly sealed and/or secured. The door should also be adjusted to prevent rubbing against frame during operation.

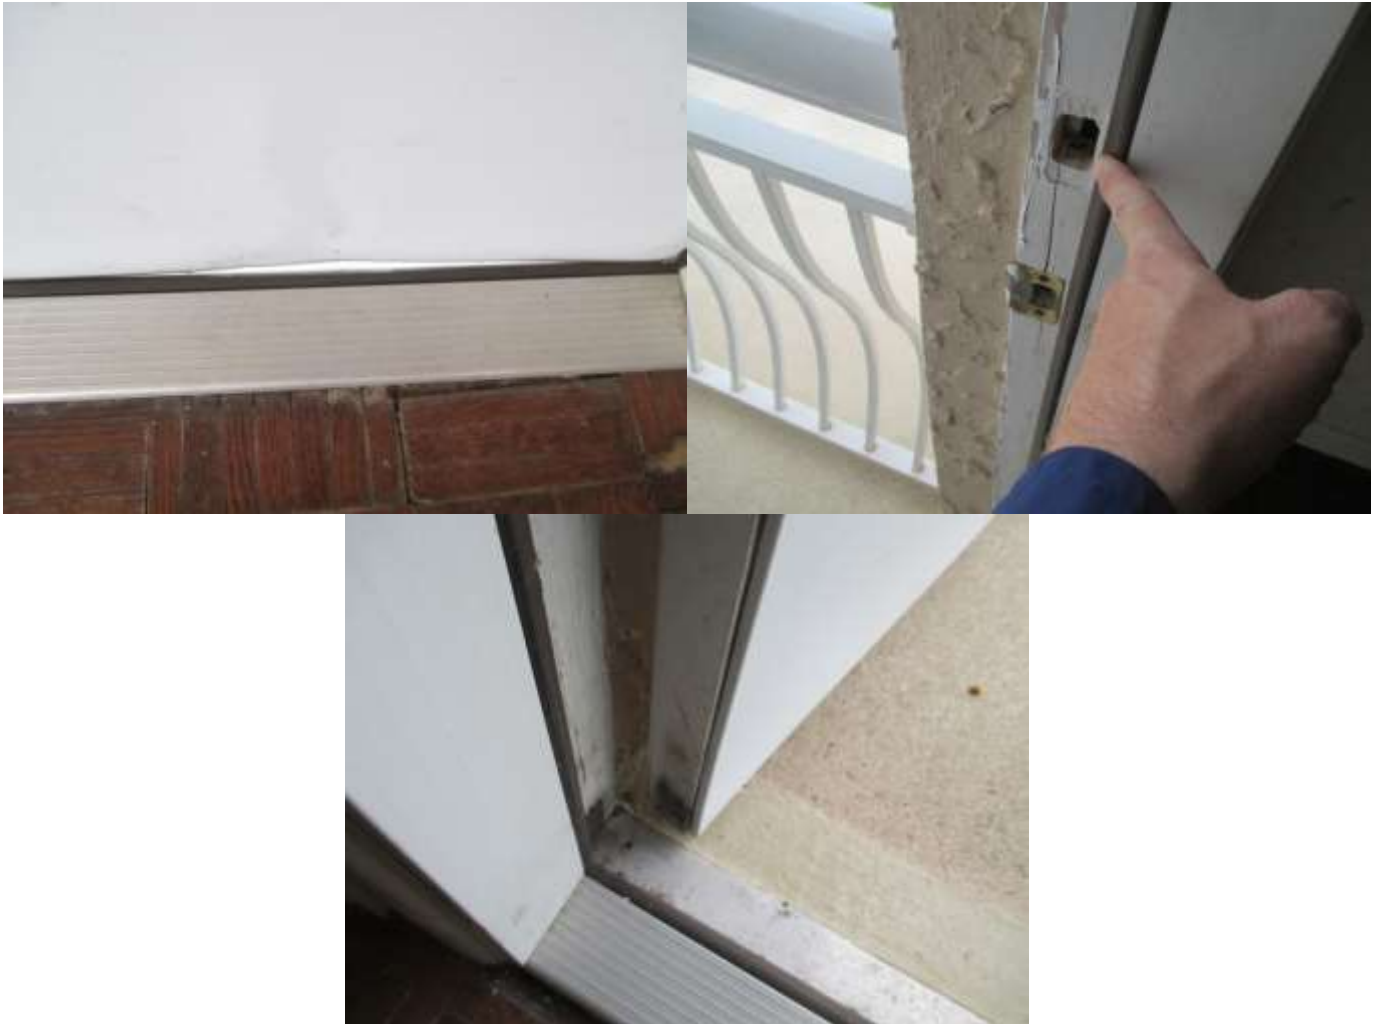
Repair Needed: The west exterior door in the master bedroom should have additional weather stripping installed along the base of the door to help with heating cooling costs. The striker plate should also be installed for the deadbolt lock. The wood deterioration at the base the door and frame should be repaired and resealed.

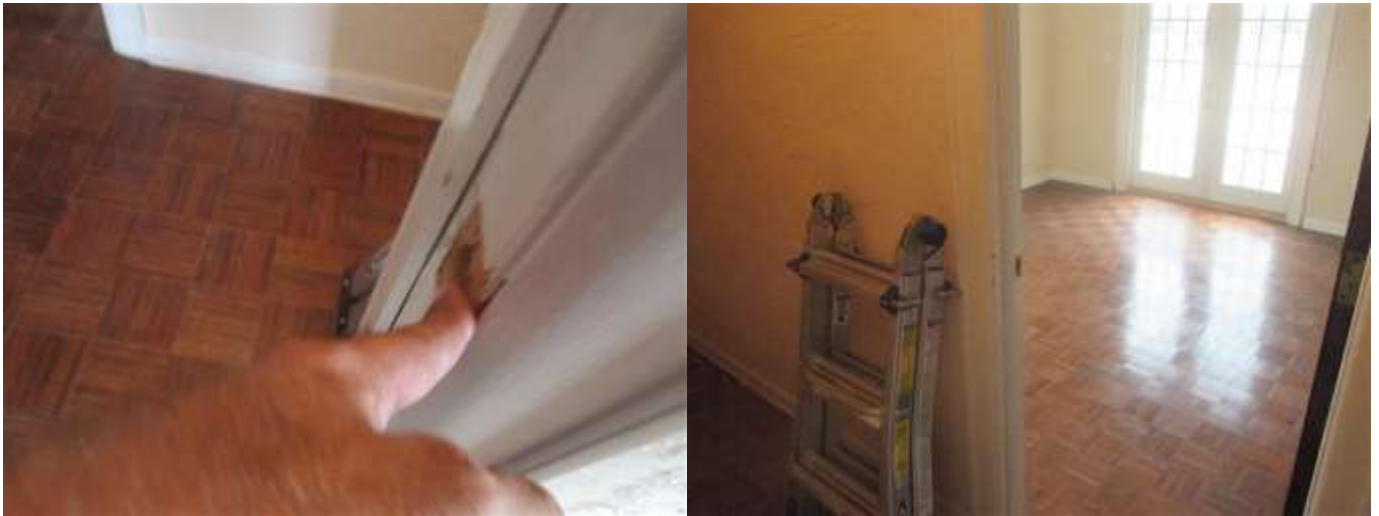
Correction Needed: The striker plate for the door to the northwest bedroom was missing.

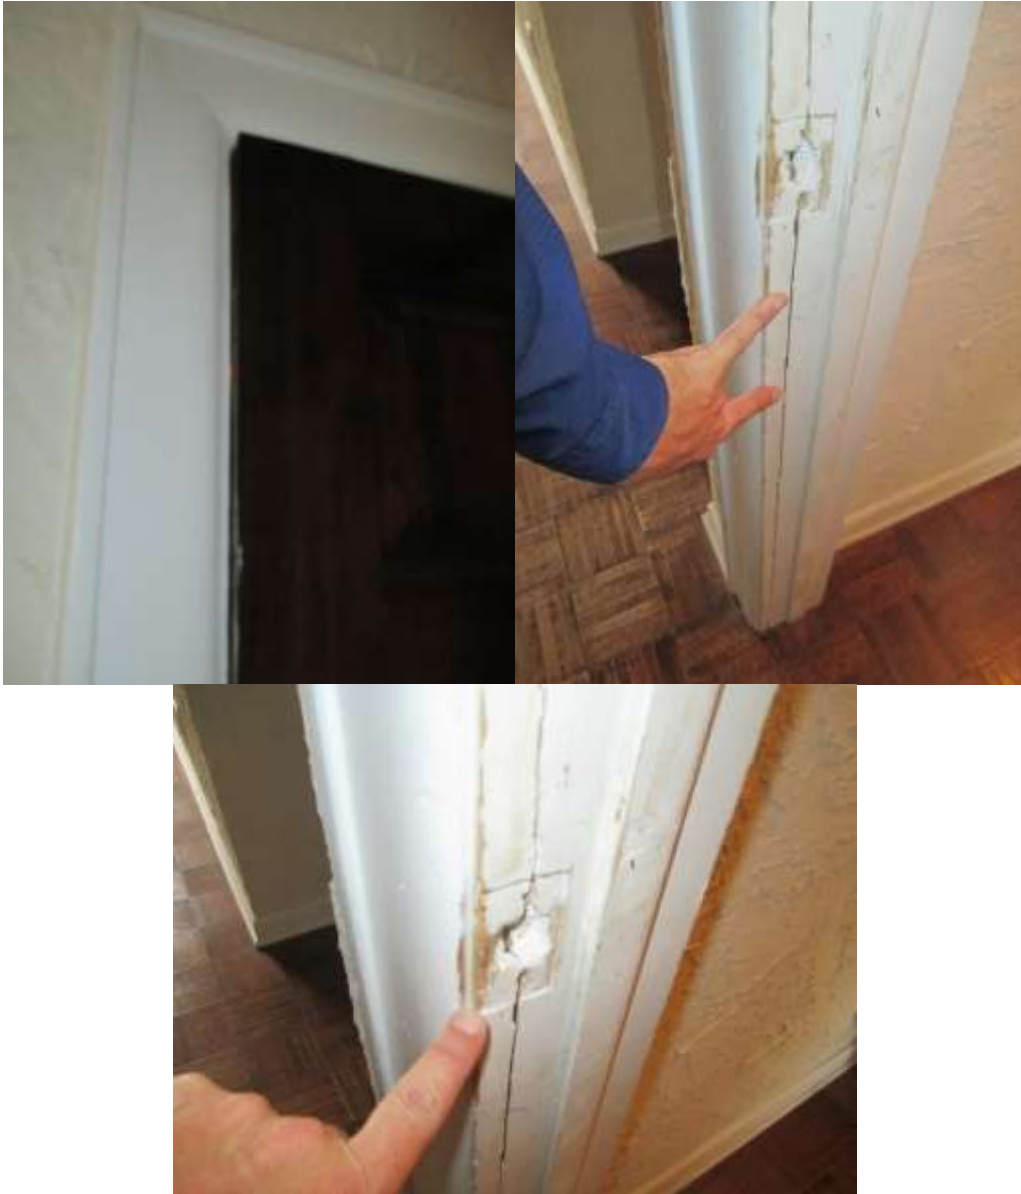
Repair Needed: We noted a crack in the doorframe to the master bedroom and the striker plate was not installed. The door also rubbed against the doorframe should be adjusted.

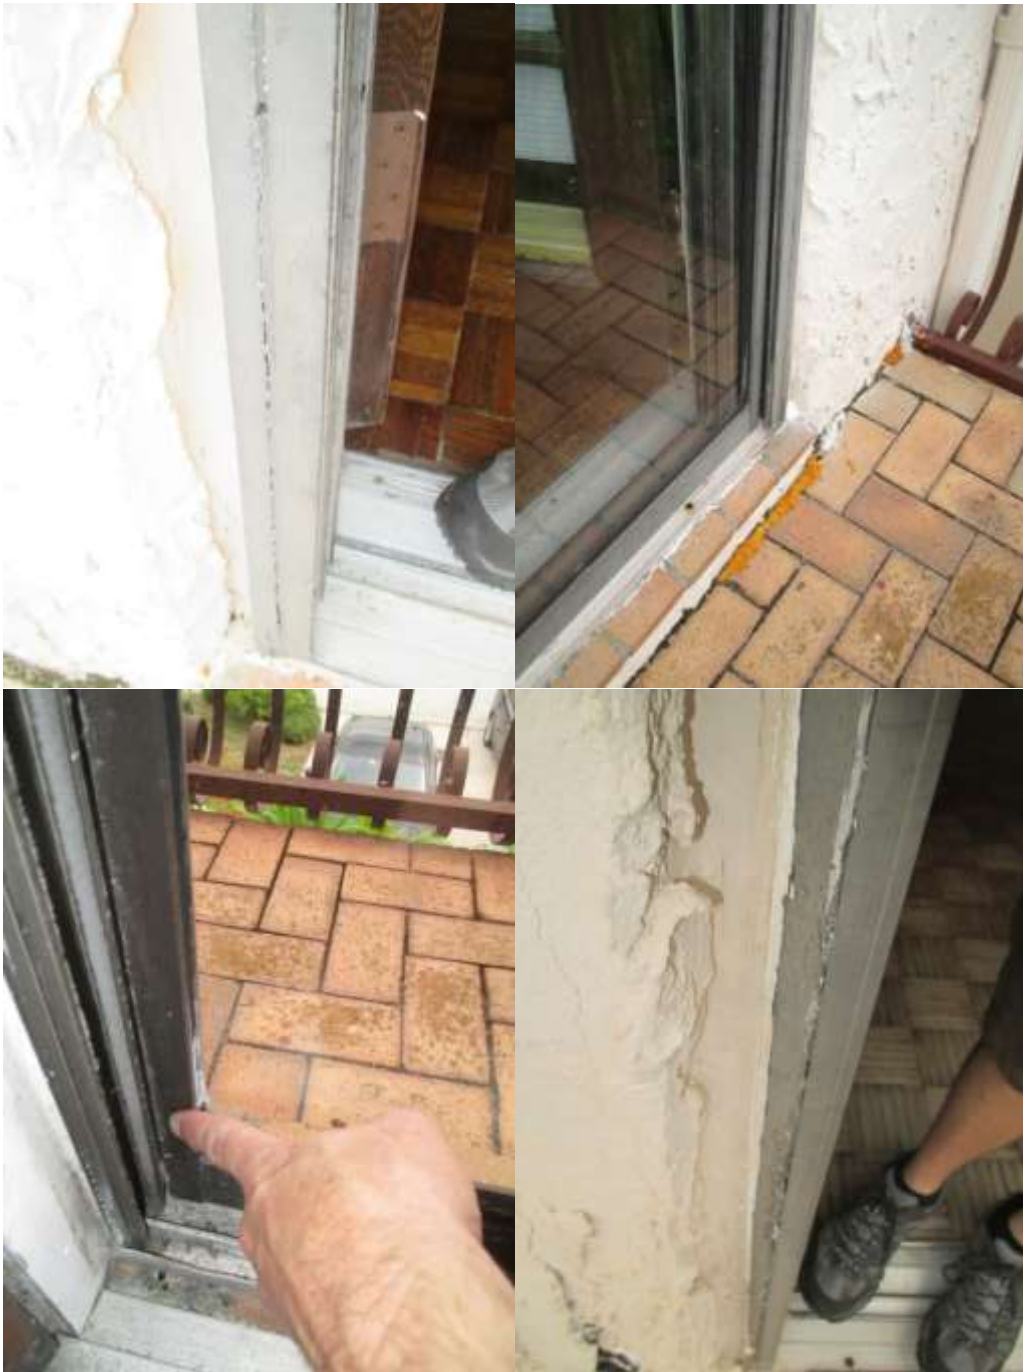
Maintenance Needed: The exterior sliding glass door openings should be resealed to prevent moisture intrusion.

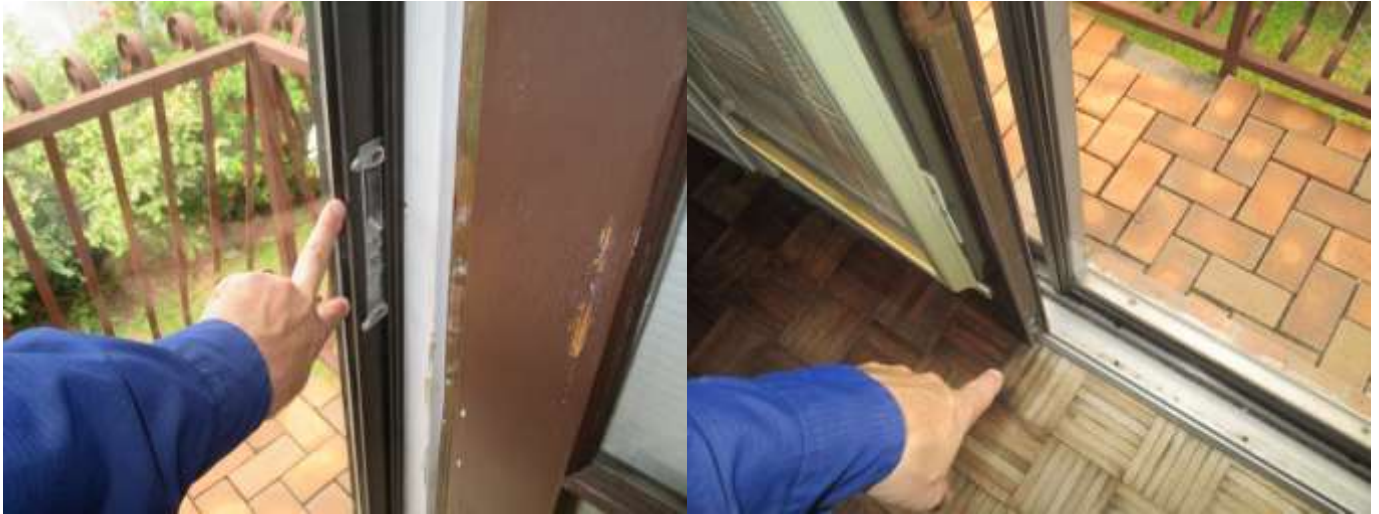
Repair Needed: The handle was damaged on the sliding glass door unit in the southeast second-floor bedroom. The door was difficult operate and likely needs the track guide rollers replaced.

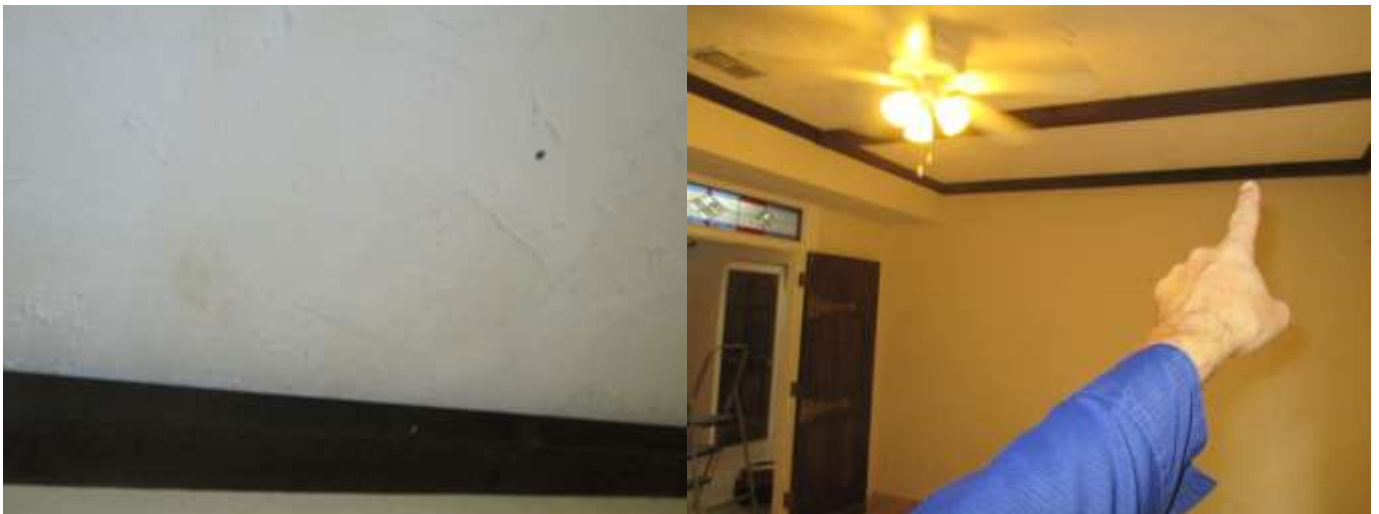
Cosmetic Item: We noted past repairs to the ceiling on the north side of the family room area. These areas tested negative for elevated moisture the time of the inspection.

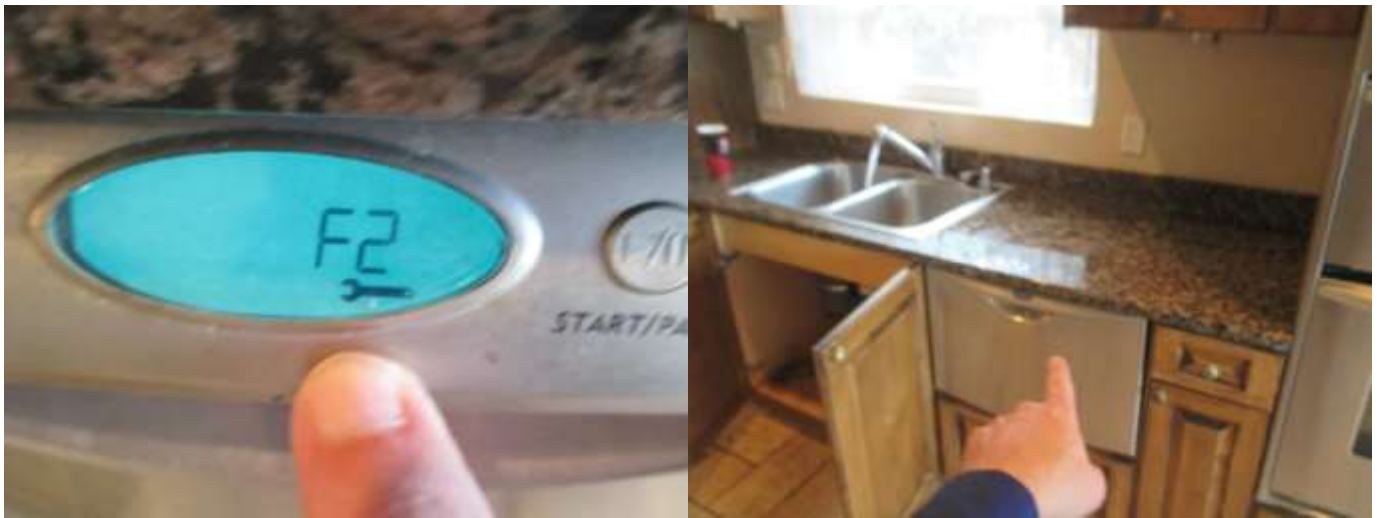
General Information Item: The right dishwasher was not able to be operated at the time of the inspection due to the sink backing up and recommend having this operational at final walk-through.
