## **GENERAL CONDITION OF DWELLING**

The dwelling is a three-story (garage, first floor and second floor) masonry and framed structure on slab with a gable type roof design. The dwelling was constructed circa 1997.

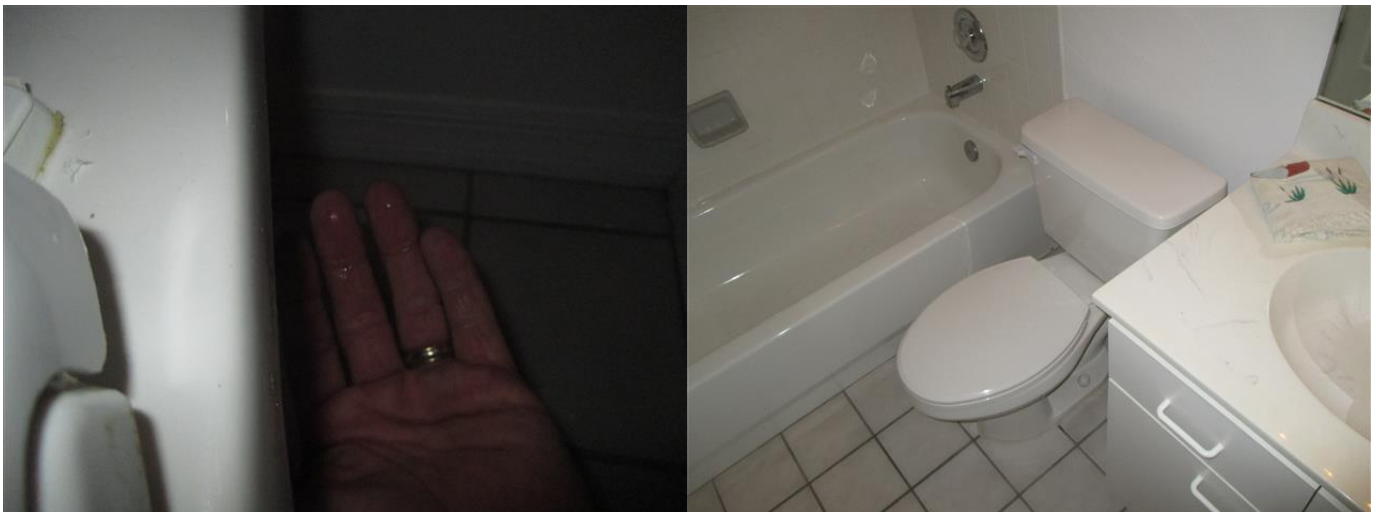
**Repair Needed:** We noted a leak from the base of the tank on the commode in the hallway bathroom.

**Recommendation:** For further evaluation and repair of the plumbing systems, we recommend contacting a licensed plumbing contractor.

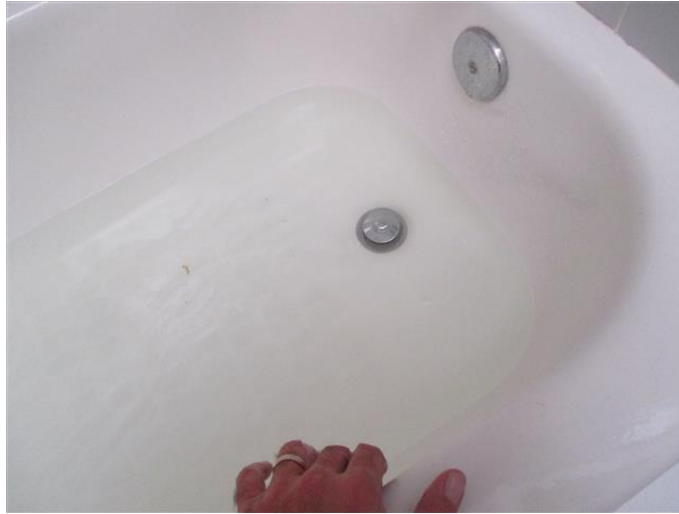
**Maintenance Needed:** The bathtub in the east bathroom drained slowly and will need servicing.

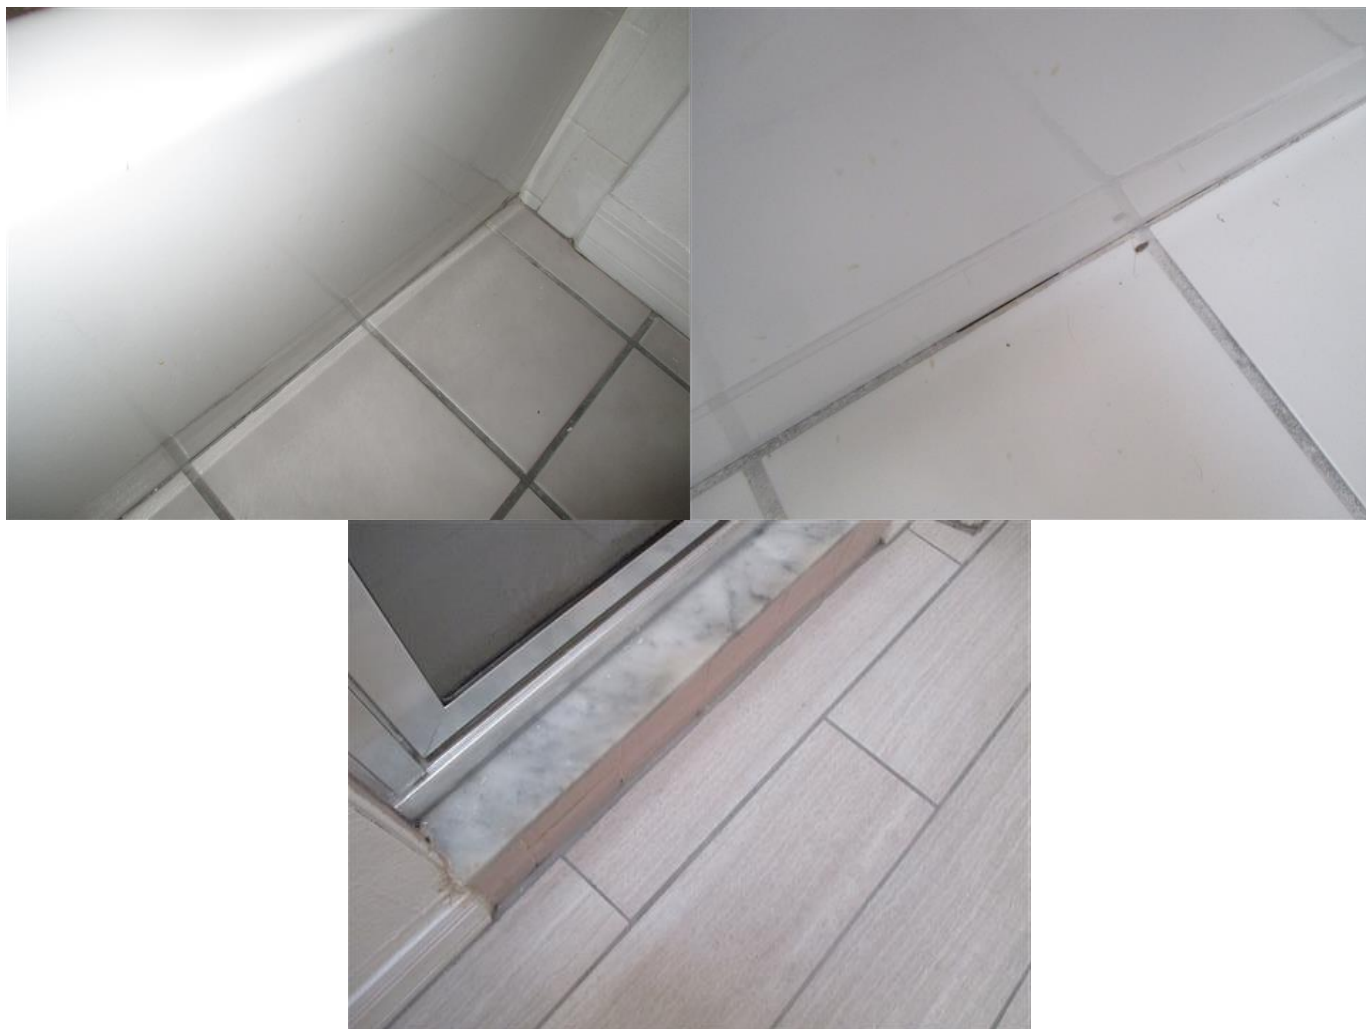
**Maintenance Needed:** The seams between the base of the bathtubs and shower threshold and the floor tile should be sealed with bathroom it silicone sealant.

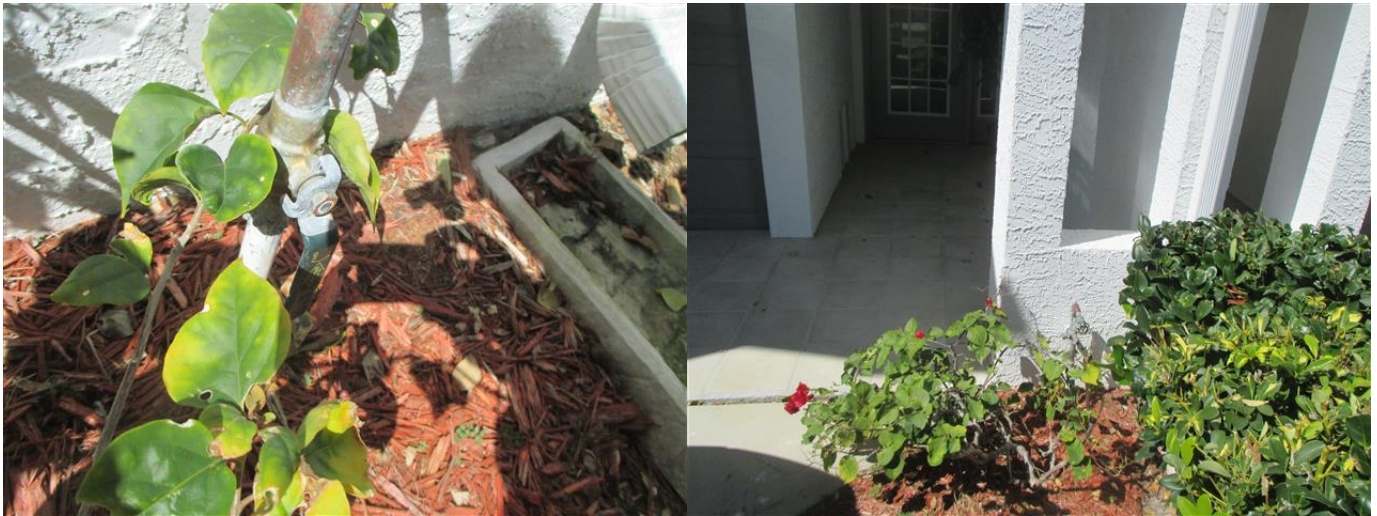
The main water cutoff for the dwelling was located on the east elevation.

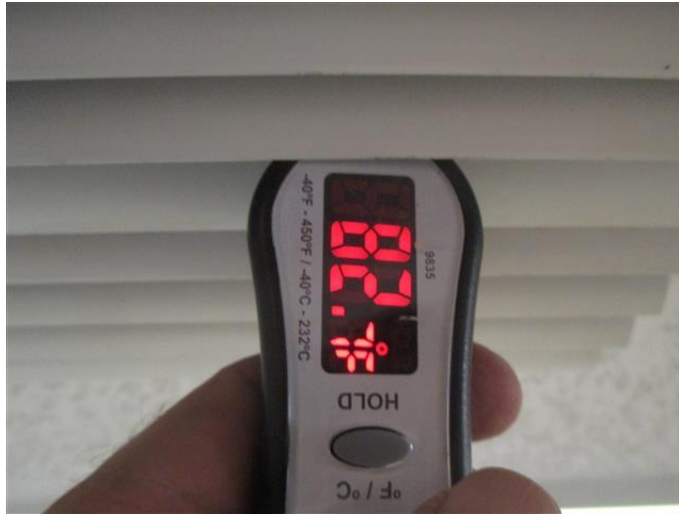
The heat mode was operational at the time of inspection.

We recommend having a licensed heating and air contractor service the system and repair as necessary.

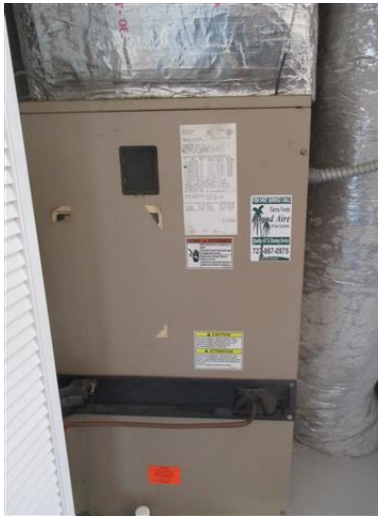
**Concern Item:** The air handler appears to be approximately 18 years old and is near the end of its useful lifespan. Electric furnaces have a normal life expectancy of 15-20 years.

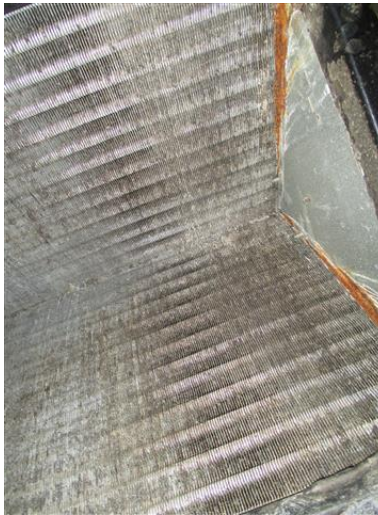
**Maintenance Needed:** The coils in the air handler were dirty and will need to be properly cleaned by a licensed HVAC contractor for the unit to operate properly and efficiently.

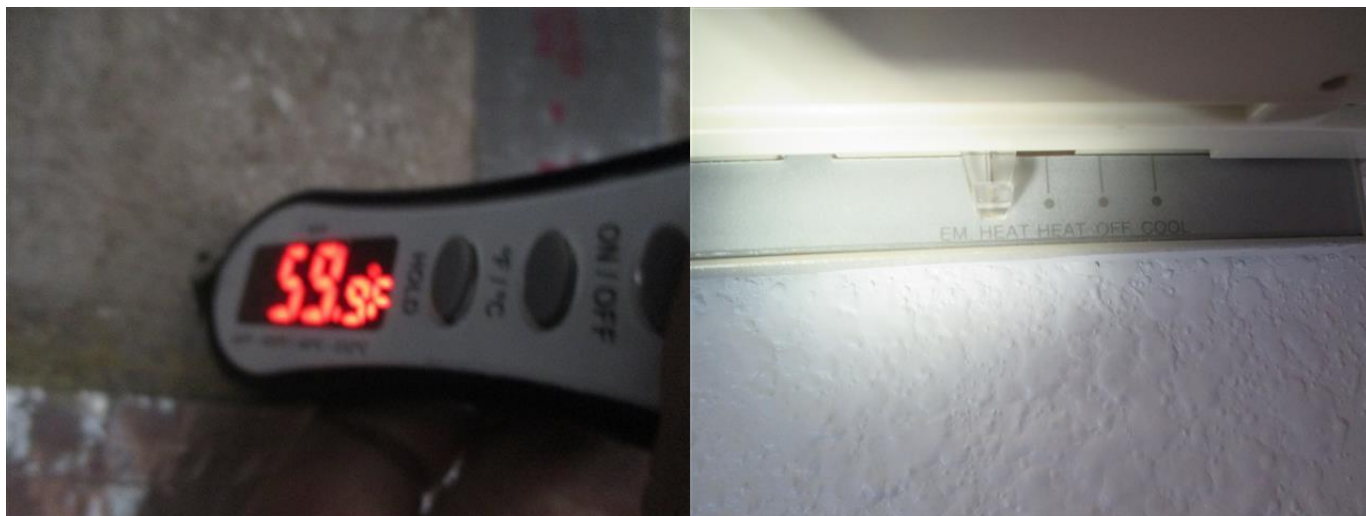
**Repair Needed:** The emergency heat mode was not functional at the time of inspection.

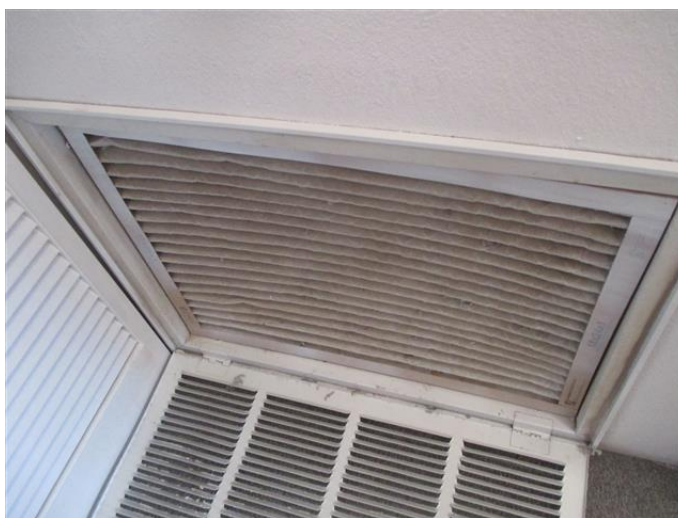
**Maintenance Needed:** The filter on the return register underneath the air handler needed replacement. As a normal maintenance item, change or clean the return filters every few months or as per the manufacturer's specification.

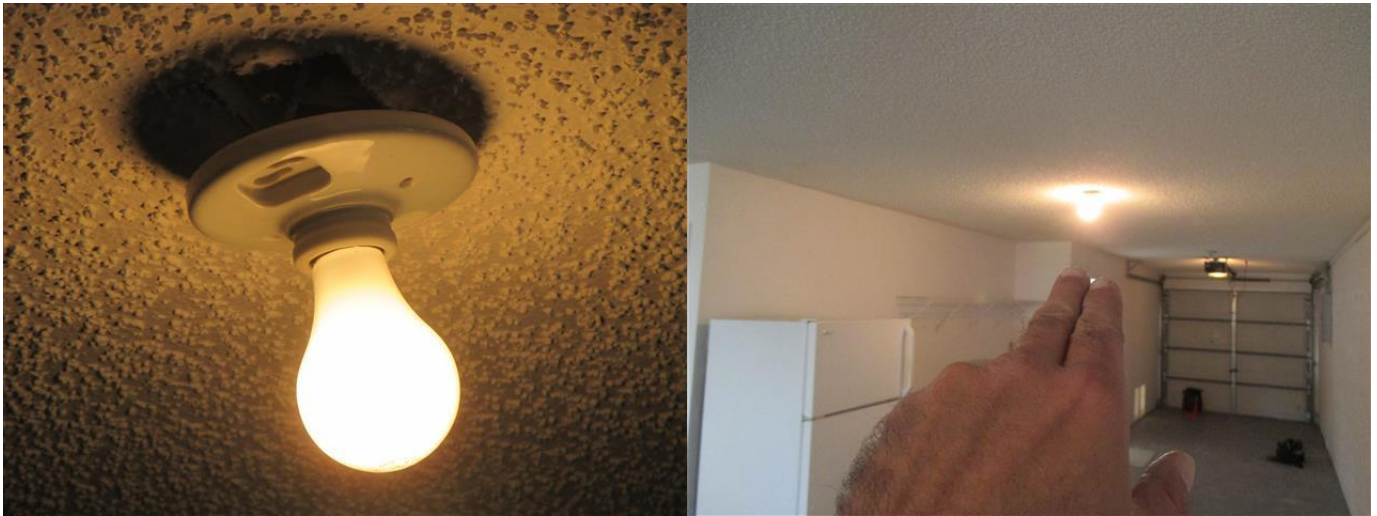
**Correction Needed: The light fixture near the midpoint of the garage was loose and should be secured to the light box.**

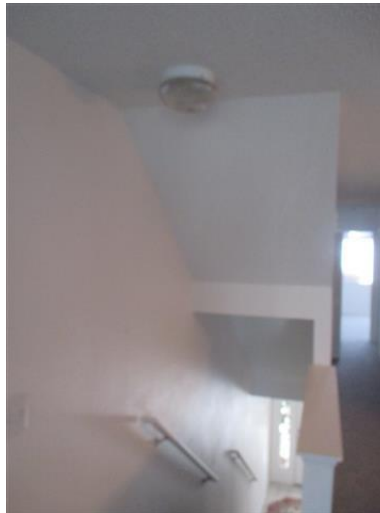
**Repair Needed:** The light fixture at the top of the stairwell between the garage and the first floor was not functional at the time of inspection.

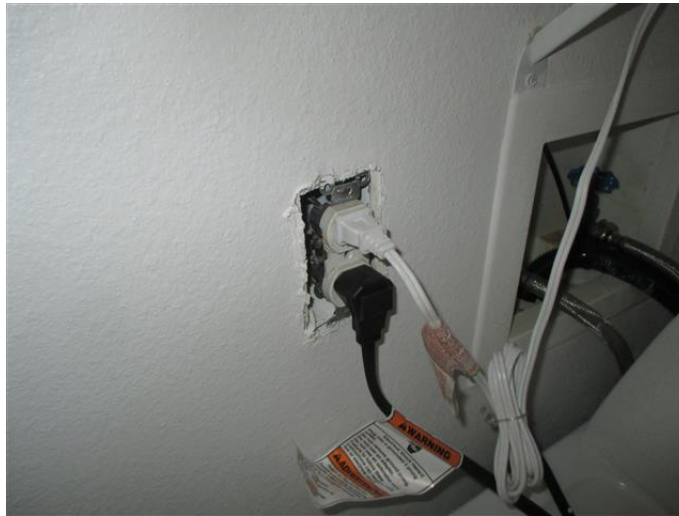
**Correction Needed:** The receptacle in the laundry closet did not have a cover plate installed.

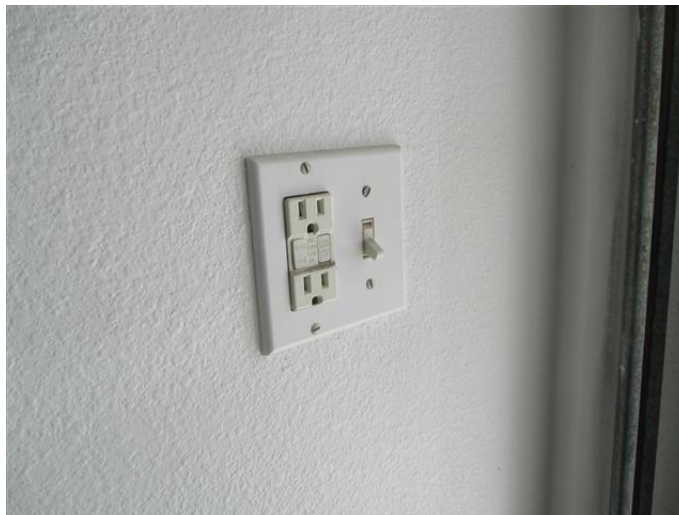
**General Information Item:** The GFCI receptacle adjacent to the garage door opening protected the other garage receptacles and the exterior receptacles on the ground floor.

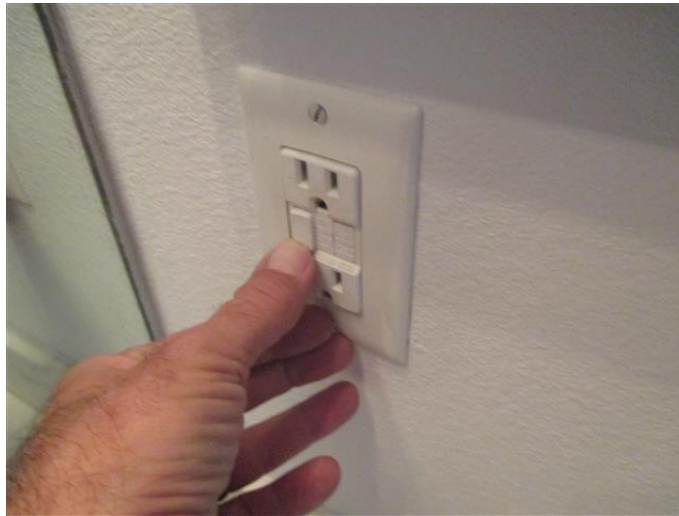
**General Information Item:** The GFCI receptacle on the first floor bathroom protected the receptacles in the second floor bathrooms.

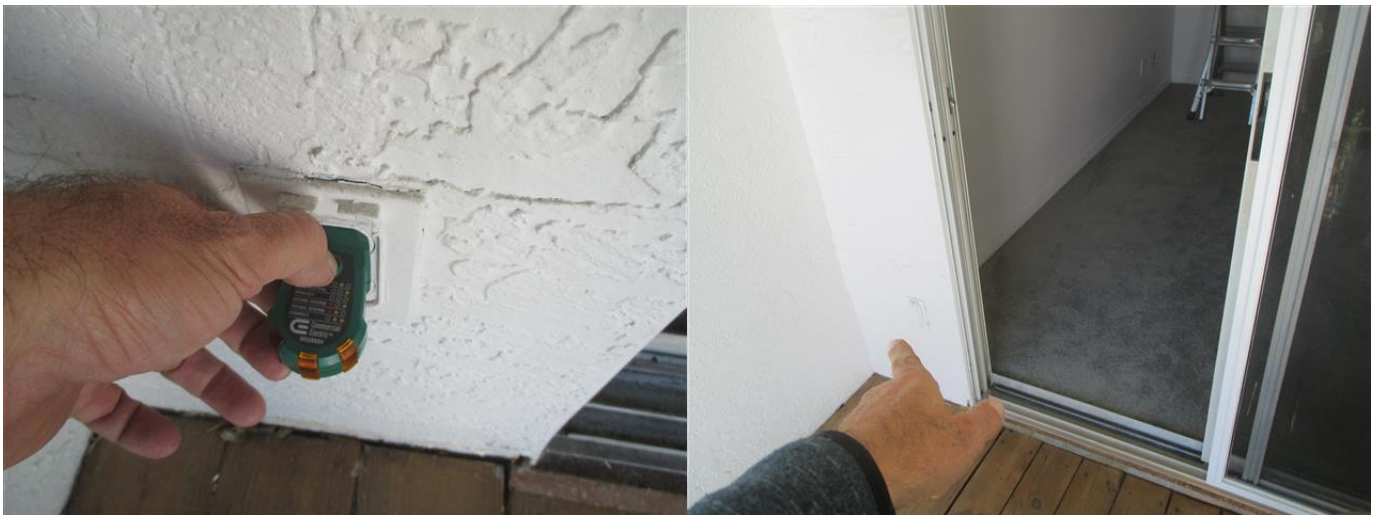
**Correction Needed:** The exterior receptacles on the first and second floor decks were not GFCI protected per current standards.

During any future upgrading of the electrical system or for added safety, we recommend installing GFCI (Ground-Fault Circuit Interrupter) receptacles in all appropriate areas to further reduce shock and/or short hazards.

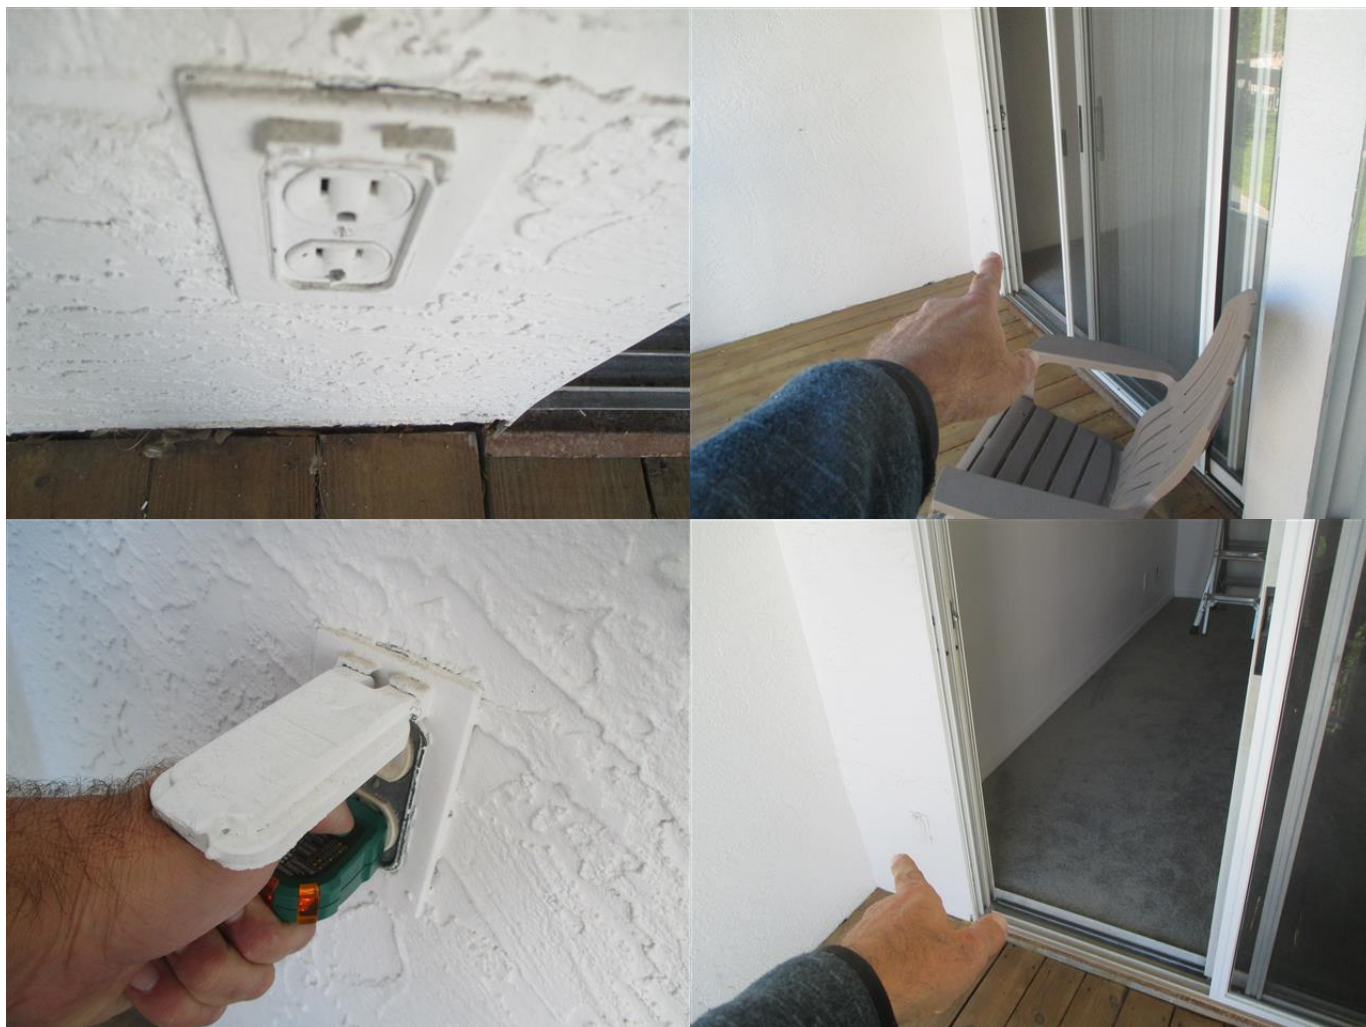
**Correction Needed:** The receptacle on the deck off the first-floor needed a new weather cover. Exterior receptacles should be weather-protected types.

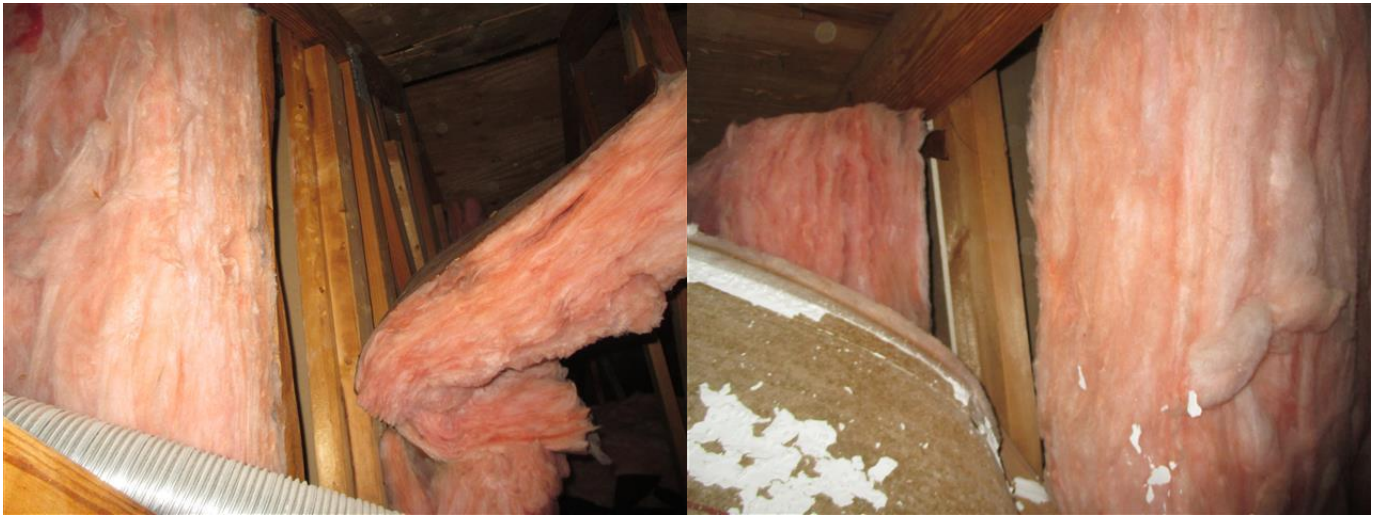
**Correction Needed:** Some of the insulation on the skylights was coming loose and should be reset and secured.

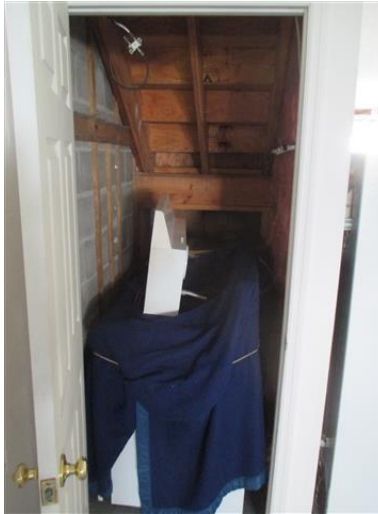
**General Information Item:** The items located in the storage closet underneath the stairwell limited our visual access to the area during the inspection.

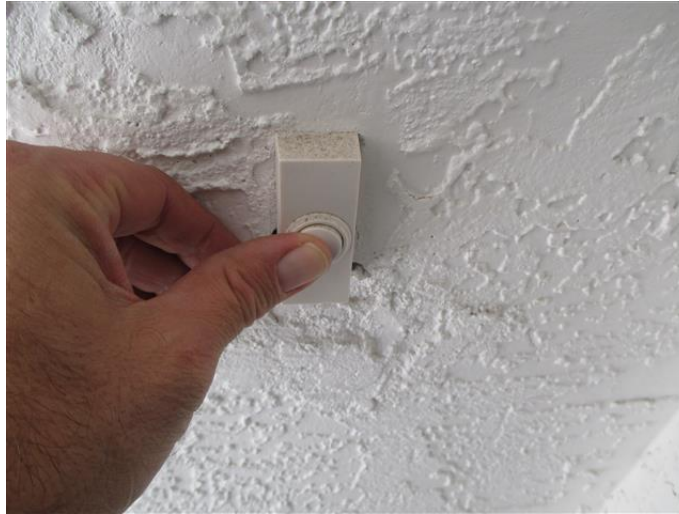
**Repair Needed: The doorbell was not functional at the time of inspection.**

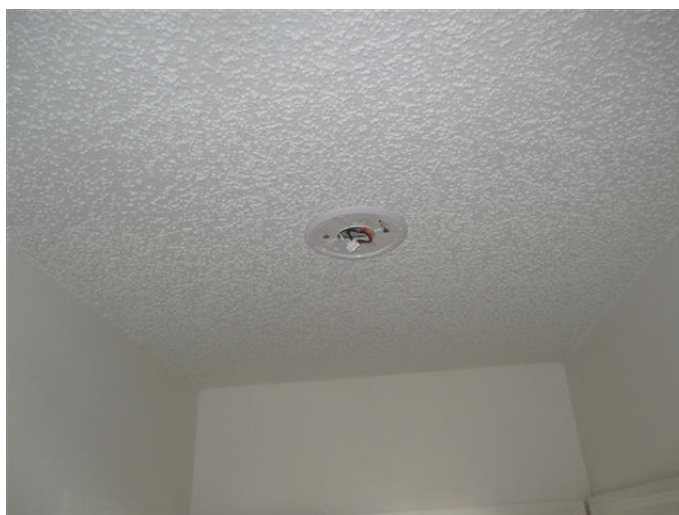
**Correction Needed: The smoke detector in the first-floor hallway had been removed.**

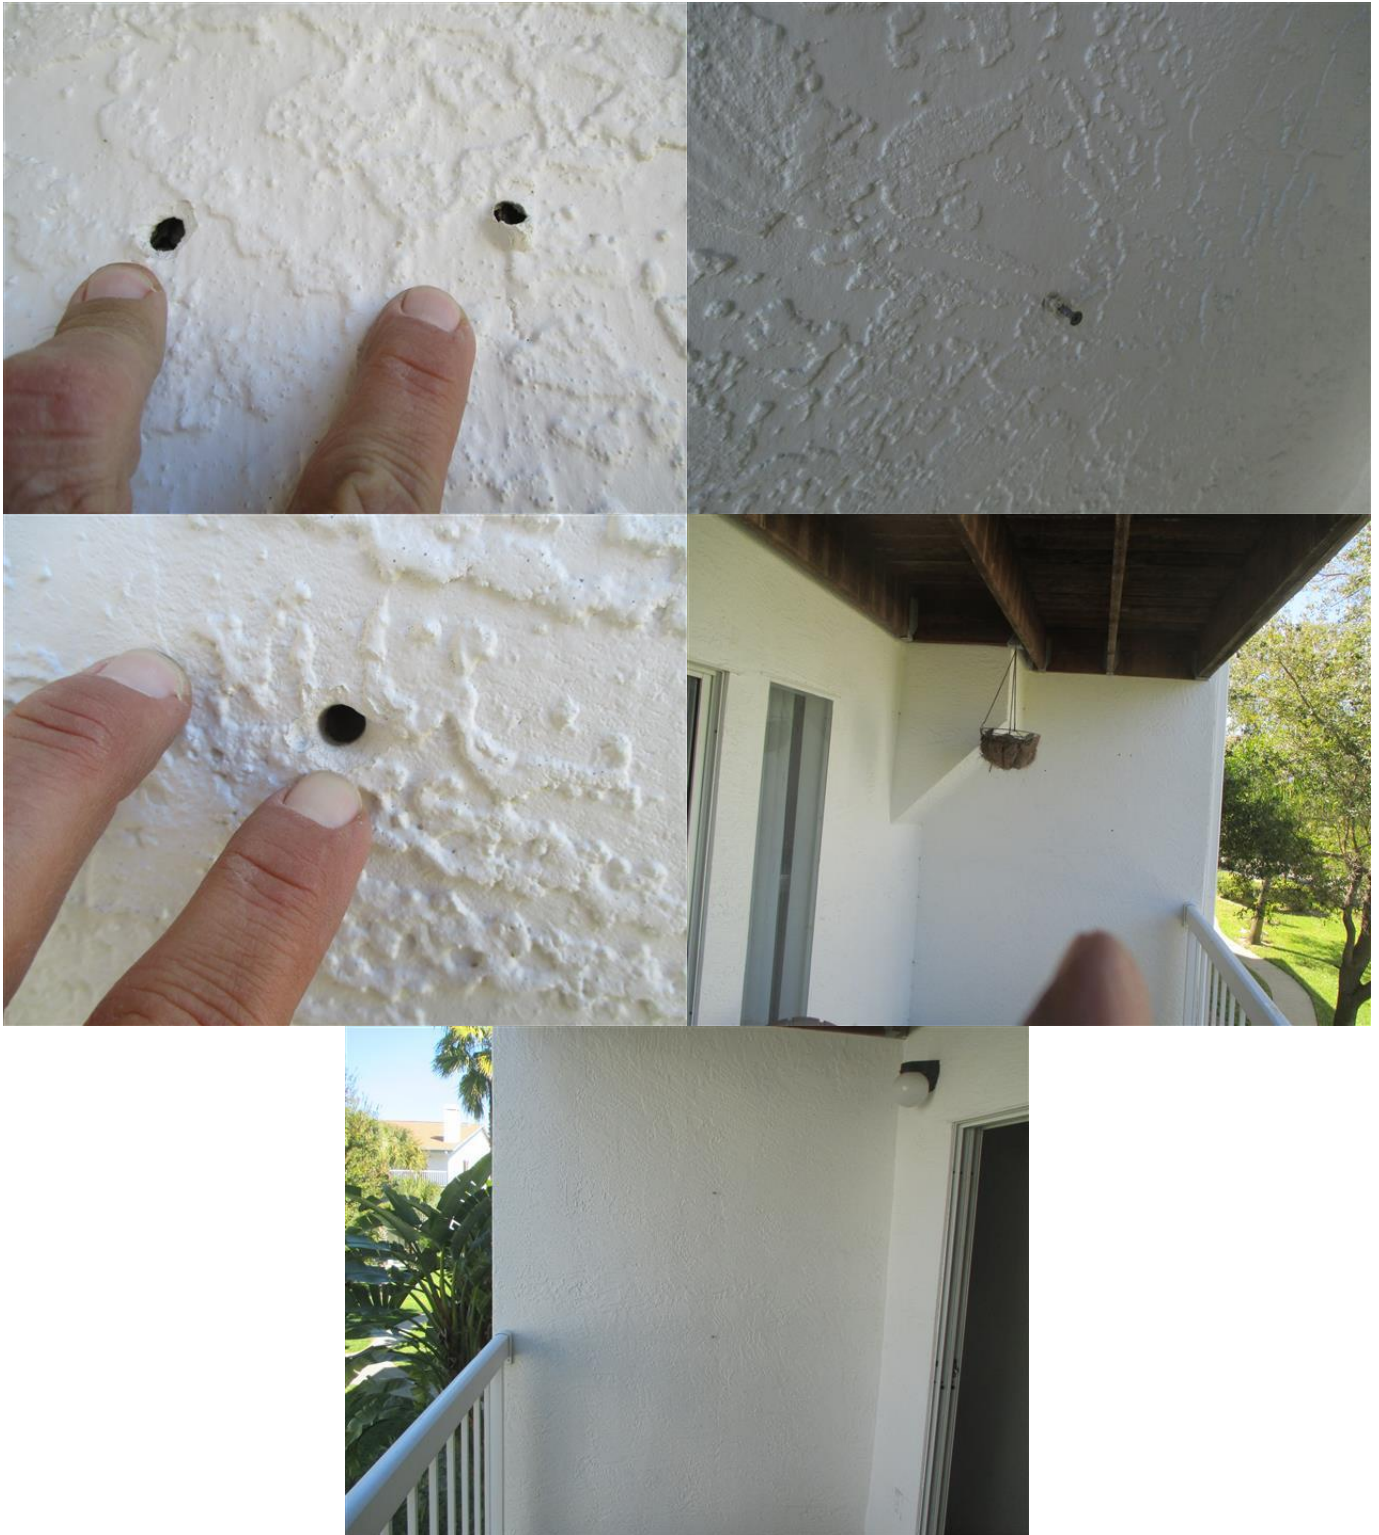
**Maintenance Needed:** The anchor holes in the stucco siding on the walls at the north and south side of the first floor deck should be sealed to prevent moisture intrusion.

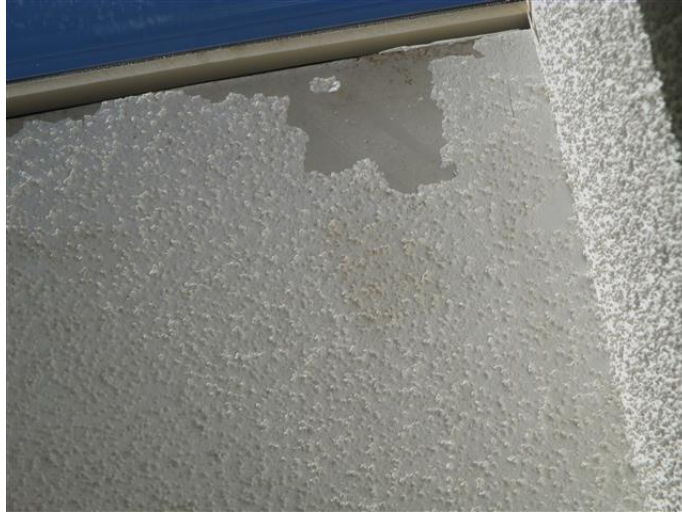
**Cosmetic Item:** We noted some peeling texture below the skylight in the east bathroom.

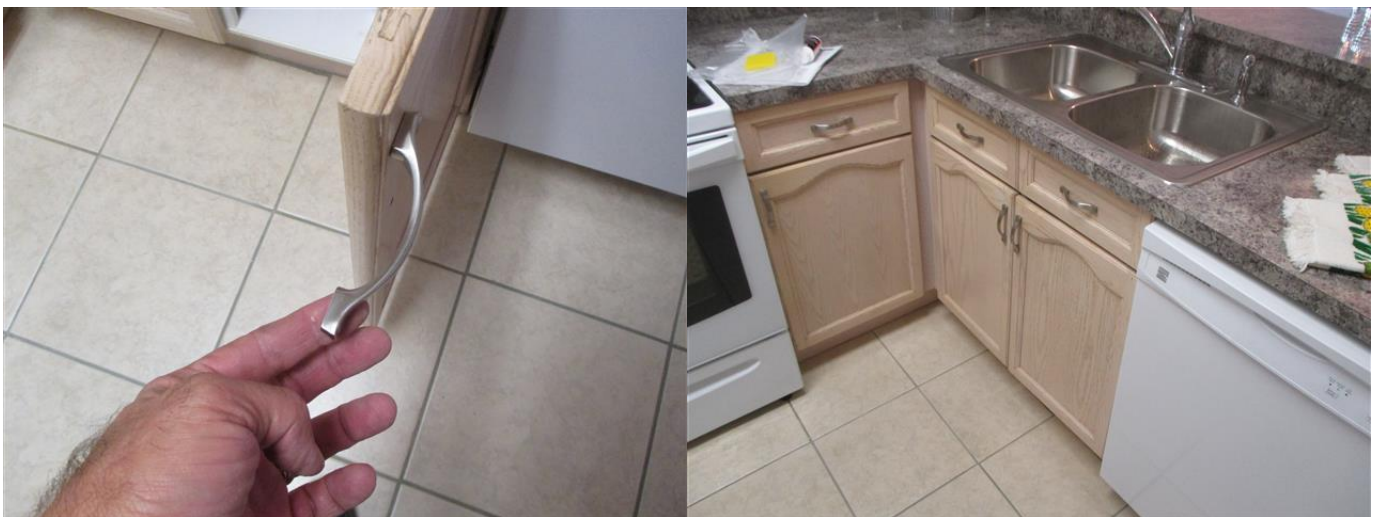
**Correction Needed:** The handle for the right side door on the cabinet underneath the kitchen sink was missing one of its fasteners.

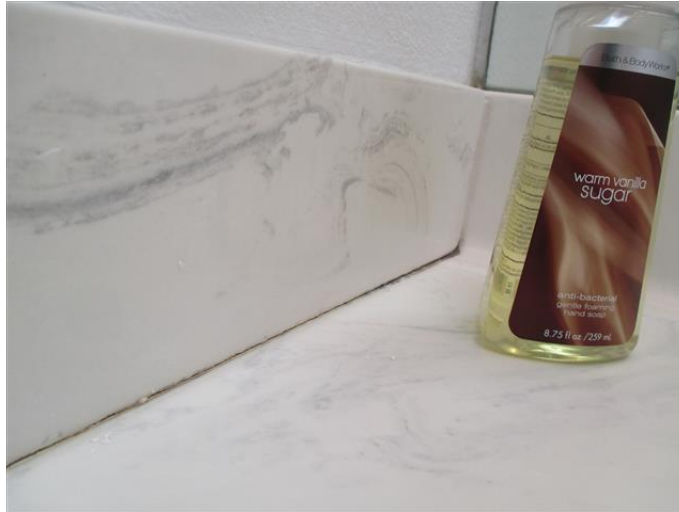
**Maintenance Needed:** The seams between the countertops and backsplash his should be resealed.

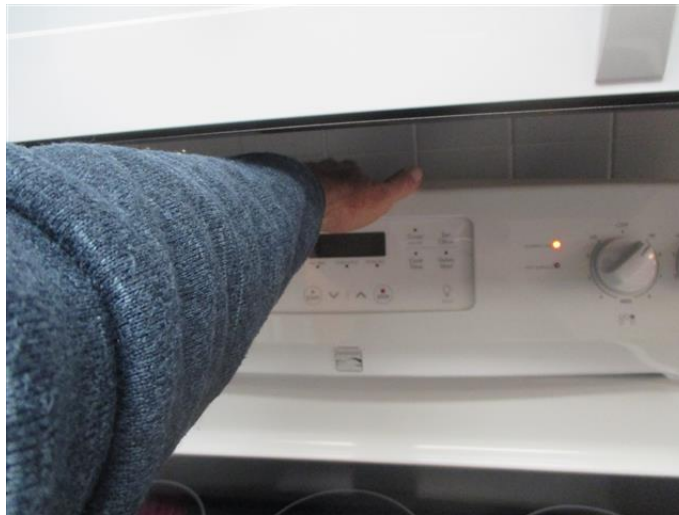
**Correction needed:** The oven did not have a tip guard installed per current safety standards.
