INTRODUCTION

GENERAL CONDITION OF BUILDING

The building is an east facing two-story masonry structure on slab with a flat (mansard) type roof design. The building was constructed circa 1923. The building had been extensively renovated circa 2000 - 2003.

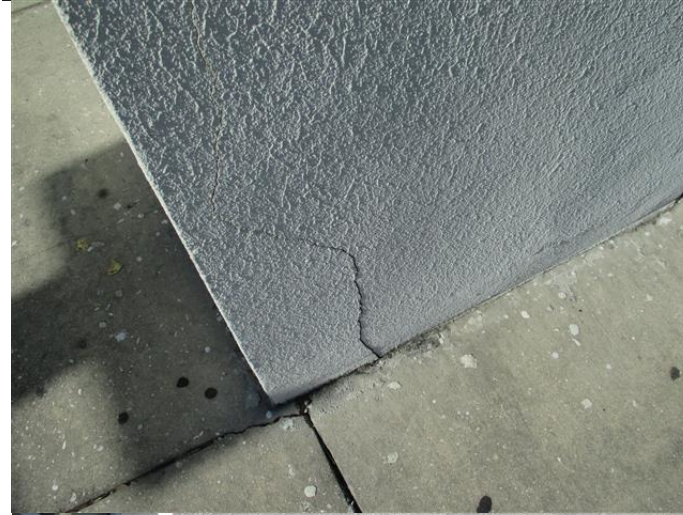
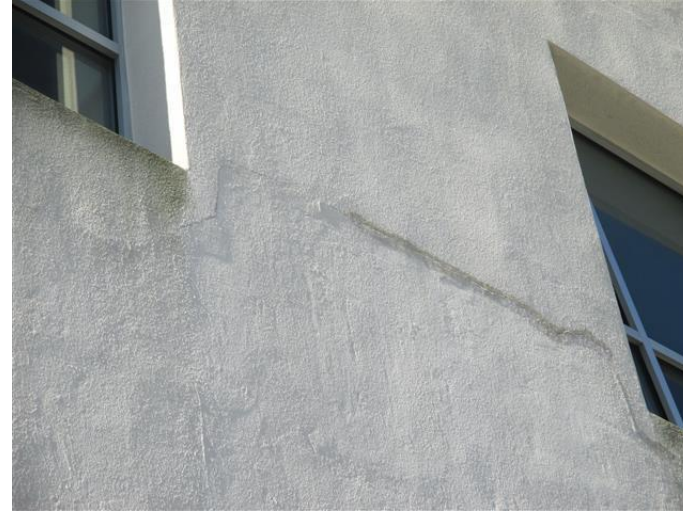
Replacement Needed: We noted numerous cracks and deterioration to the stucco around the perimeter of the building (see below). We noted evidence of moisture intrusion at many of the cracks (electronic moisture meter). The stucco siding had been installed without the proper weep screeds to allow the stucco drain any water that enters between the siding and the exterior wall. The stucco condition is such that it is not repairable and will likely need to be removed and replaced on the entire exterior of the building. We recommend contacting a licensed stucco contractor for further evaluation of the siding. Any new stucco siding should comply with current standards for installation, particularly in regards the horizontal drainage. Sufficient control joints should also be added to minimize further cracking in the stucco.

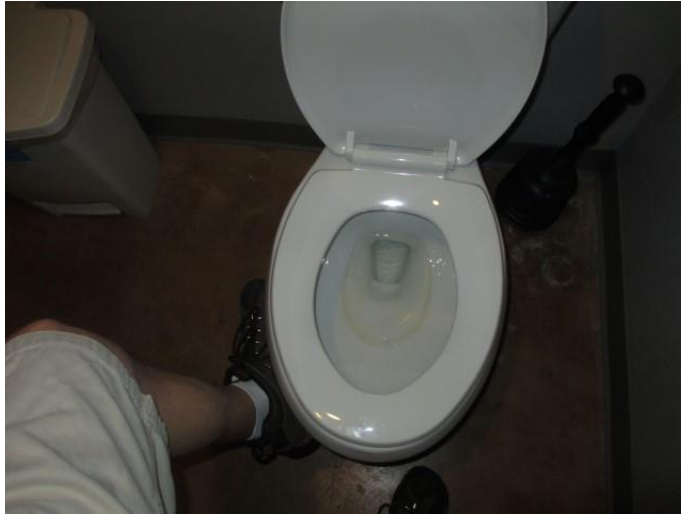
Correction Needed: The commode was loose in the 1st floor north hall men's restroom and should be secured.

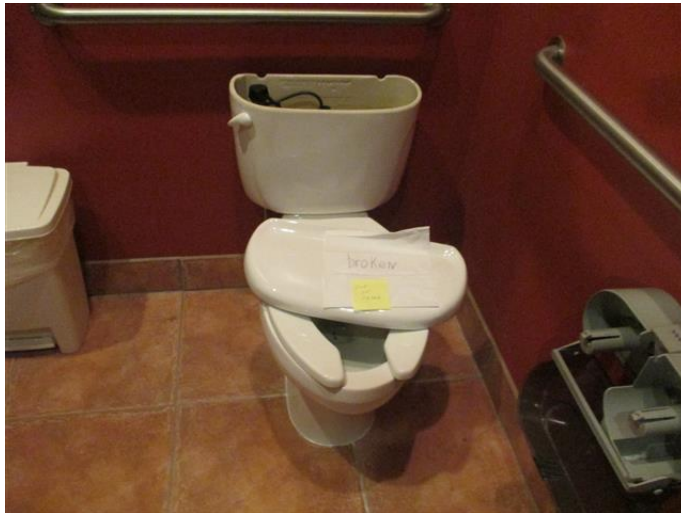
Repair Needed: We noted that the commode in the handicap stall in the women's hallway bathroom on the second floor was marked as not operational.

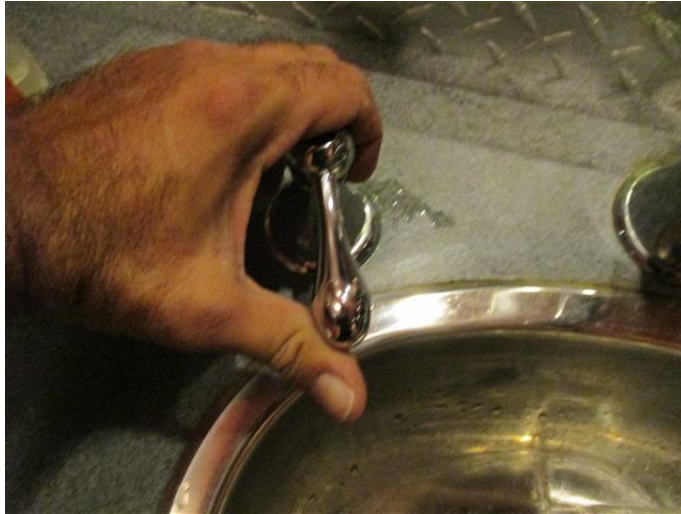
Repair Needed: The cold water control for the sink in the men's hallway bathroom on the second floor was difficult to operate.

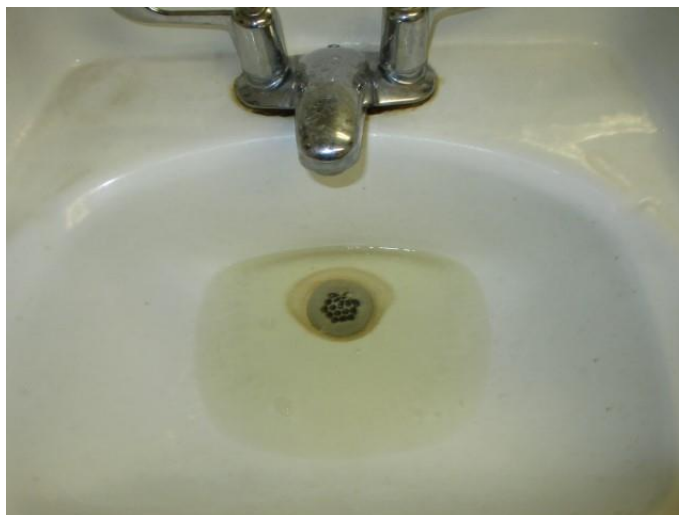
Maintenance Needed: The southwest second-floor bathroom sink was slowly the time of the inspection will need servicing.

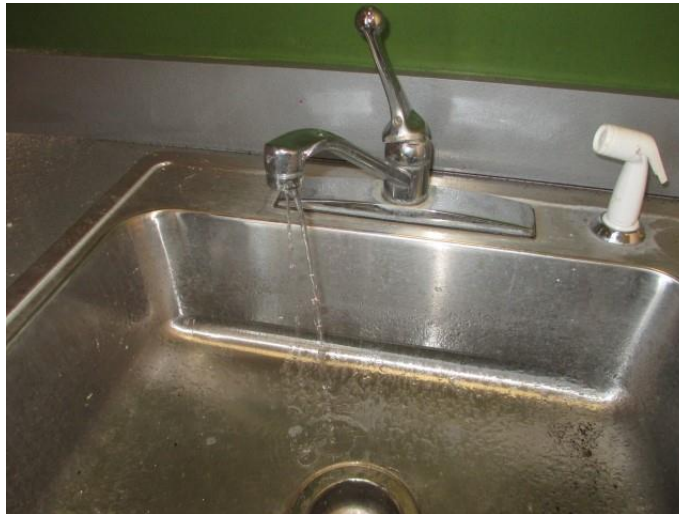
Repair Needed: We noted low water flow in the break room sink of the northwest third-floor suite.

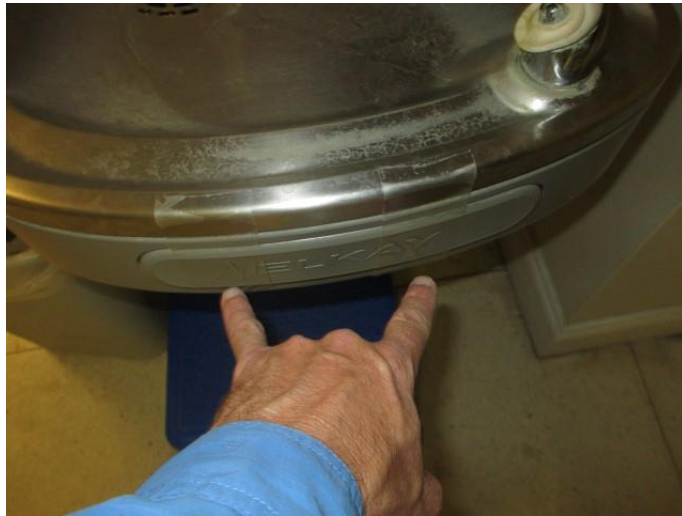
Concern Item: We noted tape on the water fountain controls and the 1st floor dance studio.

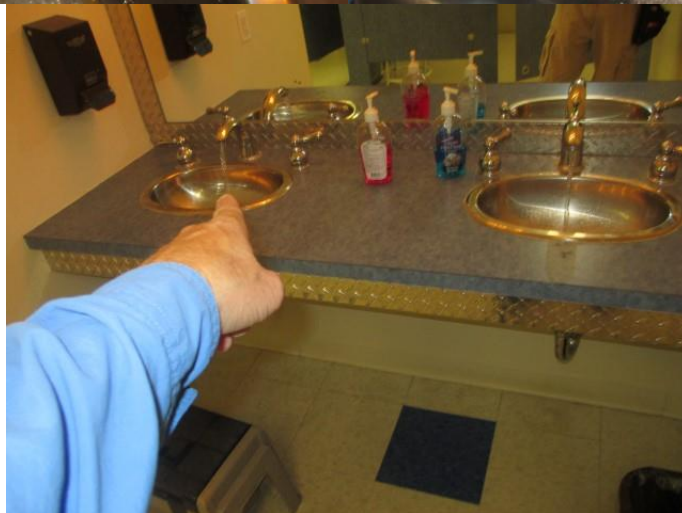
Repair Needed: The drain stop knob was missing in the faucet was loose on the left women's bathroom sink in the 1st floor dance studio.

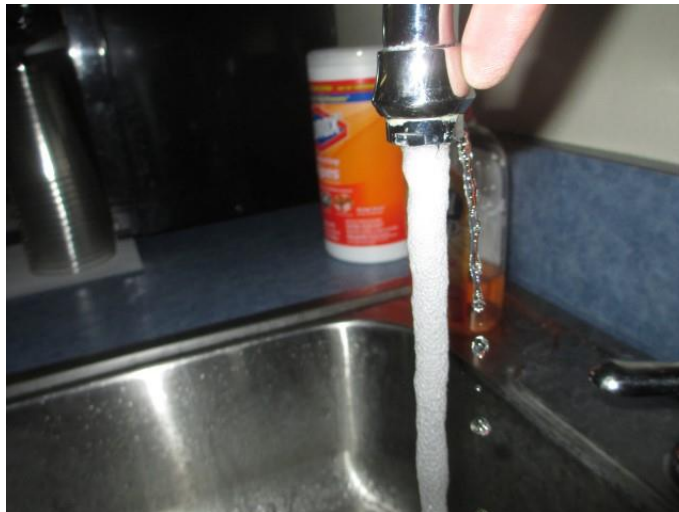
Repair Needed: The aerator should be replaced on the break room sink faucet in the 1st floor dance studio.

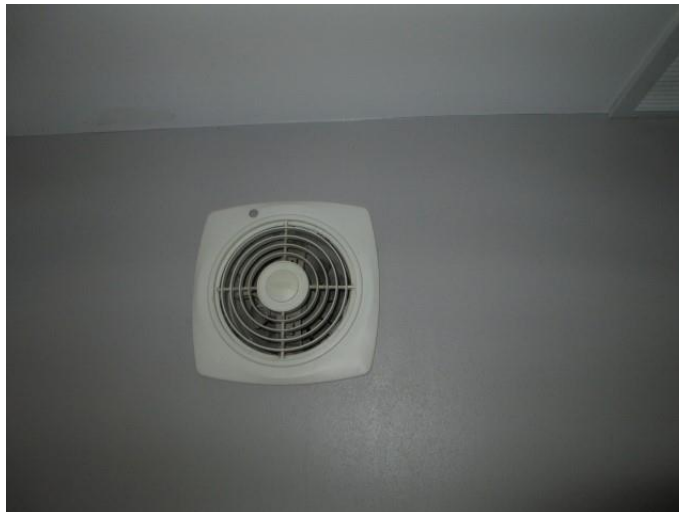
Repair Needed: The exhaust vent in the 1st floor north hall men's restroom did not appear to be operational the time of the inspection.

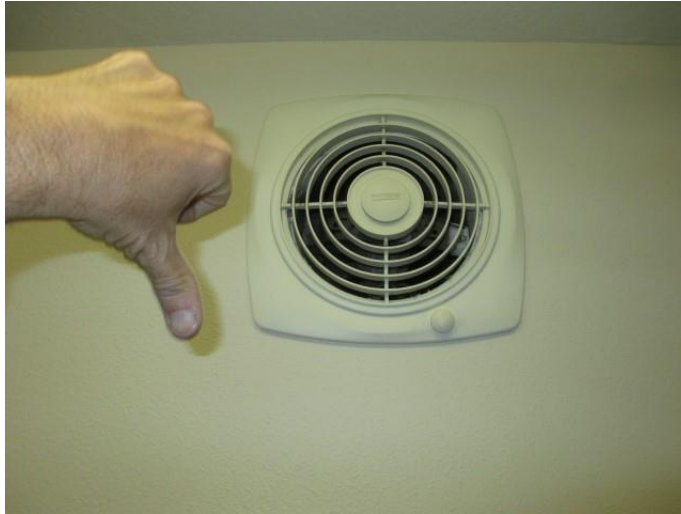
Repair Needed: The exhaust vent in the men's bathroom in the 1st floor dance studio was not operational at the time the inspection.

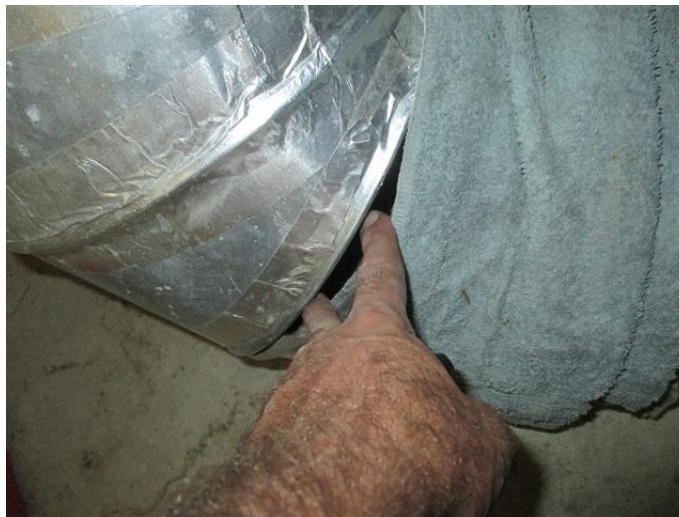
Repair Needed: We noted some loose ductwork connected to the air handler located in the utility closet of the large first floor suite.

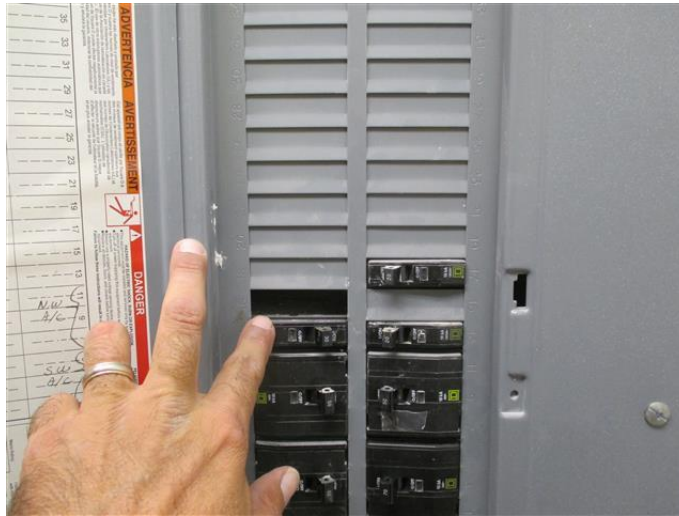
Correction Needed: The open circuit breaker slot in subpanel 2-B should be properly covered.

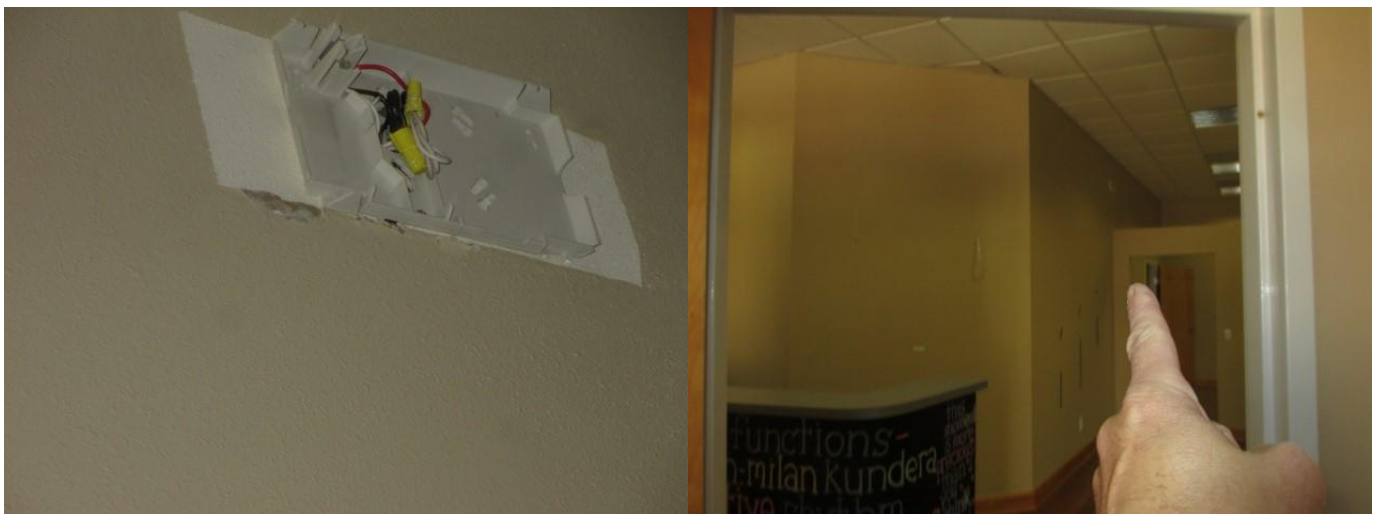
Correction Needed: The exposed wiring on the east wall in the northwest 3rd floor suite should be properly sealed secured.

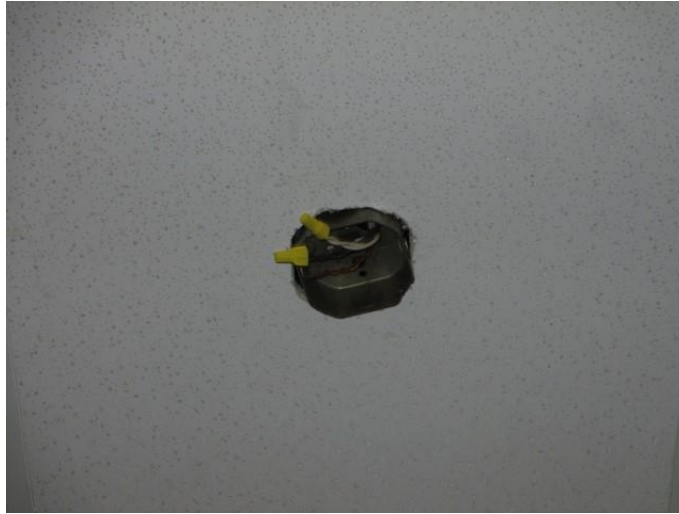
Correction Needed: The exposed wiring and ceiling in the southeast conference room in the northwest 3rd floor suite should be sealed and secured.

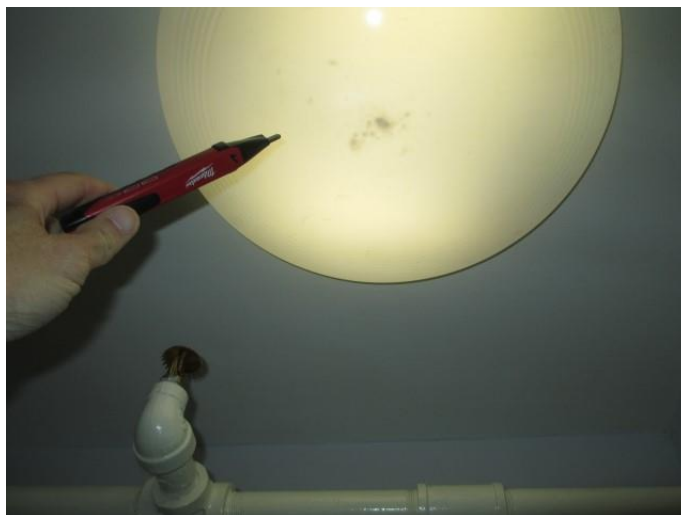
Correction Needed: The light fixture in the closet of the north room on the 2nd floor was not grounded at the time of the inspection.

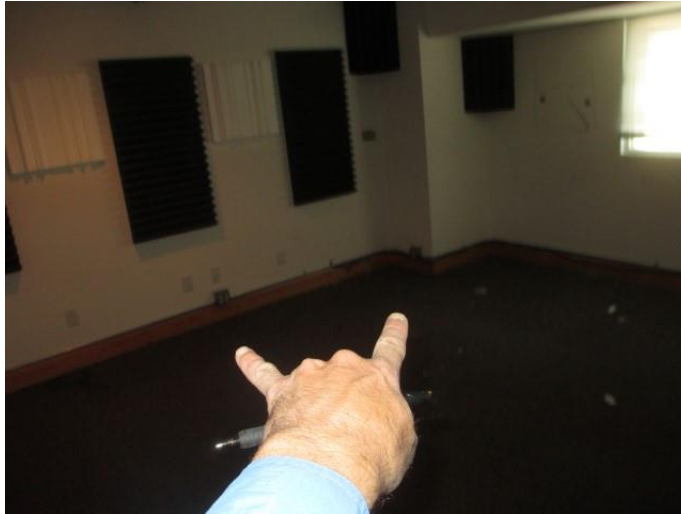
Maintenance Needed: The receptacles on the south wall in the recording studio was loose and should be secured.

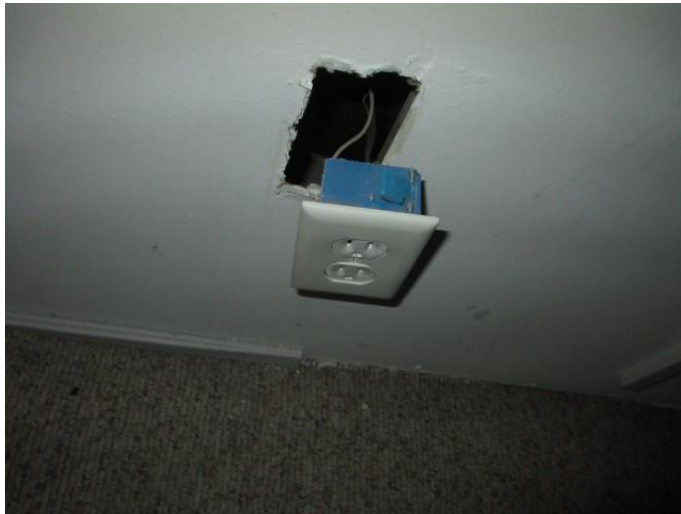
Maintenance Needed: The receptacle on the north wall (northwest corner) of the east room on the 2nd floor was detached and should be secured.

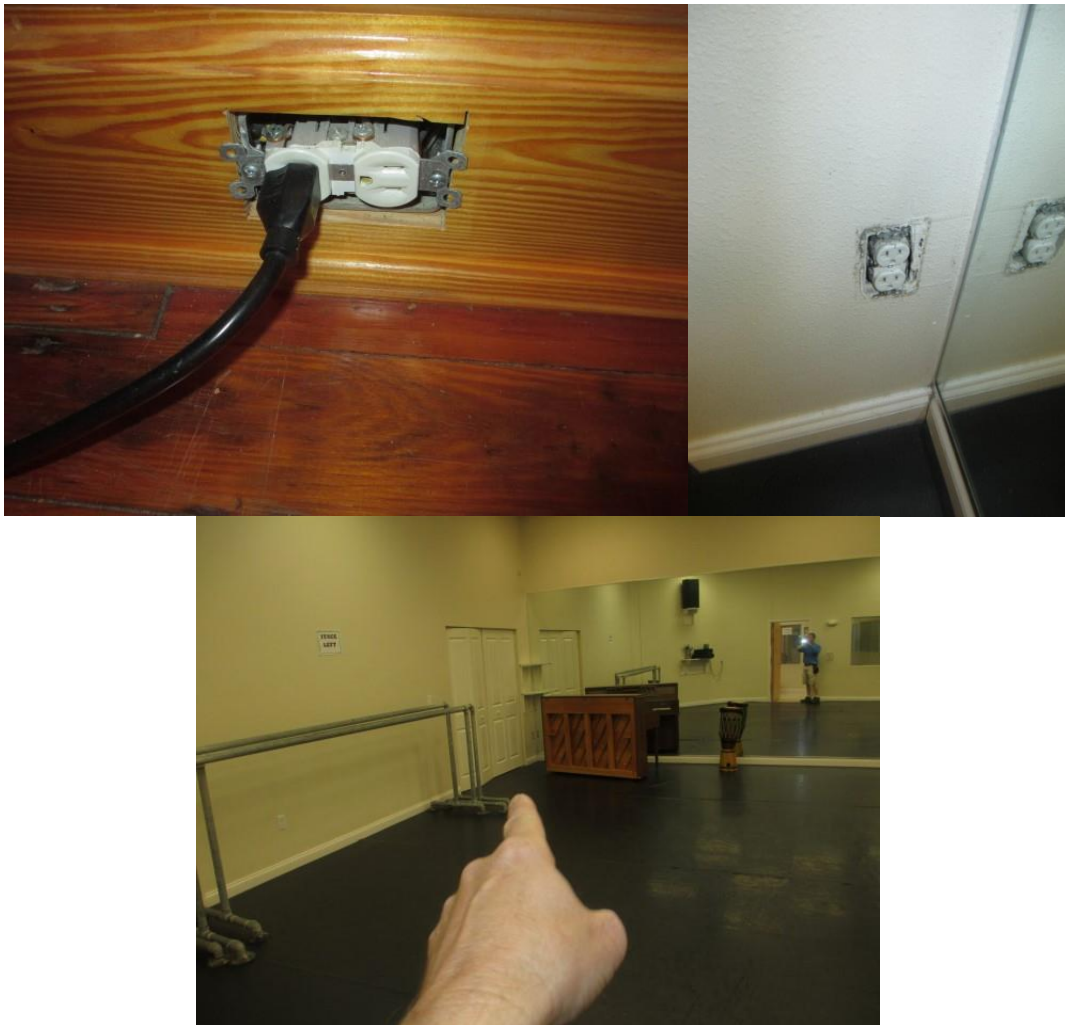
Correction Needed: The cover plate was not on the receptacle on the south side of office in Suite 203 and on the southeast receptacle on the east wall in the south dance room on the 1st floor.

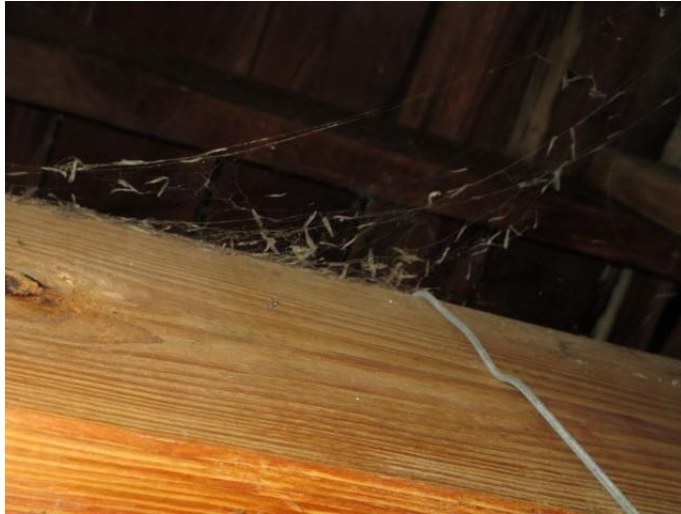
Concern Item: We noted evidence of termite intrusion in the attic area (droppings, damage etc.). Some the droppings were noted on top of the ceiling tiles in the west offices, indicating that they were deposited since the building had last been renovated. We recommend contacting a licensed pest specialist for further evaluation and remediation.

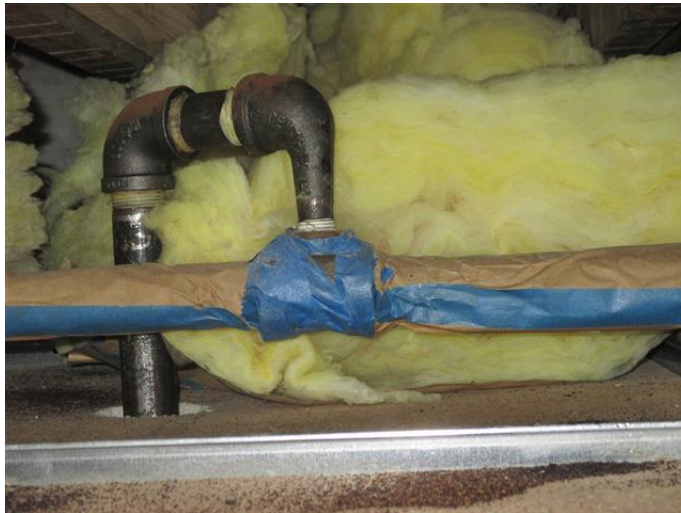
Repair Needed: In the south office in the northwest suite on the second floor, we noted that the fire suppression supply system appeared to be leaking (also see Interior notes).

Repair Needed: In the south office in the northwest second-floor suite, we noted staining around the fire suppression nozzle. The area tested positive for active moisture intrusion at the time of inspection, indicating leakage from the supply piping for the fire suppression system (also see Attic notes).

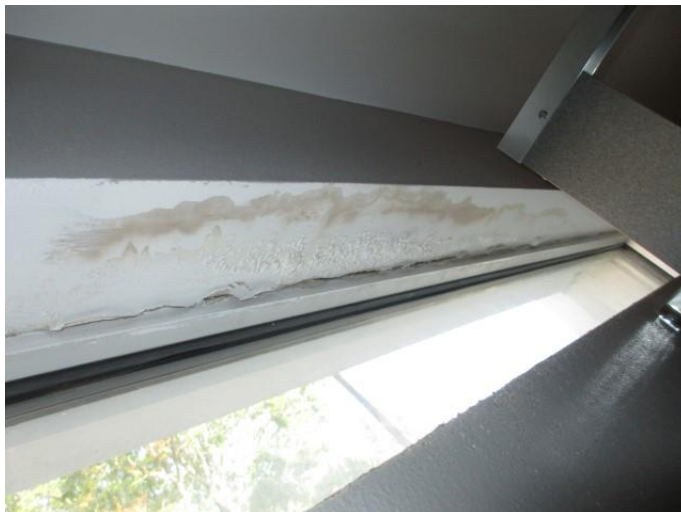
Concern Item: We noted staining on the top of the window opening in the 1st floor north hall men the bathroom. This area tested negative for elevated moisture the time of the inspection.

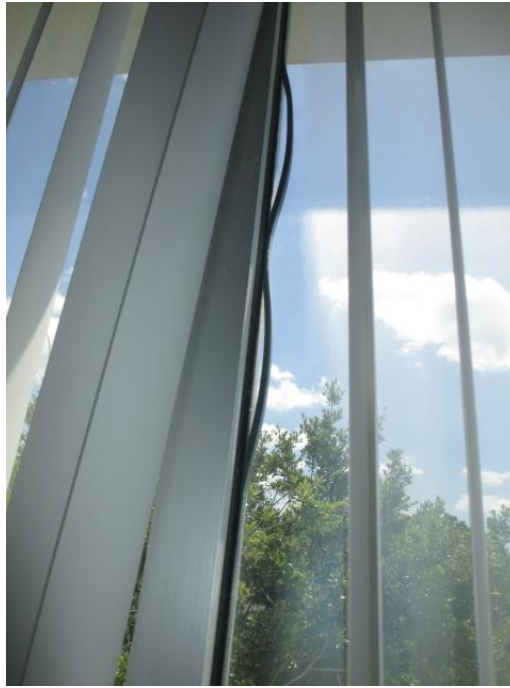
Repair Needed: We noted that the inner seal was starting to fail in the main office in suite 202 on the 3rd floor and will likely need to be resealed.

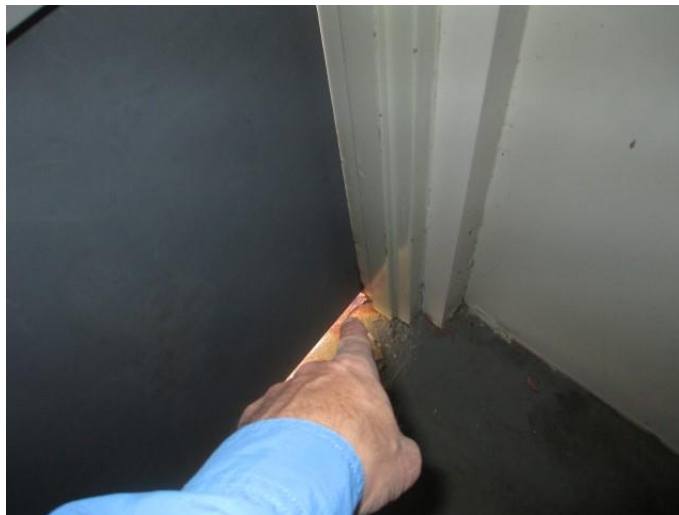
Maintenance Needed: We noted corrosion to the base of the exterior door in the west stairwell that should be treated and resealed.

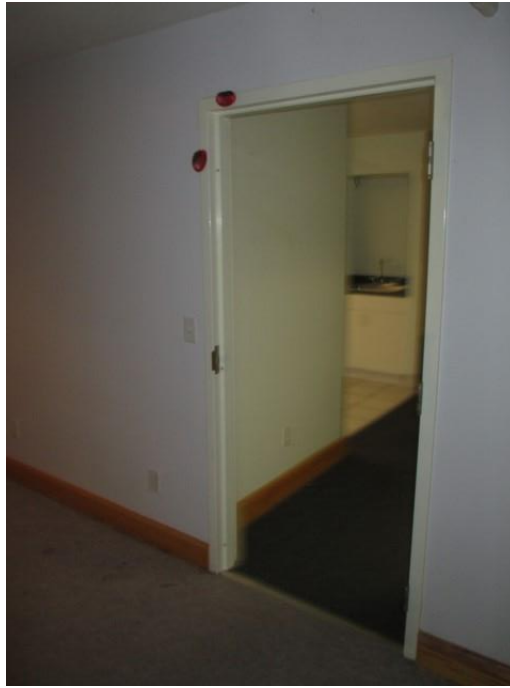
Correction Needed: The door was not installed on the southeast second-floor room.

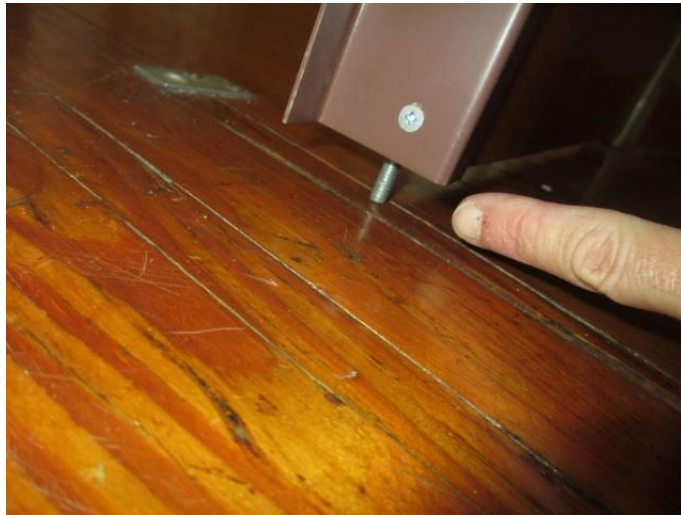
Repair Needed: We noted that the bottom latching pin was not operating properly on the southeast double doors in the northwest third-floor suite.

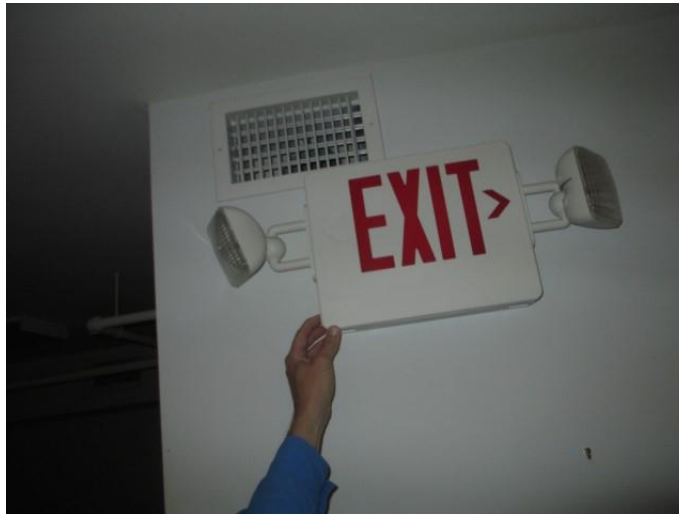
Repair Needed: The emergency lighting for the exit signs throughout the second floor were not operational the time of inspection.

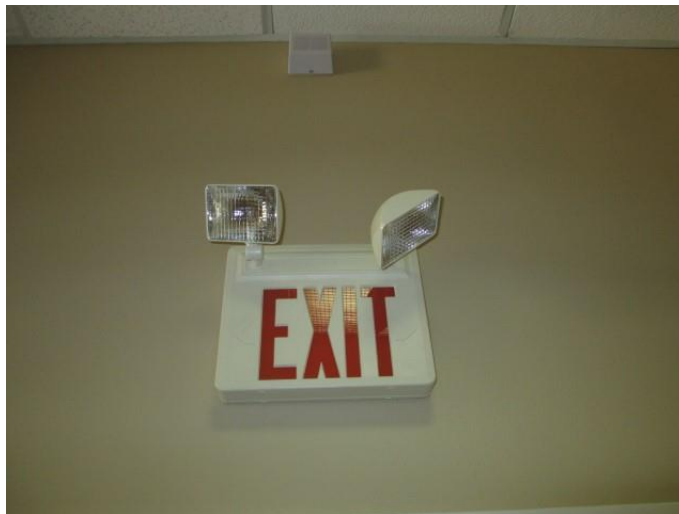
Repair Needed: The emergency lighting for the exit signs 3rd floor hallway was not operational the time of inspection and the northwest suite.

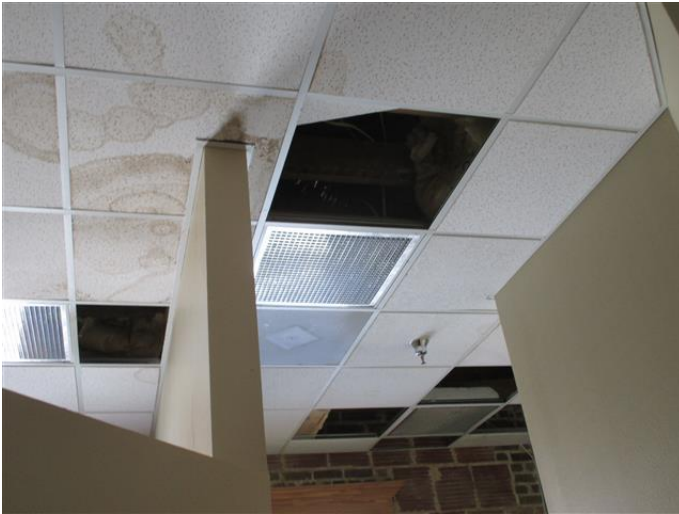
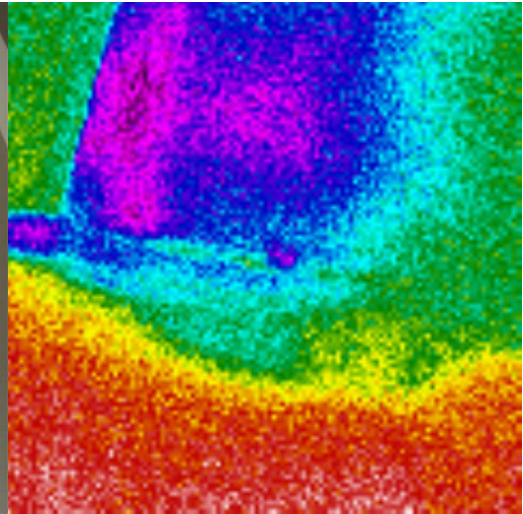
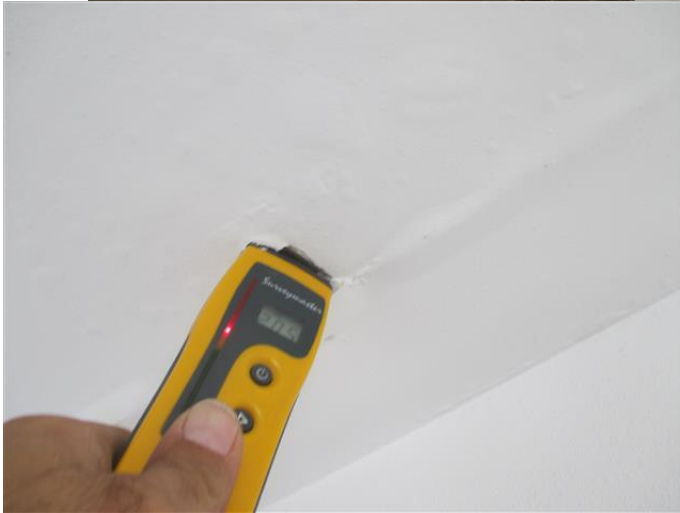
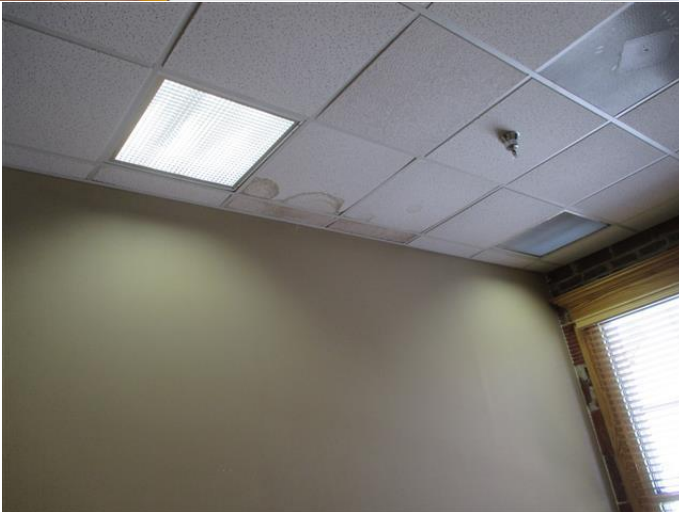
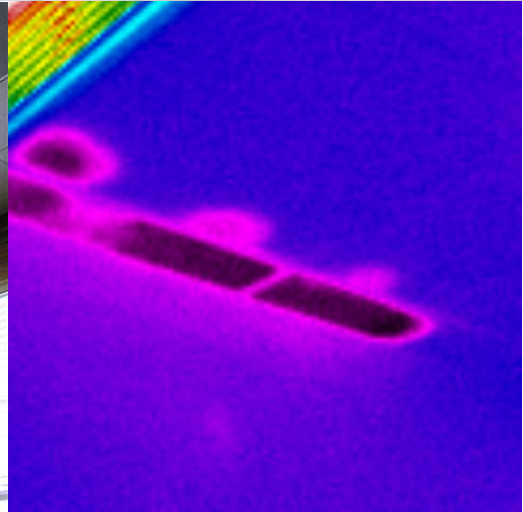
Concern Item: We noted staining to the ceiling and walls at the entry between the mezzanine in the second-floor hallway, and along the west side of the northwest office on the second floor. Most of these areas tested positive for active moisture intrusion at the time of inspection, indicating areas of active roof leakage.
