INTRODUCTION

GENERAL CONDITION OF DWELLING

The dwelling is a north facing two-story block and framed structure on slab with a hip type roof design. The dwelling was constructed circa 1984.

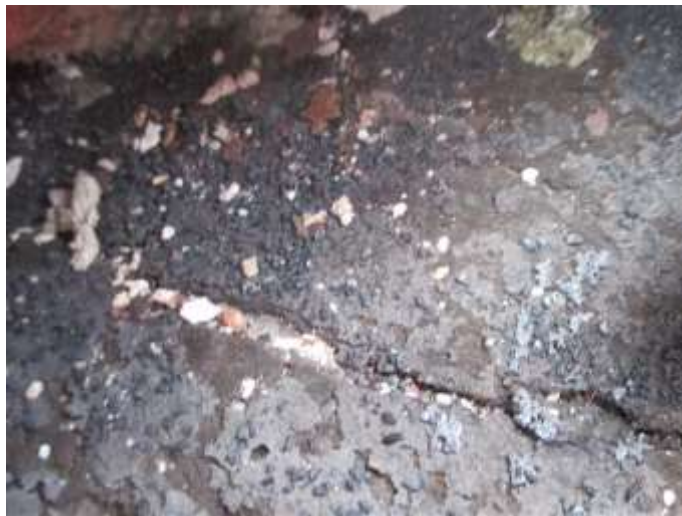
Repair Needed: some of the exposed underlayment was showing signs of deterioration and will need to be repaired or replaced.

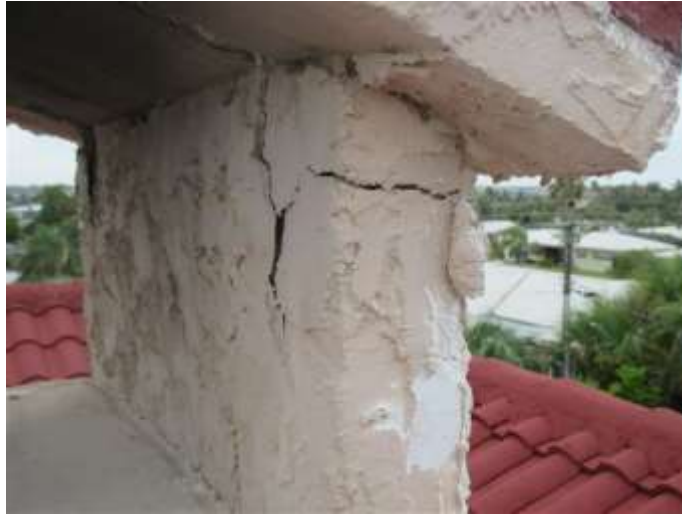
Repair Needed: The masonry crown and cap were heavily deteriorated and will need to be rebuilt or removed.

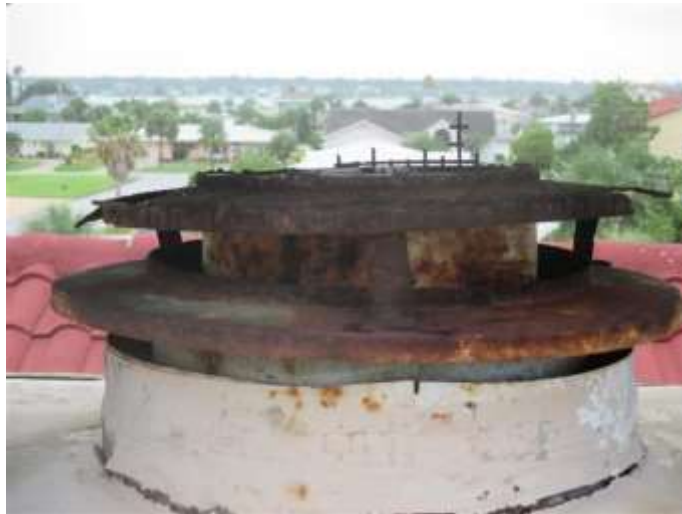
Replacement Needed: The metal cap for the chimney had corroded away.

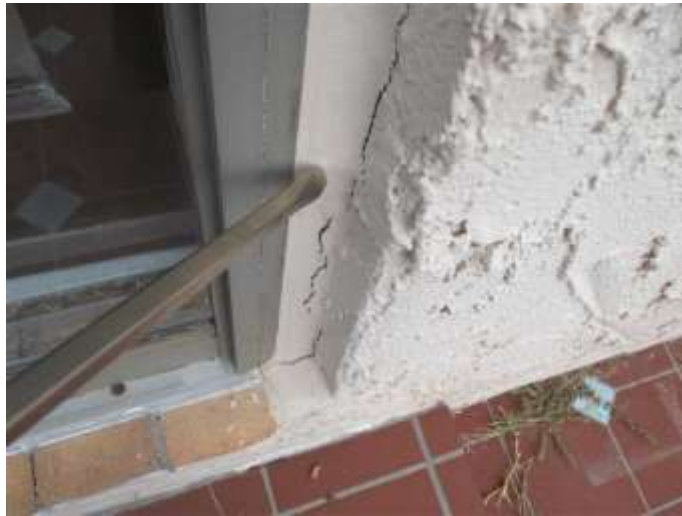
Maintenance Needed: The exterior doorways and window opening should be resealed.

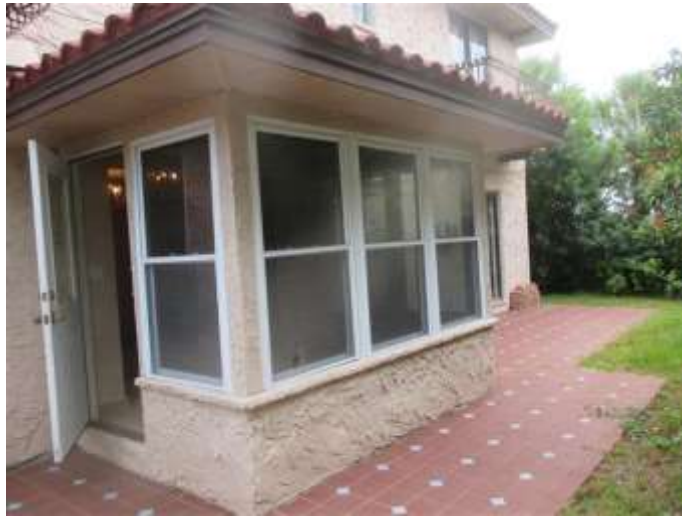
Maintenance Needed: The window openings on the sunroom should be sealed prevent moisture intrusion behind the stucco.

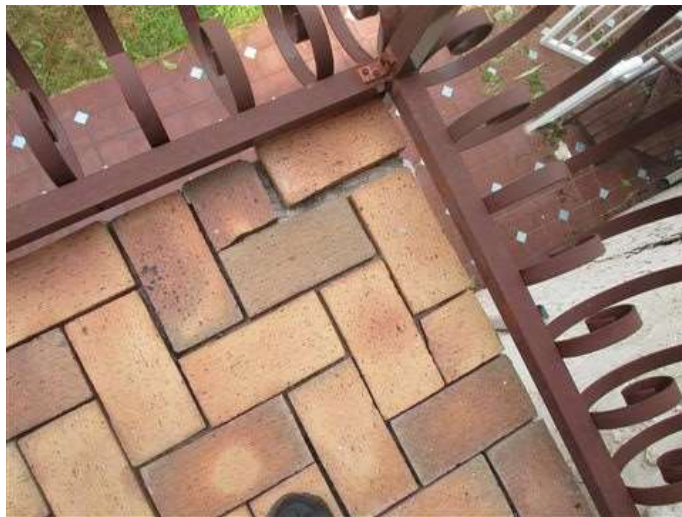
Repair Needed: The loose pavers on the upper deck near the midpoint the elevation should be reset and secured.

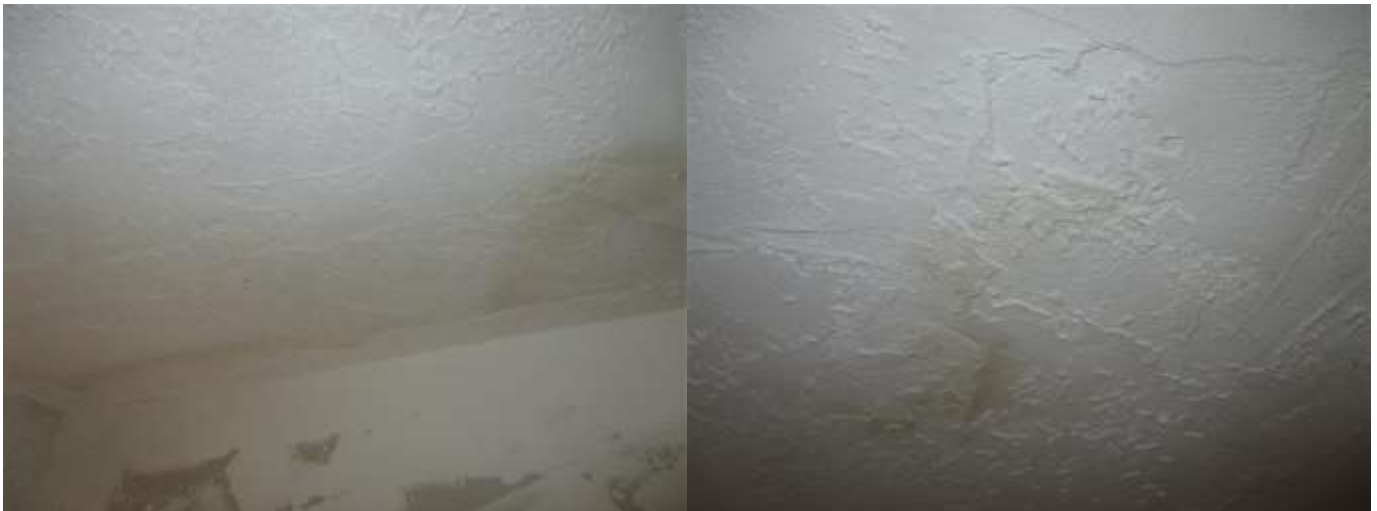
Concern Item (To Be Monitored): We noted numerous areas of staining to the ceiling in the garage, indicating areas of past moisture intrusion. Although these areas tested negative for active moisture intrusion at the time of inspection, they should be monitored.

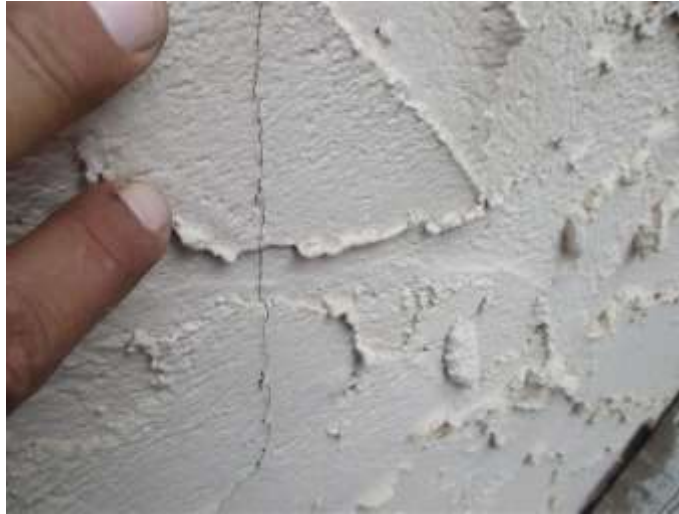
Some minor cracking (hairline, less than 1/16", etc.) was noted in a few areas around the perimeter of the dwelling.

These generally appeared to follow the mortar joints between the courses of blocks (stair step pattern) and are a normal occurrence found in homes of this design. We did not notice any wall deflection or evidence of racking to doorframes or window openings in these areas at the time of the inspection.

No visual evidence of structural problems was found, however, the cracks should be monitored for further movement.

As part of normal maintenance caulk and seal all of the gaps in the exterior of the building (around doors, windows, plumbing and electrical entry openings, etc.) to prevent air, moisture, and pest infiltration. Settlement cracks should be monitored for any further movement after patching.

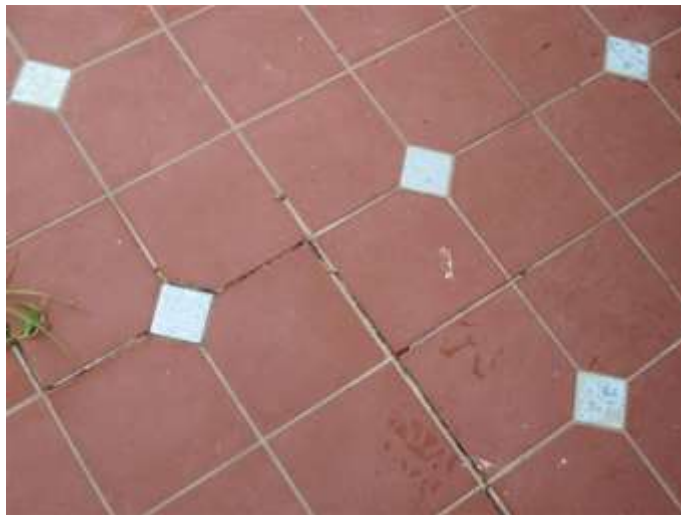
Repair Needed: We noted crack in the concrete patio on the south elevation.

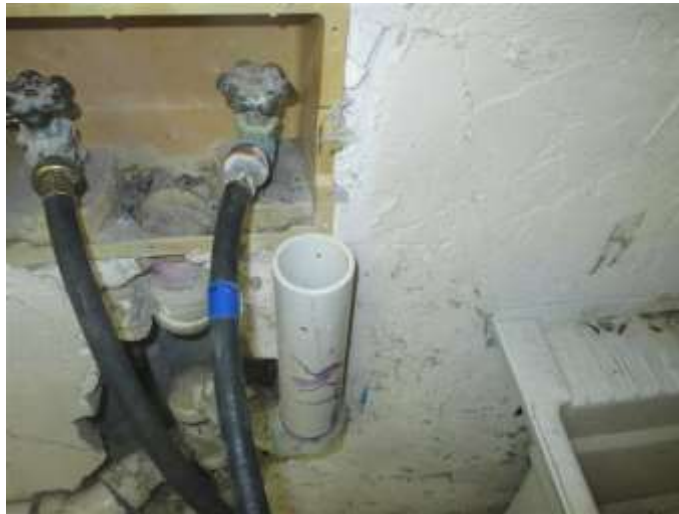
Correction Needed: The standpipe in the laundry did not appear to have a drain trap installed. They should be corrected to prevent sewer gases from venting into the room (safety concern).

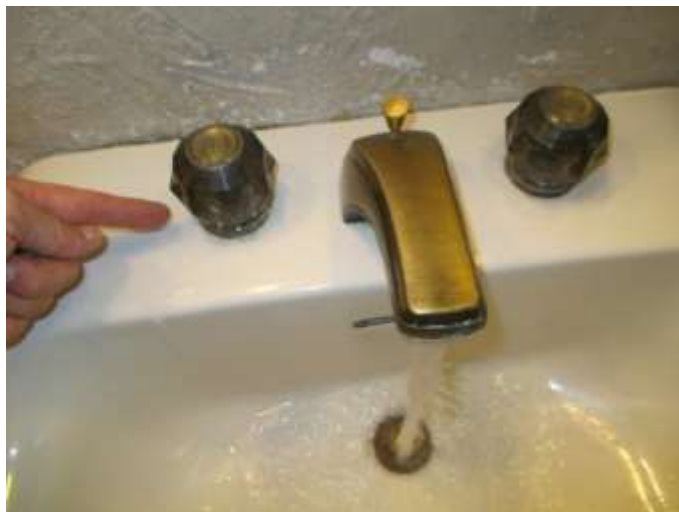
Repair Needed: The hot control knob was leaking at the sink in the south hall bathroom should be replaced.

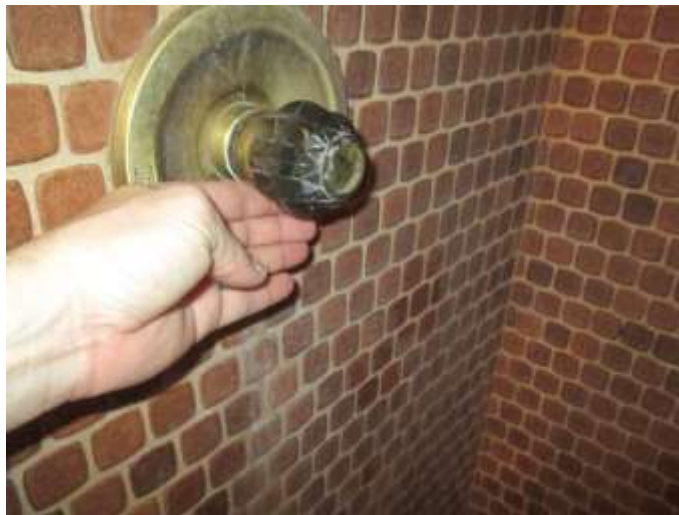
Repair Needed: The control knob was leaking in the south hall bathroom shower and likely needs the cartridge replaced.

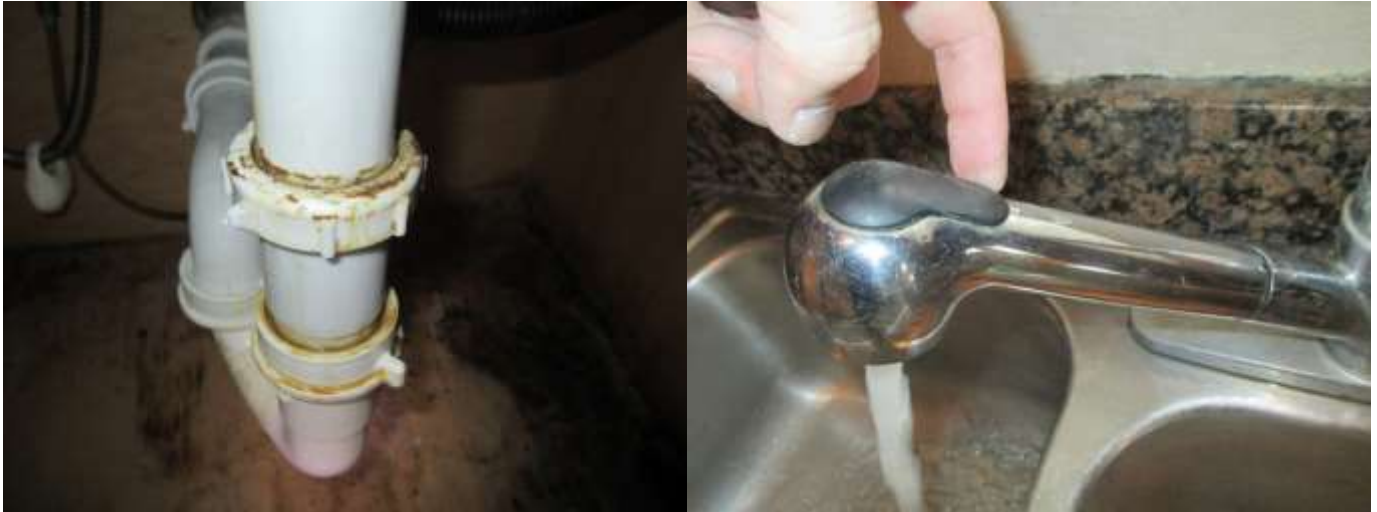
Repair Needed: We noted a leak from the drain pipe under the left set of kitchen sinks and the faucet was leaking at the switch mechanism.

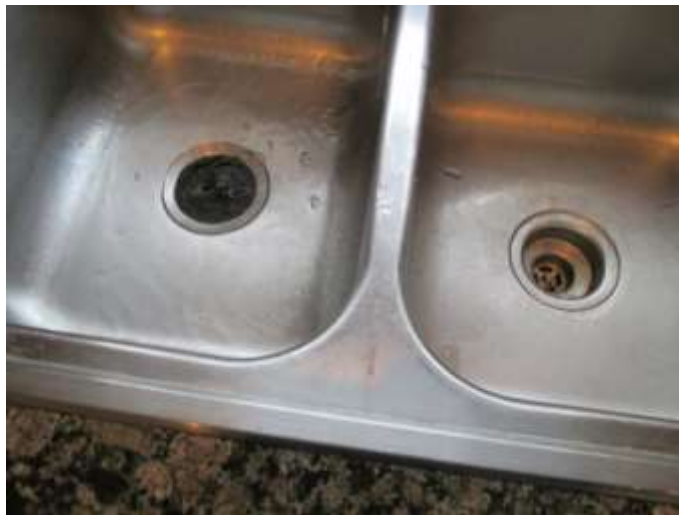
Maintenance Needed: The left kitchen sink (left set) was not drain properly the time of the inspection will need servicing.

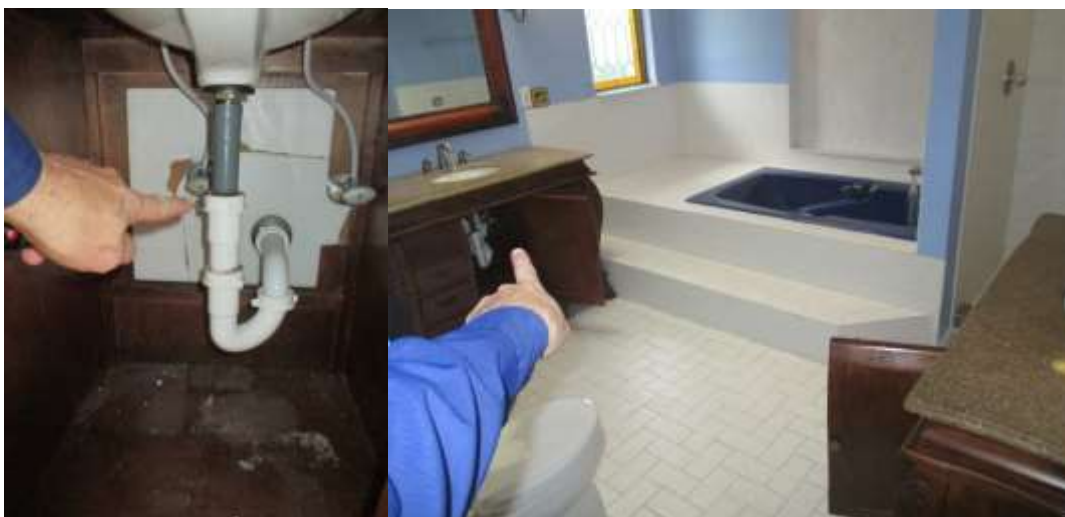
Repair Needed: The left master bathroom sink drain pipe was leaking.

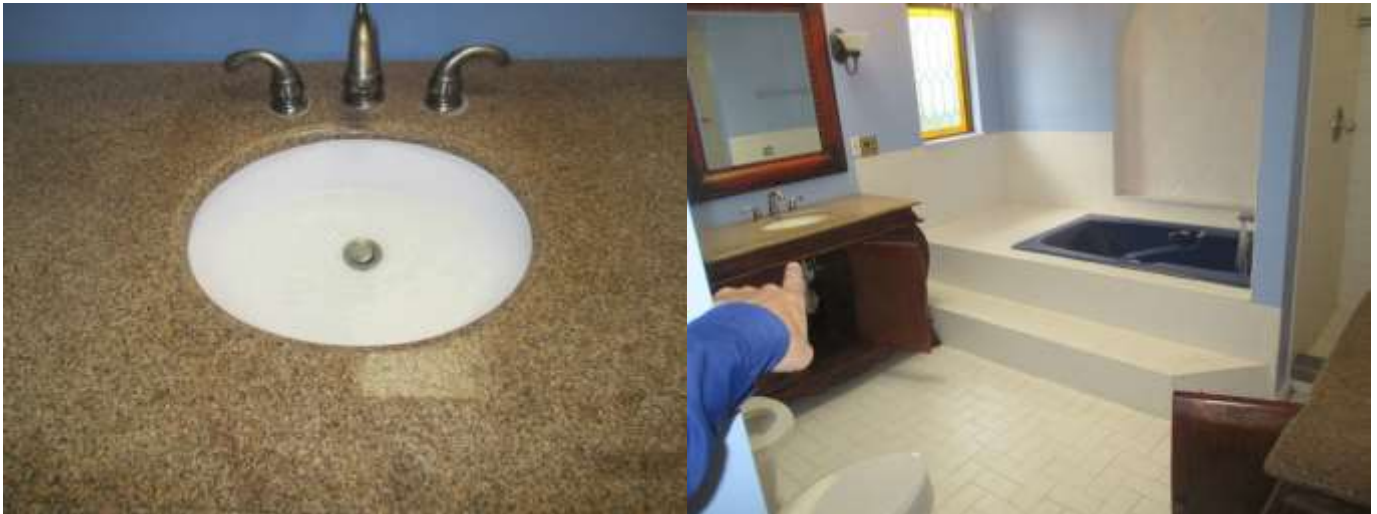
Maintenance Needed: The left master bathroom sink drained slowly the time the inspection will need servicing.

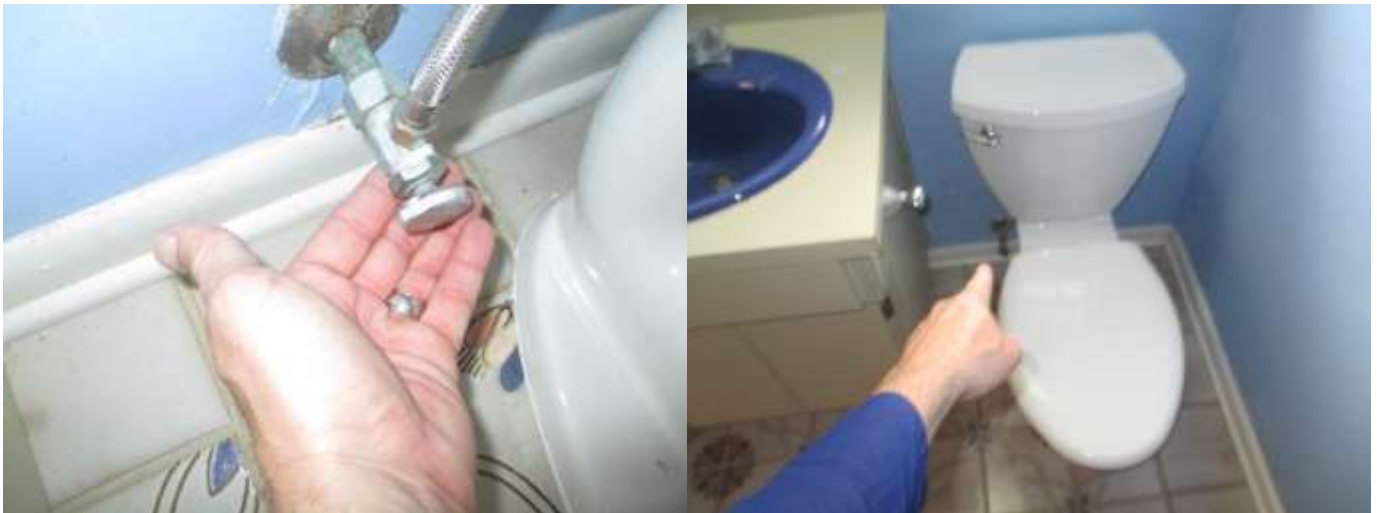
Repair Needed: The cutoff valve for the commode in the southeast second-floor bathroom and both cutoff valves for the bidet in the second-floor hall bathroom were leaking and likely needs the packing replaced.

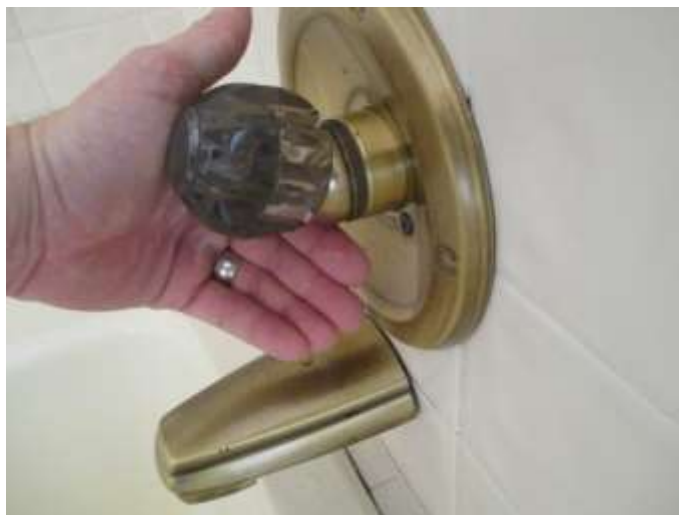
Repair Needed: The control knob was leaking in the second-floor hall bathroom tub and likely needs the cartridge replaced.

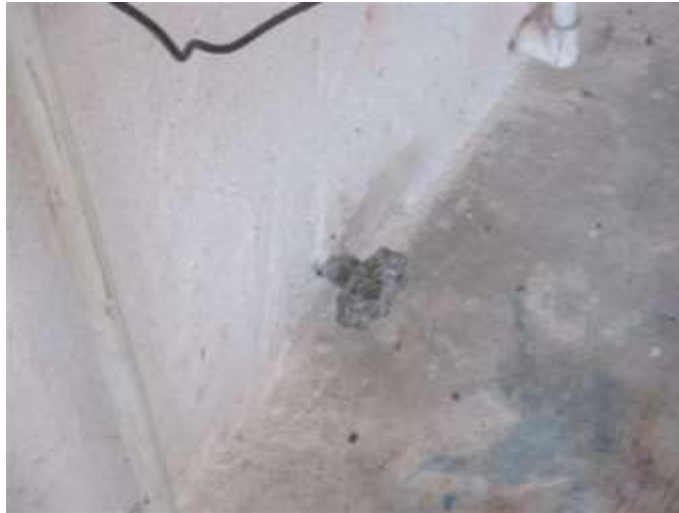
The main water cutoff for the dwelling was located on the north wall the garage.

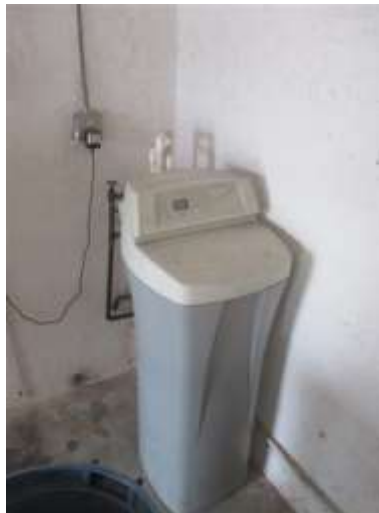
General Information Item: A water conditioning system was installed in the garage. The system was only visually inspected. For further information regarding the operation and servicing of the system we recommend contacting the installer or the manufacturer.

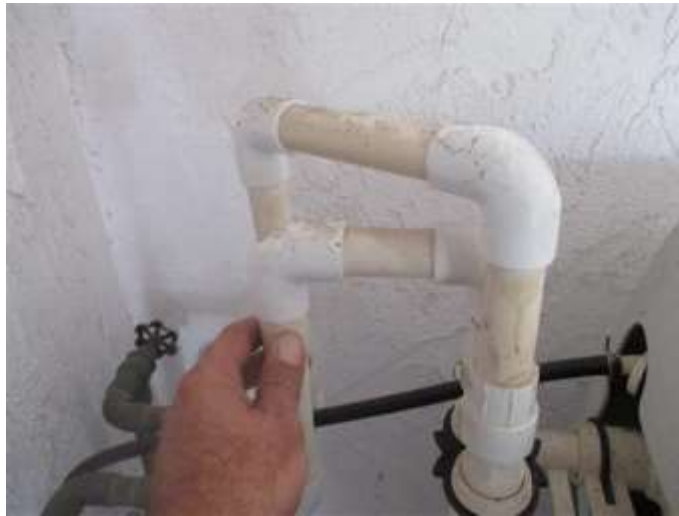
Correction Needed: The water conditioning system was connected to the water supply using standard (schedule 40) PVC, which should be replaced with piping rated for interior use (i.e. copper, CPVC or PEX) .

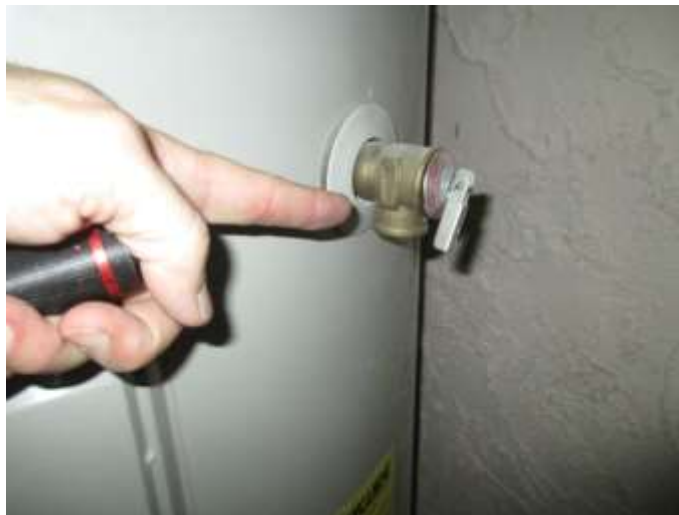
Correction needed: The relief valve did not have a drain line installed, which should be corrected for proper safety. The relief valve was not tested.

According to present day requirements, hot water heaters should have a pressure relief valve and drain line, which flows by gravity to the exterior, or downward to within 4 inches of the structure floor.

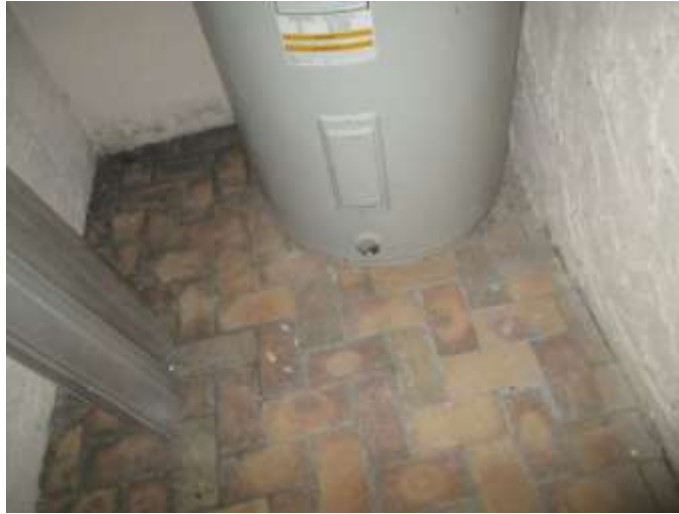
Correction Needed: An auxiliary drain pan was not installed under the hot water heater unit at time the inspection.

The size of the drain line should match the outlet size of the relief valve, and an auxiliary pan with a 1" drain line is required underneath when the unit is installed at or above the level of the living area.

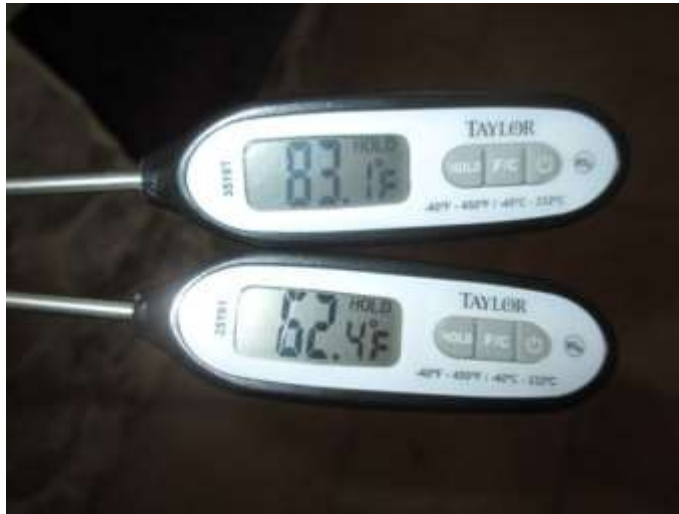
Repair needed: The air conditioning mode on the 1st floor did not appear to be operating properly at the time of the inspection. In the A/C mode the supply air was 62.4°; the return air was 83.1° for an operating differential of 20.7°. The normal operating differential range is between 14.0° and 20.0°.

Recommendation: We recommend having a licensed heating and air contractor service the system and repair as necessary.

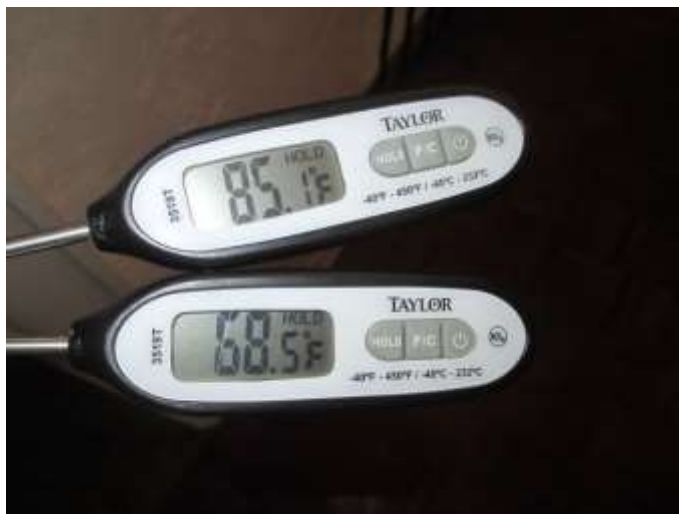
Repair needed: The air conditioning mode on the second-floor did not appear to be operating properly at the time of the inspection. In the A/C mode the supply air was 68.5°; the return air was 85.1° for an operating differential of 16.6°. The normal operating differential range is between 14.0° and 20.0°.

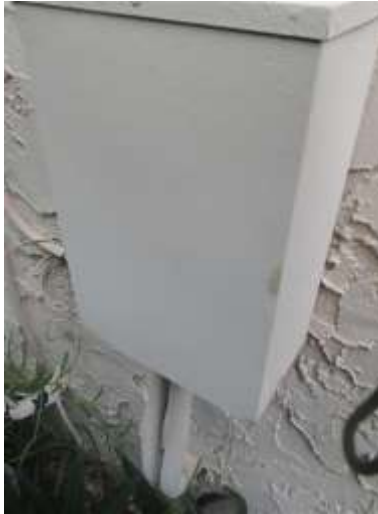
General Information Item: We noted the remnants of a heat recovery system mounted on the wall behind the heat pump units. The unit was no longer in use at the time of inspection.

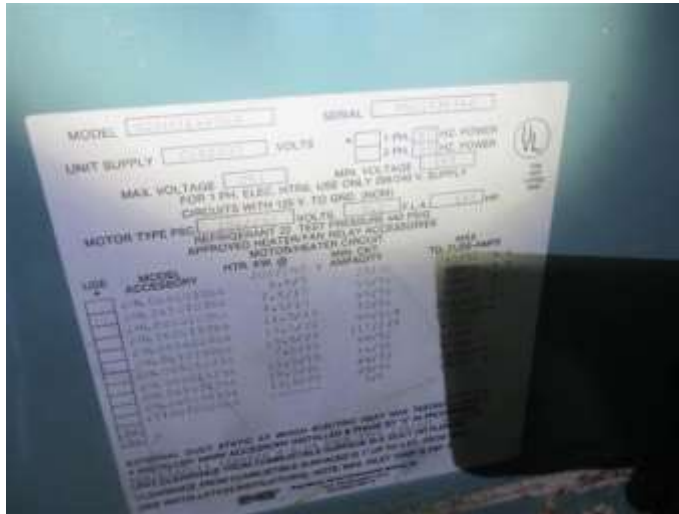
Concern Item: We could not determine the size or age of the air handler unit in the second-floor hallway closet from the manufacturer's plate. Based on our visual inspection, the unit appeared to be original to the dwelling is likely at the end of juice lifespan. Electric furnaces have a normal life expectancy of 15-20 years.

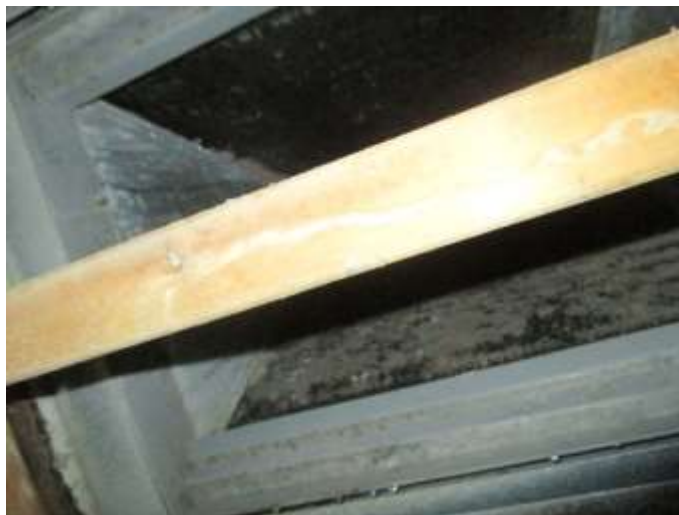
Maintenance Needed: The coils were dirty in the air handler (1st floor) should be cleaned by a licensed HVAC contractor.

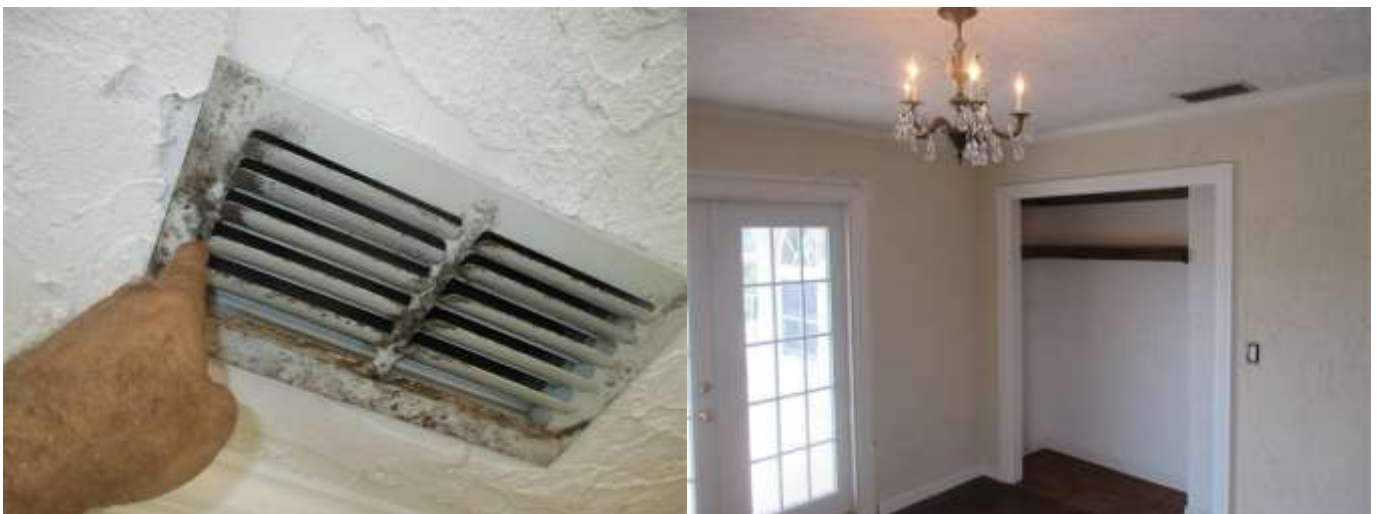
Maintenance Needed: We noted mold-like spotting on the register in the northwest bedroom and recommend treating the register with a solution of bleach and water.

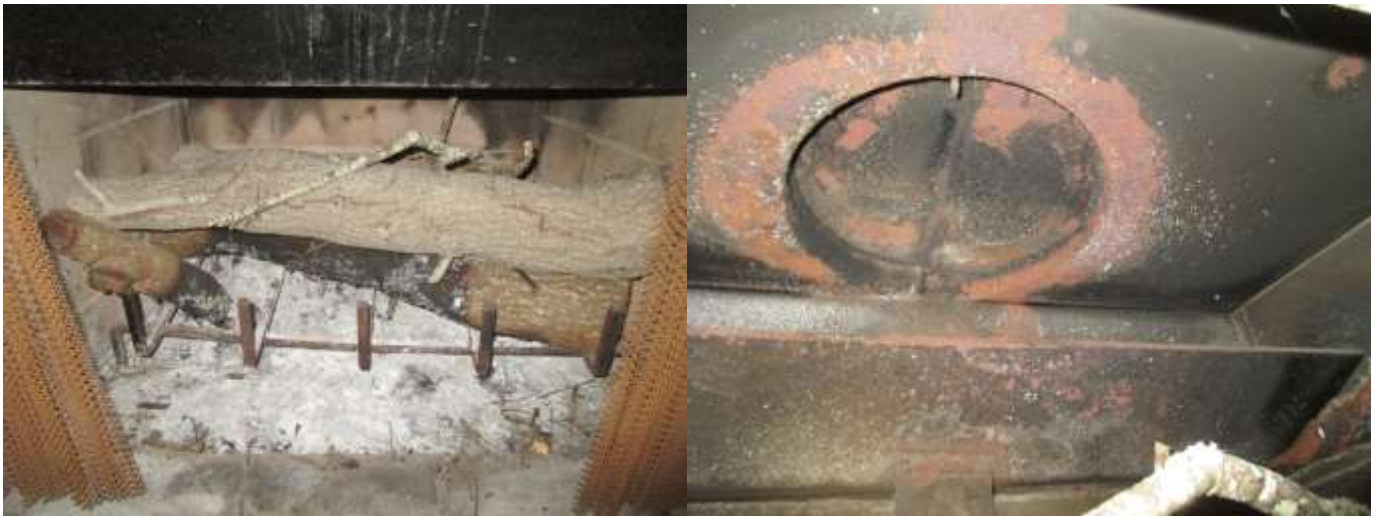
The fireplace is equipped with a damper. The fireplace damper was operational. We recommend having the unit cleaned prior to use.

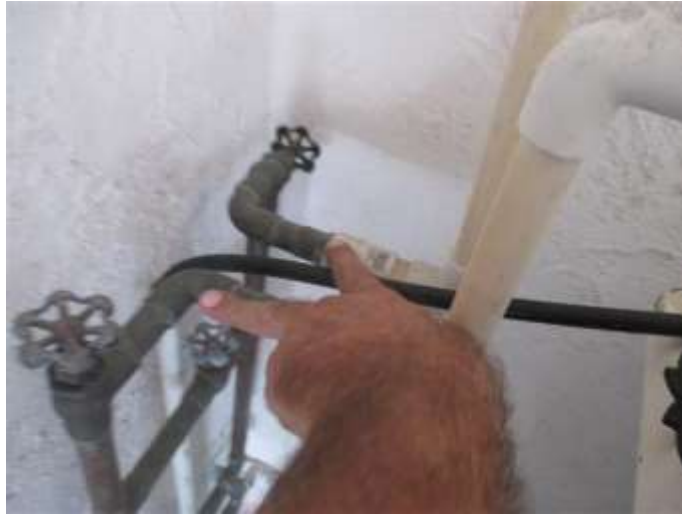
Correction Needed: Because PVC had been inserted in between the copper piping in the garage allow the installation of the water conditioning system, a grounding jumper should be added to ensure that the plumbing ground is functional.

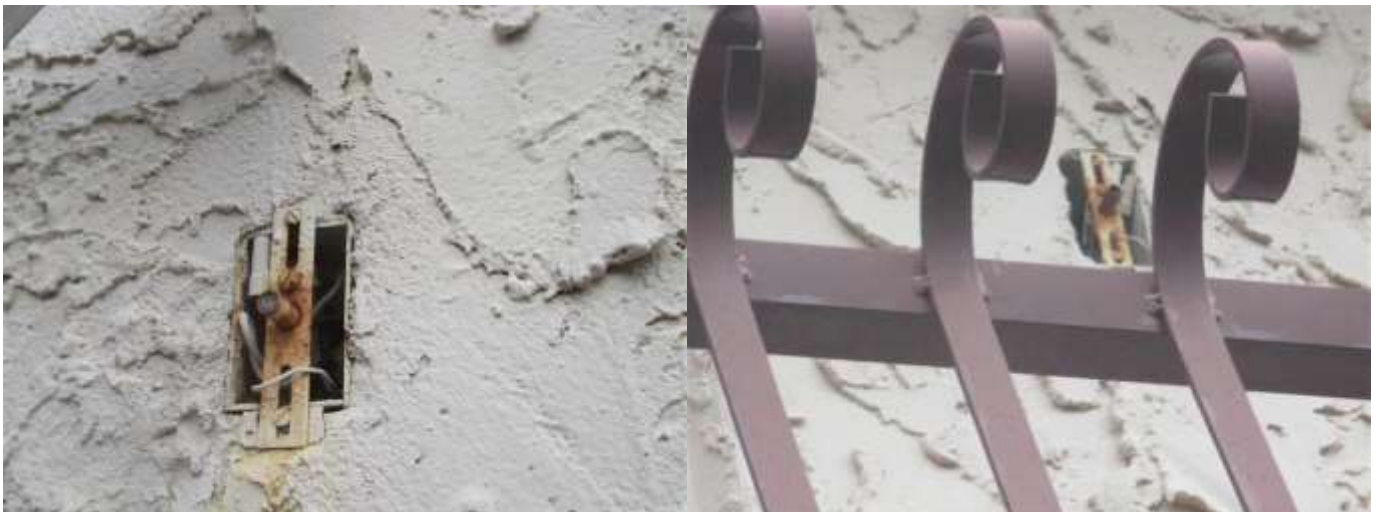
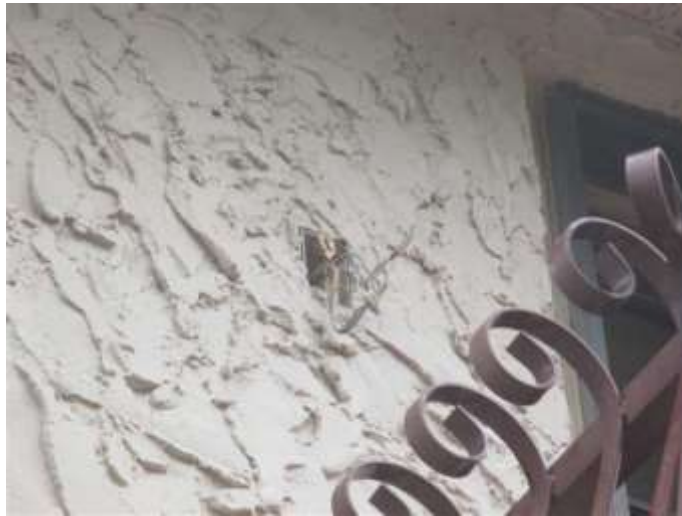
Correction Needed: We noted numerous open light boxes around the perimeter of the dwelling. These boxes should be covered until new fixtures are installed.

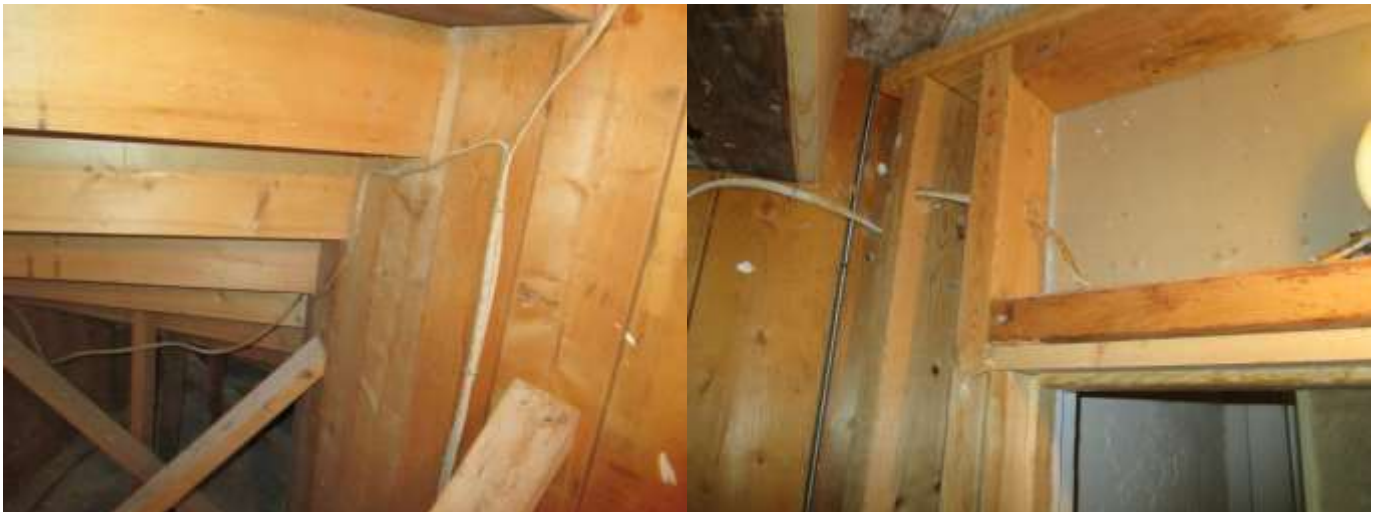
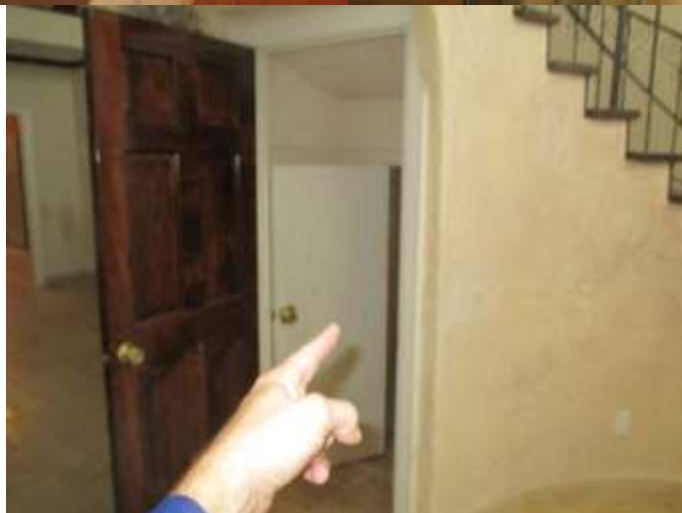
Correction Needed: The exposed wiring in the under stairs closet of the main hallway should be in conduit.

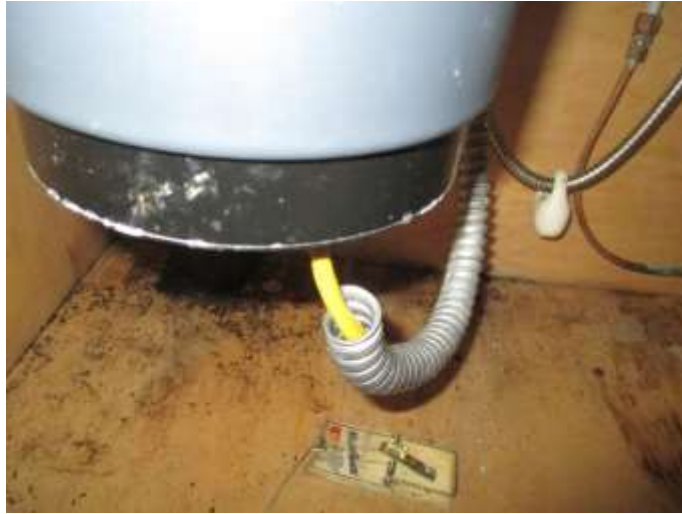
Correction Needed: The conduit was loose on the base of the food disposal under the left kitchen sink and should be properly secured.

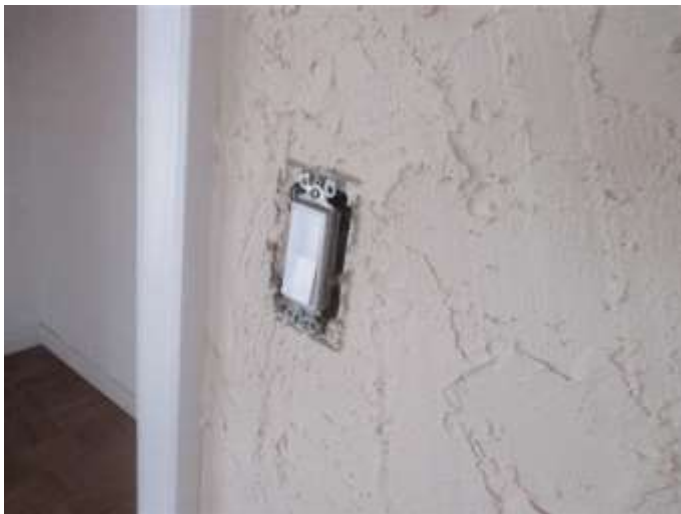
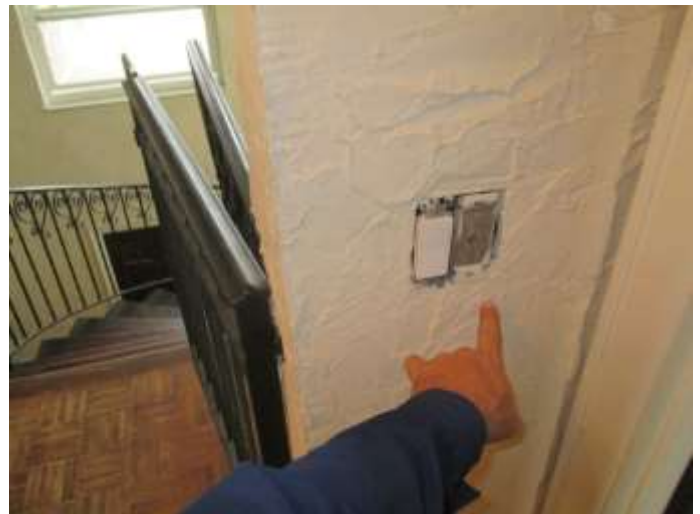
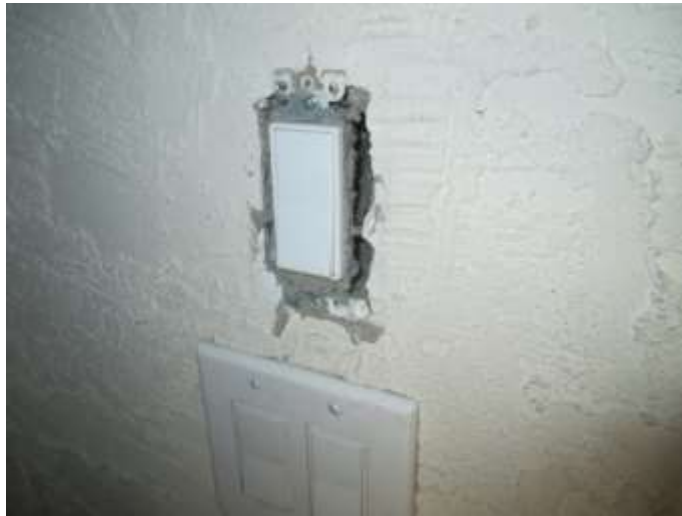
Correction Needed: Any missing cover plates for the light switches throughout the dwelling should be replaced.

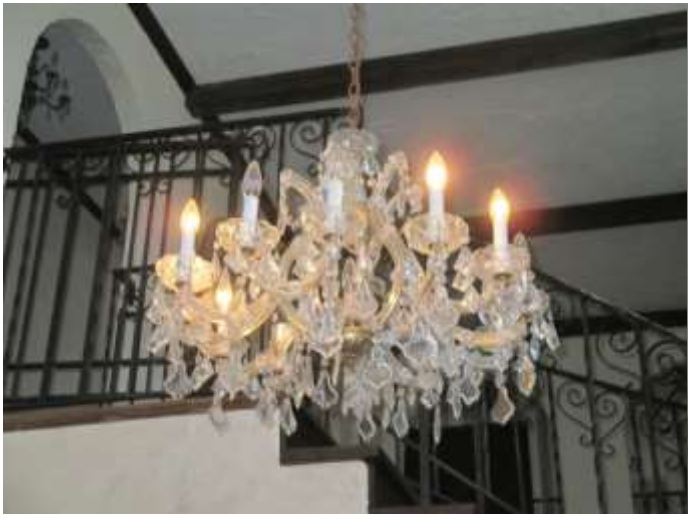
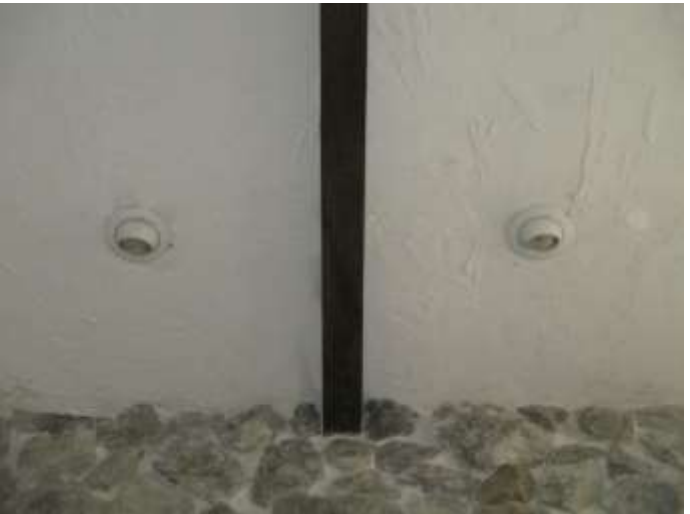
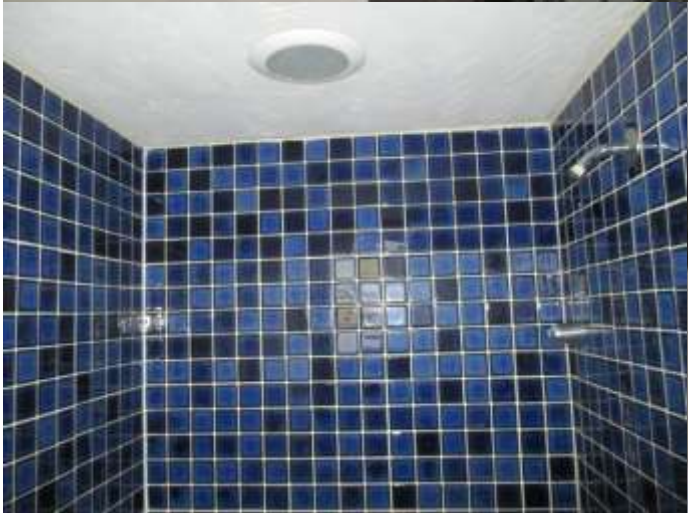
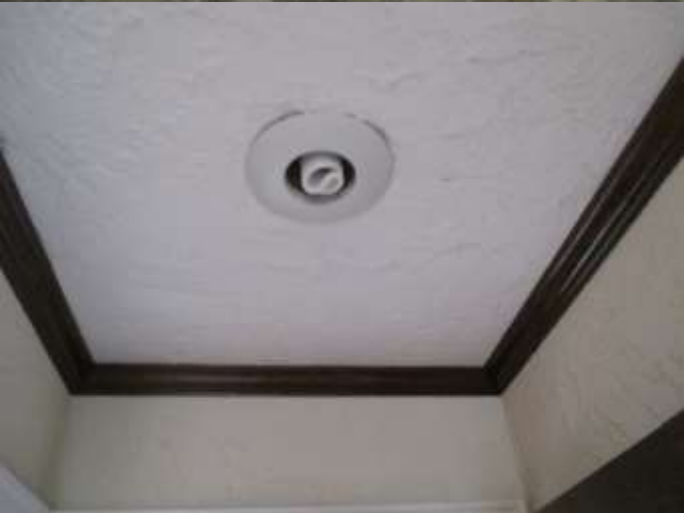
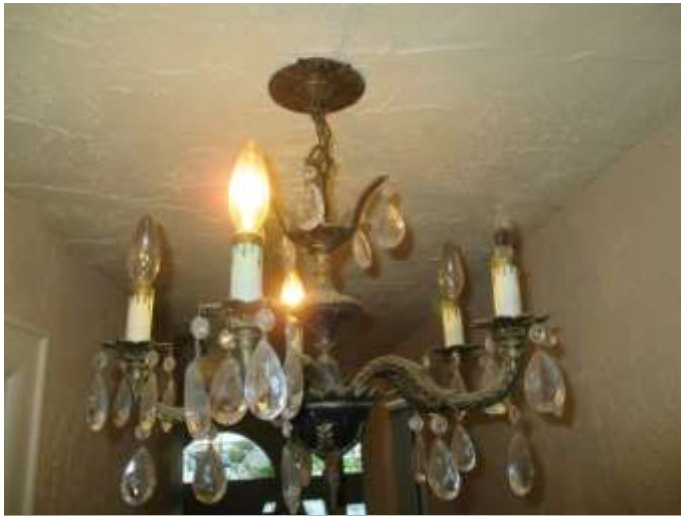
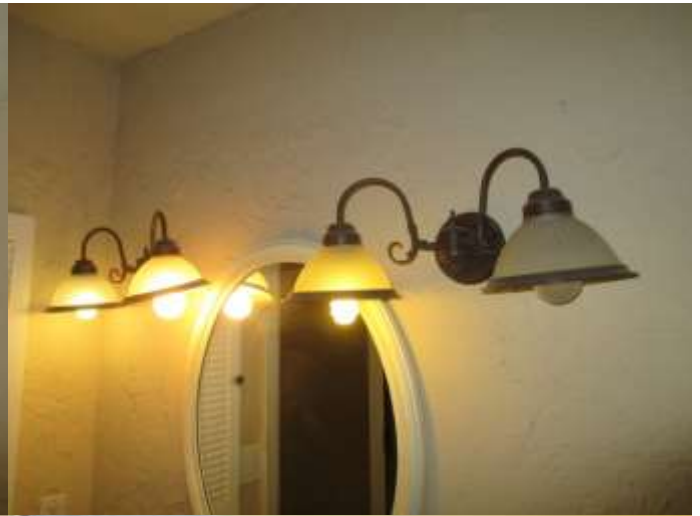
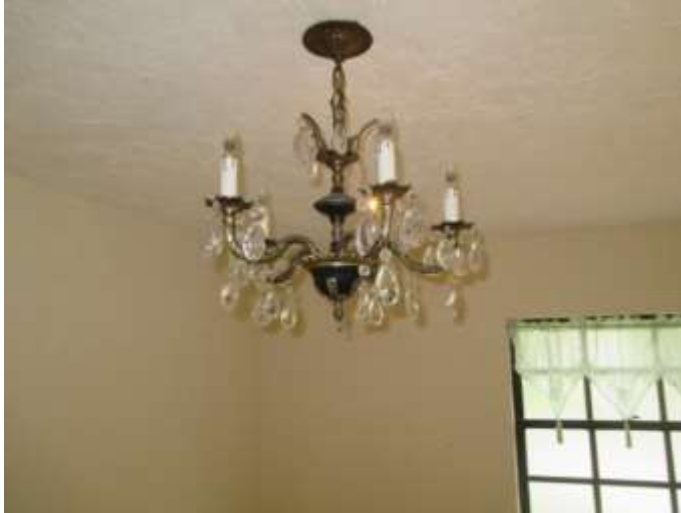
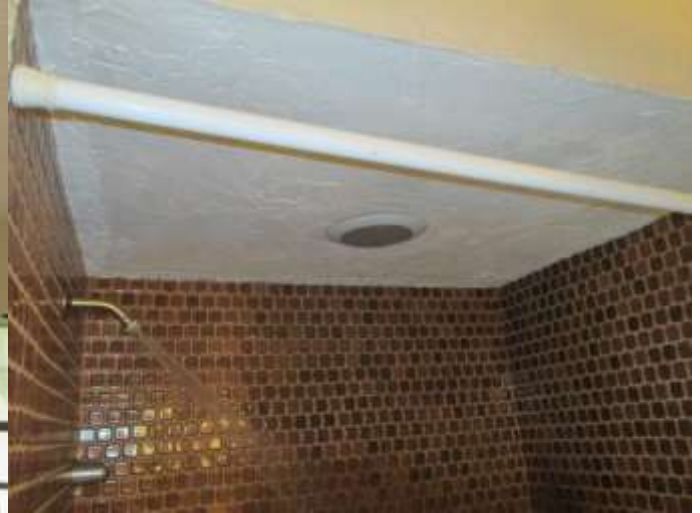
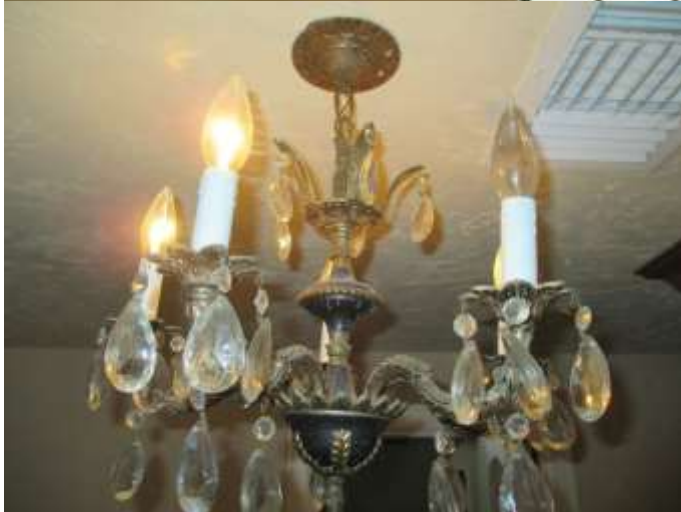
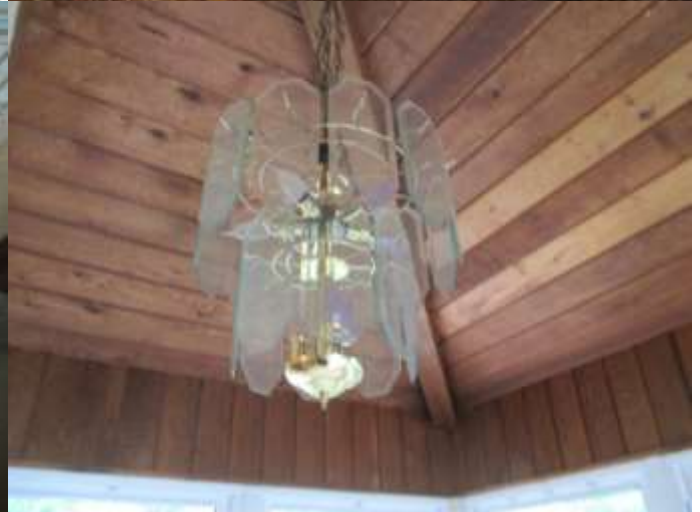
Repair Needed: We noticed numerous light bulbs were not working in and/or not installed throughout the dwelling and likely need the light bulbs replaced.

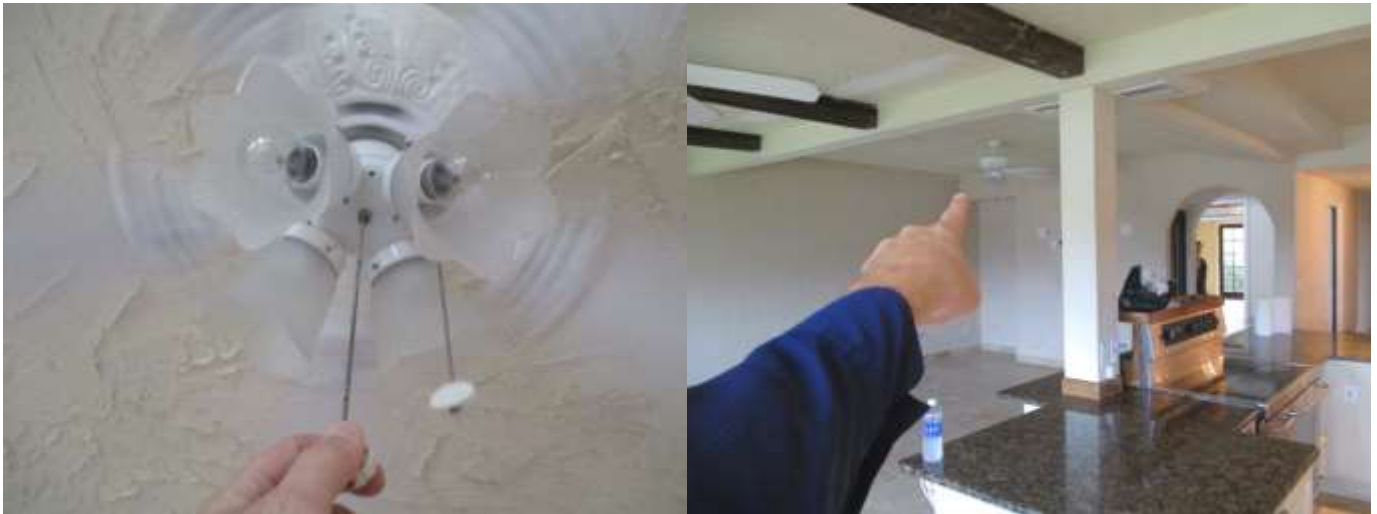
Repair Needed: The pull chain for the ceiling fan light fixture was stuck in could not be operated on the east side of the family room area.

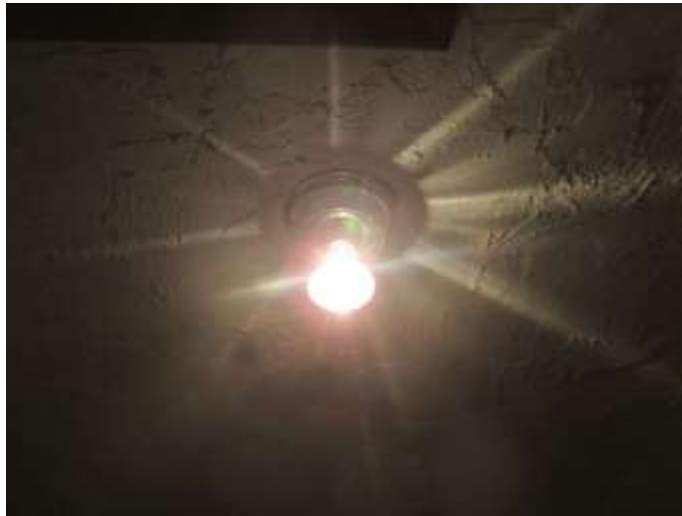
Correction Needed: The light cover was not installed on the master bedroom closet light fixture.
