INTRODUCTION

GENERAL CONDITION OF DWELLING

The dwelling is a north facing two-story block and framed structure on slab with a hip type roof design. The dwelling was constructed circa 1984.

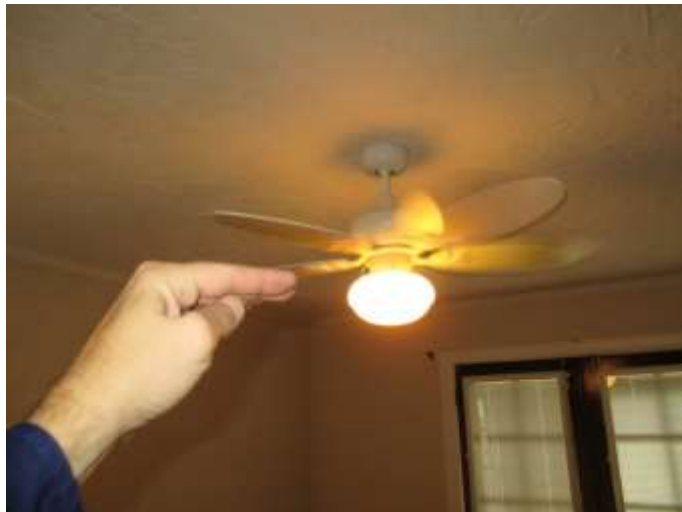
Maintenance Needed: The ceiling fan in the southeast second-floor bedroom wobbled during operation and should be balanced.

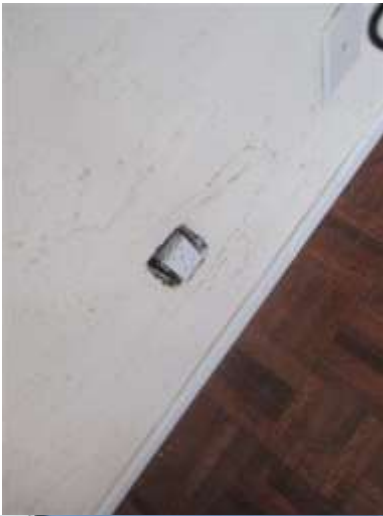
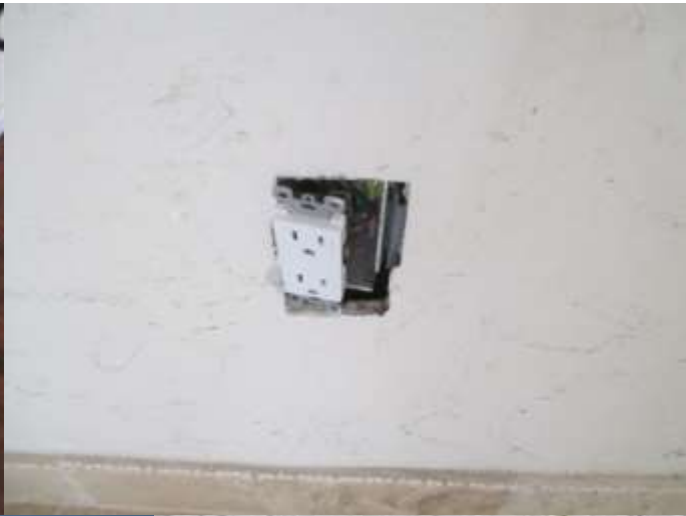
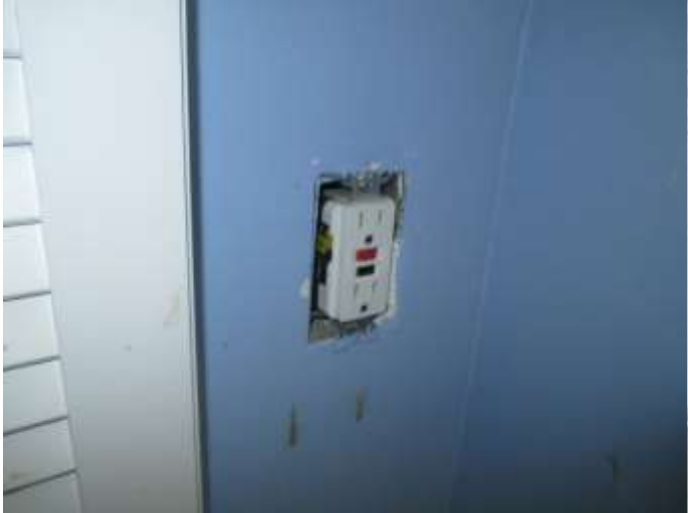
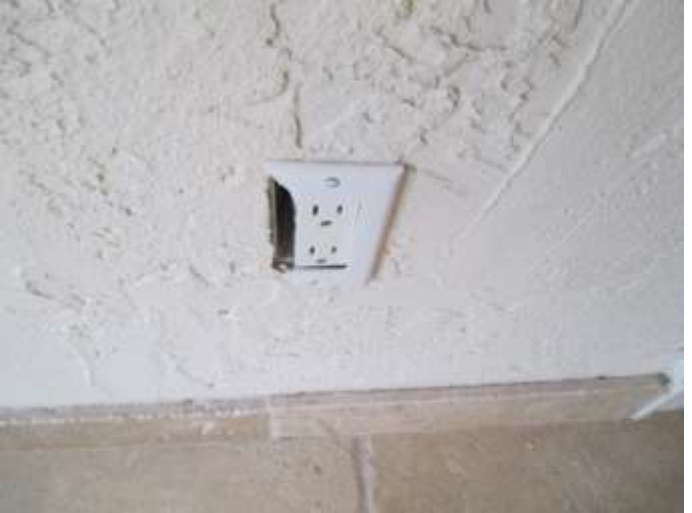
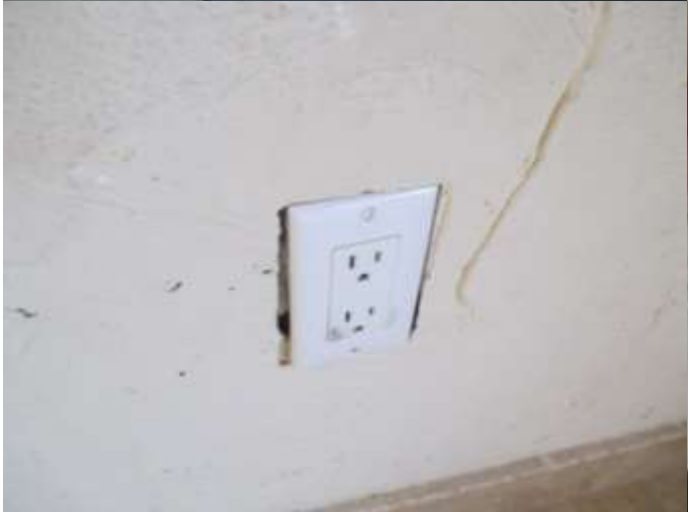
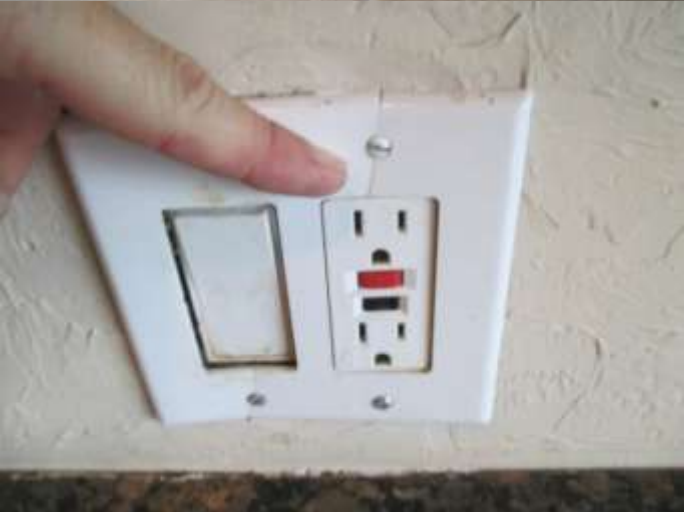
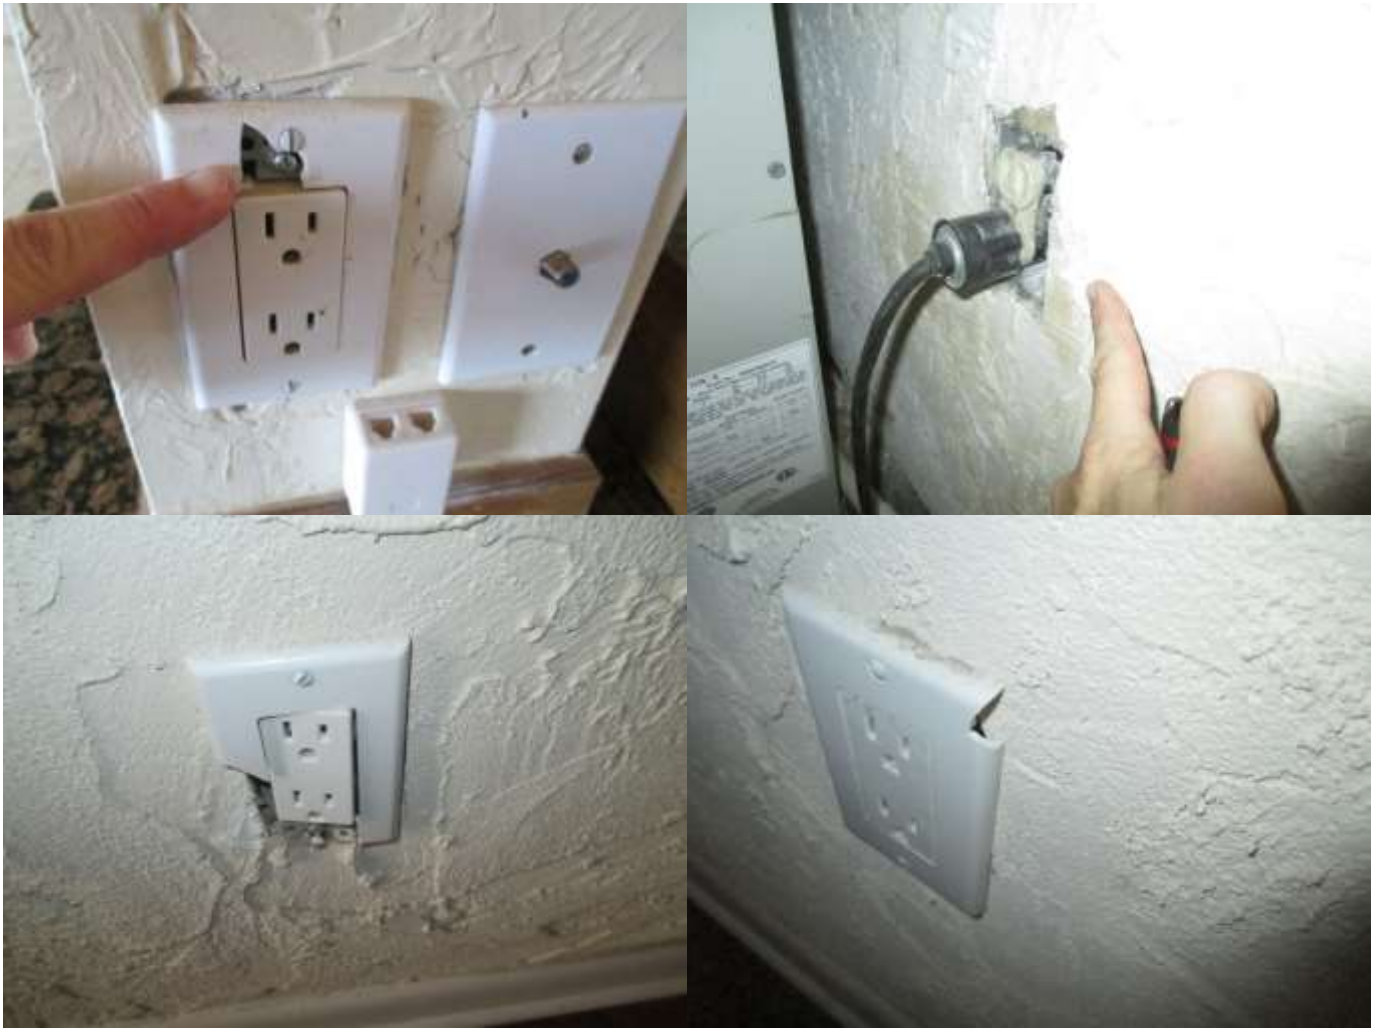
Correction Needed: Any receptacles that were missing cover plates or had damaged cover plates should have them replaced.

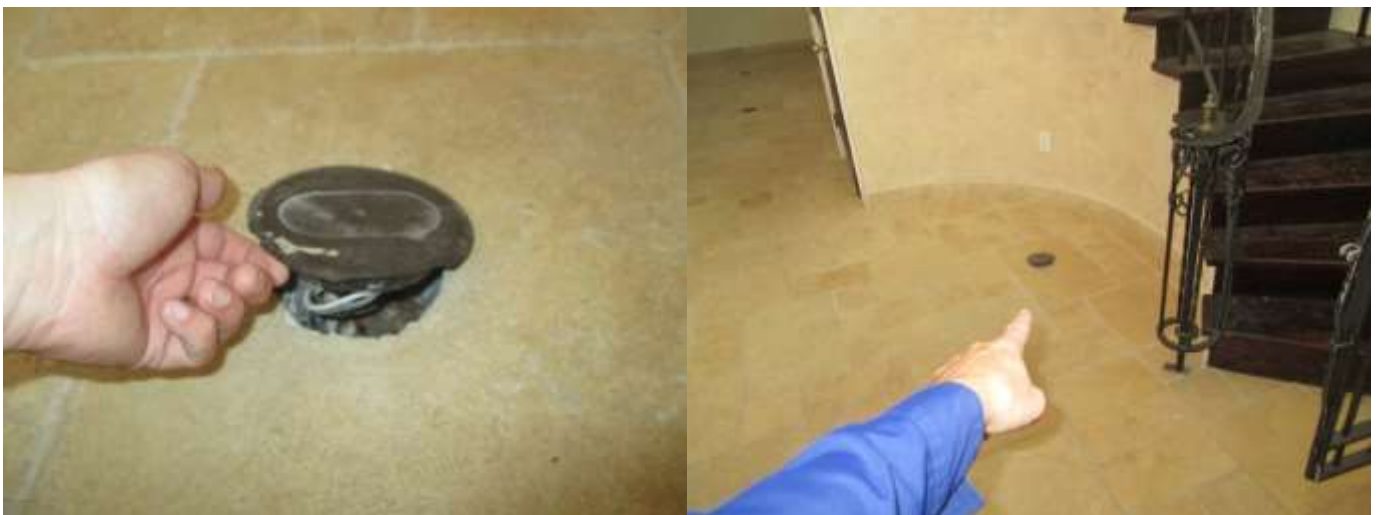
Correction Needed: The receptacle in the floor to the left of the staircase in the main entry hallway should be properly secured.

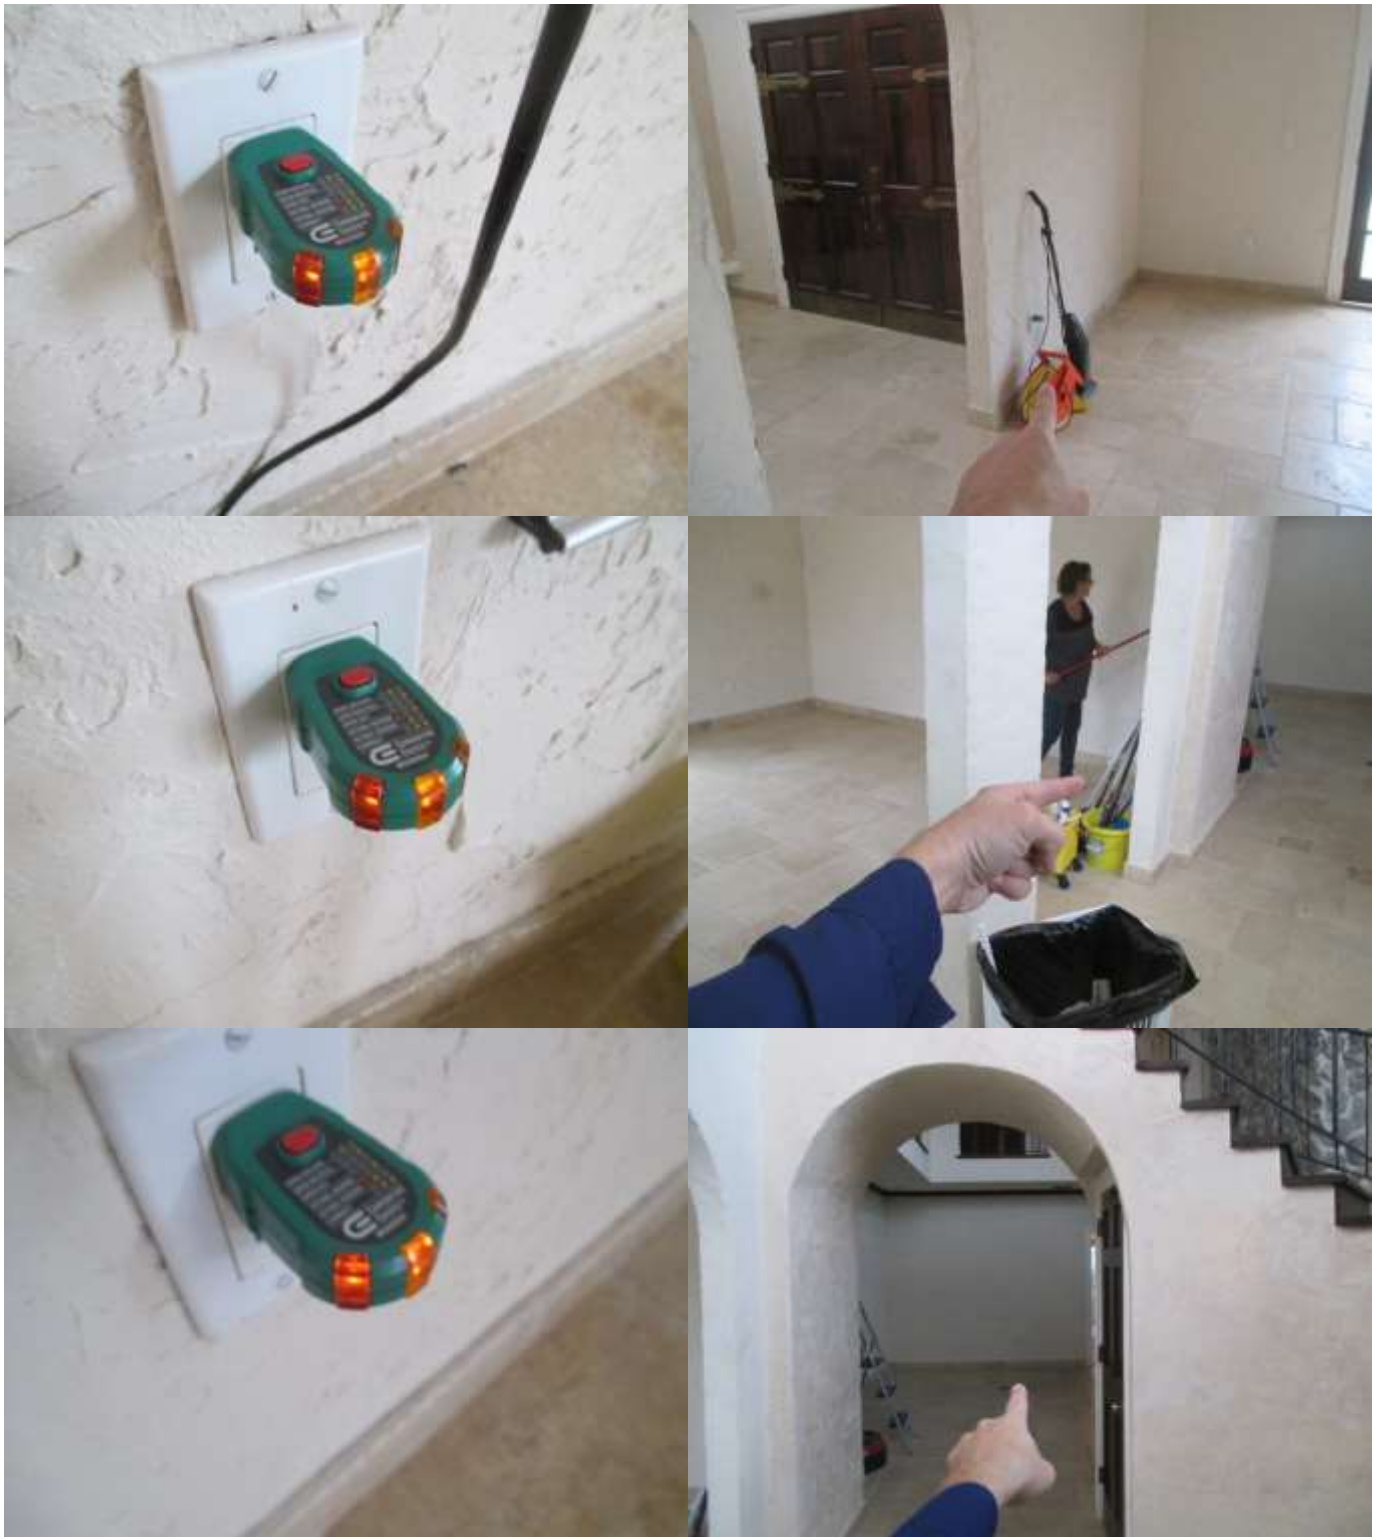
Correction needed: The following outlets had the hot and neutral wires reversed (reversed polarity), which should be corrected. Both

of the receptacles on the west wall of the northeast room off of the main hallway, the receptacle on the south wall of the living room area, the receptacle in the floor (south side) of the living room area, and the receptacle on the southeast corner (east wall) family room area.

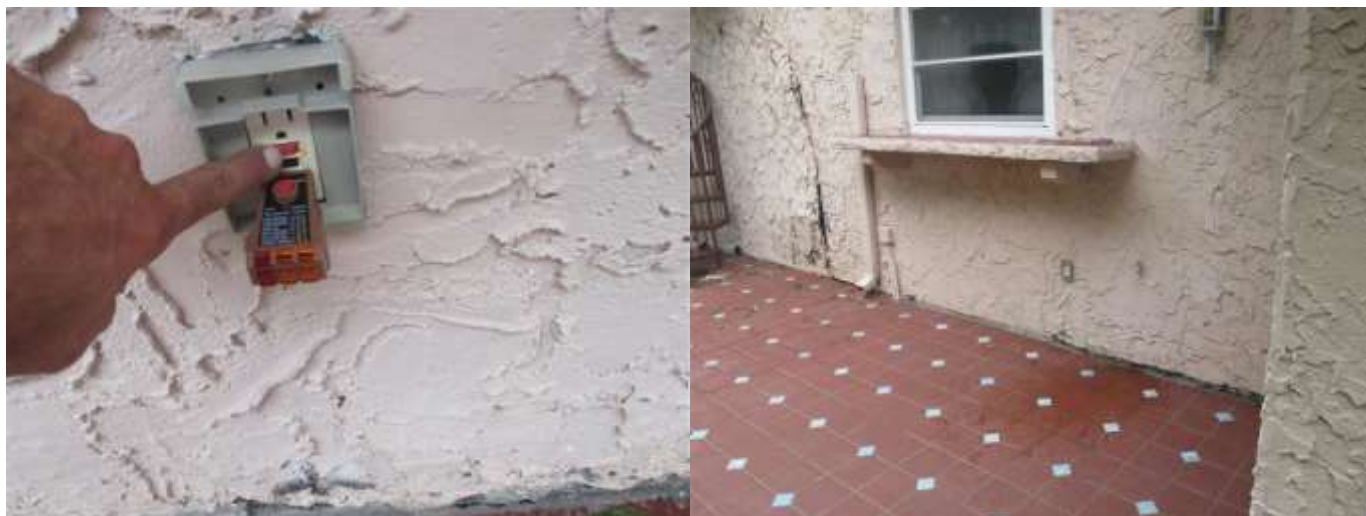
Correction Needed: The exterior GFCI receptacle on the south elevation was tripped and would not reset. The receptacle needed a new weather cover.

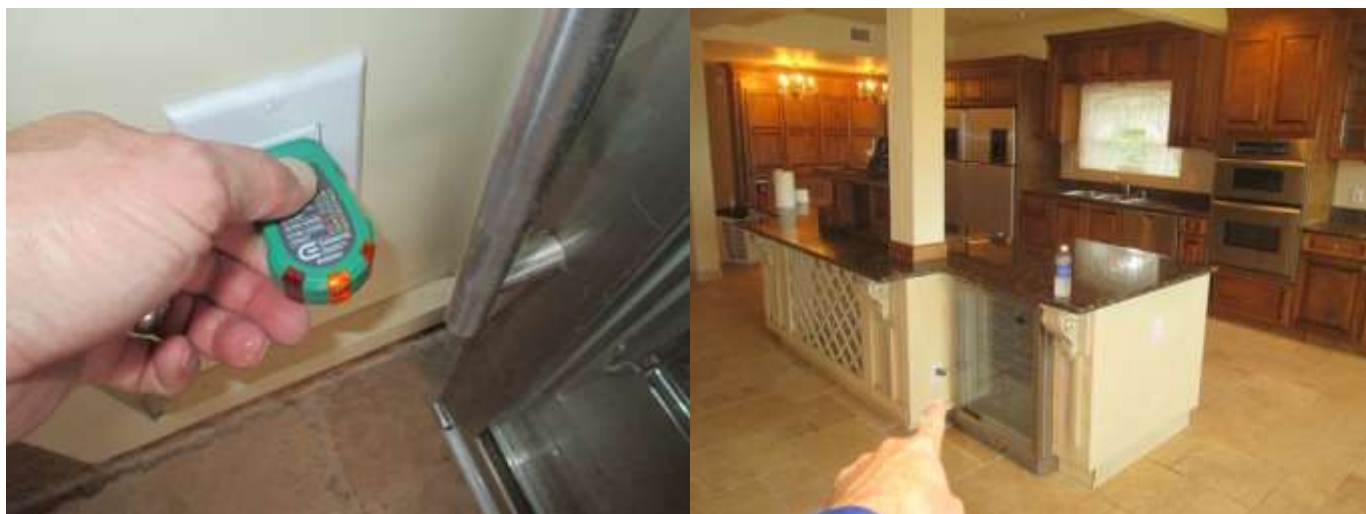
Correction Needed: Receptacle on the northeast side of the kitchen island (by wine cooler) was not GFCI protected per current standards.

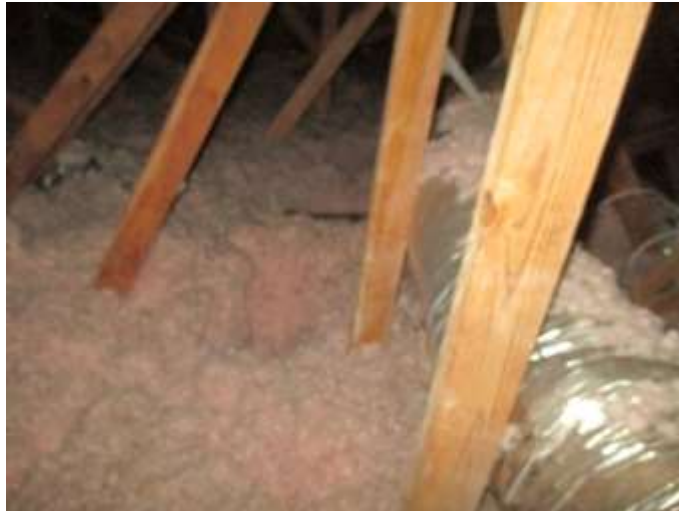
The attic area over the main structure was insulated at an average depth of 8 inches with blown fiberglass. The attic is vented through the soffit and the roof vents.

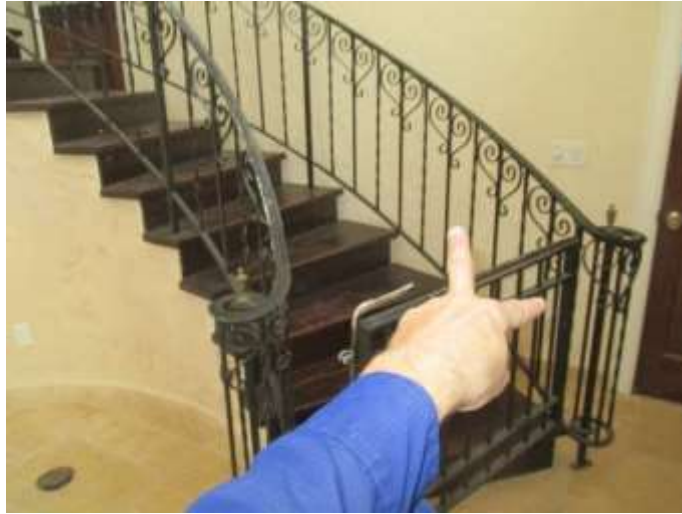
Correction Needed: The left hand rail was loose at the base of the stairs and should be reinforced (safety concern).

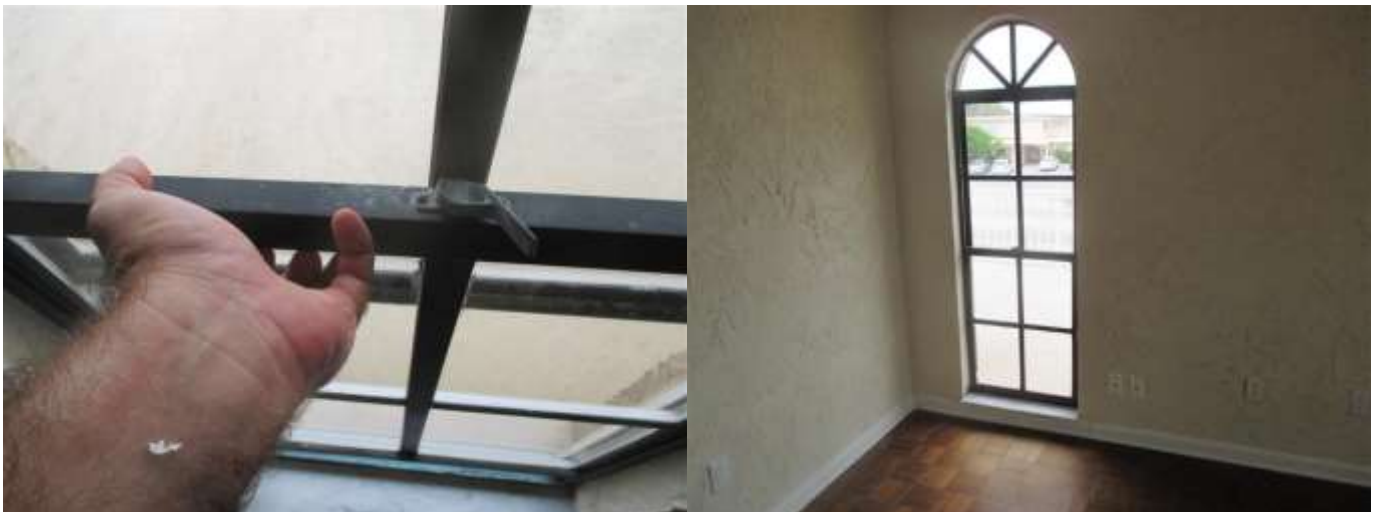
Repair Needed: The window in the northwest bedroom would not stay open.

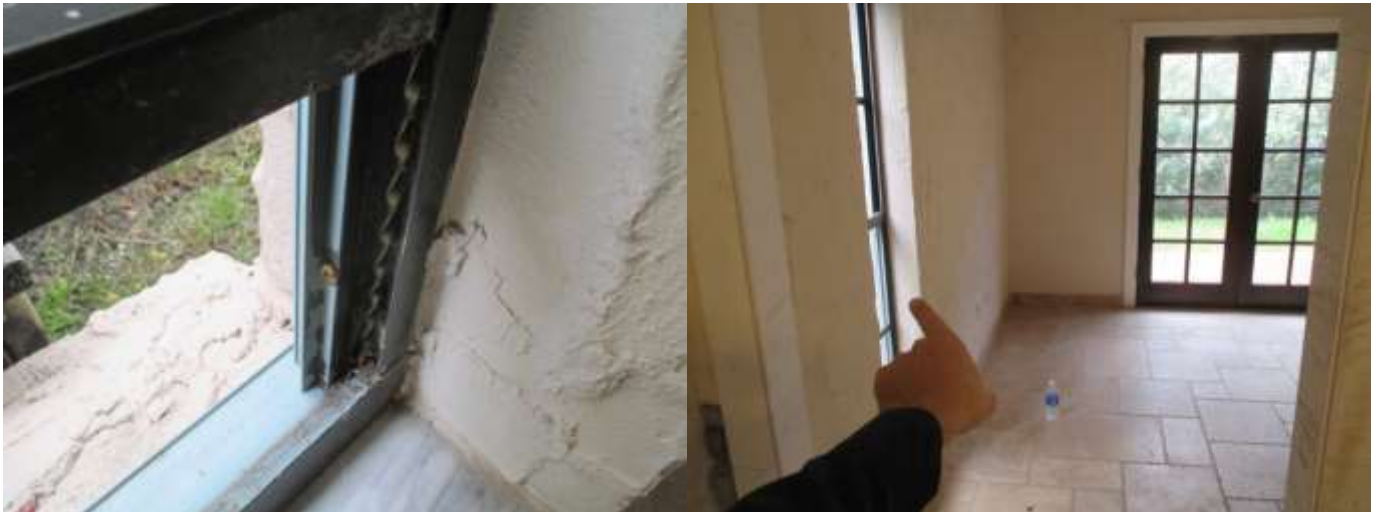
Repair Needed: The east window in the southeast bedroom had a detached control springs.

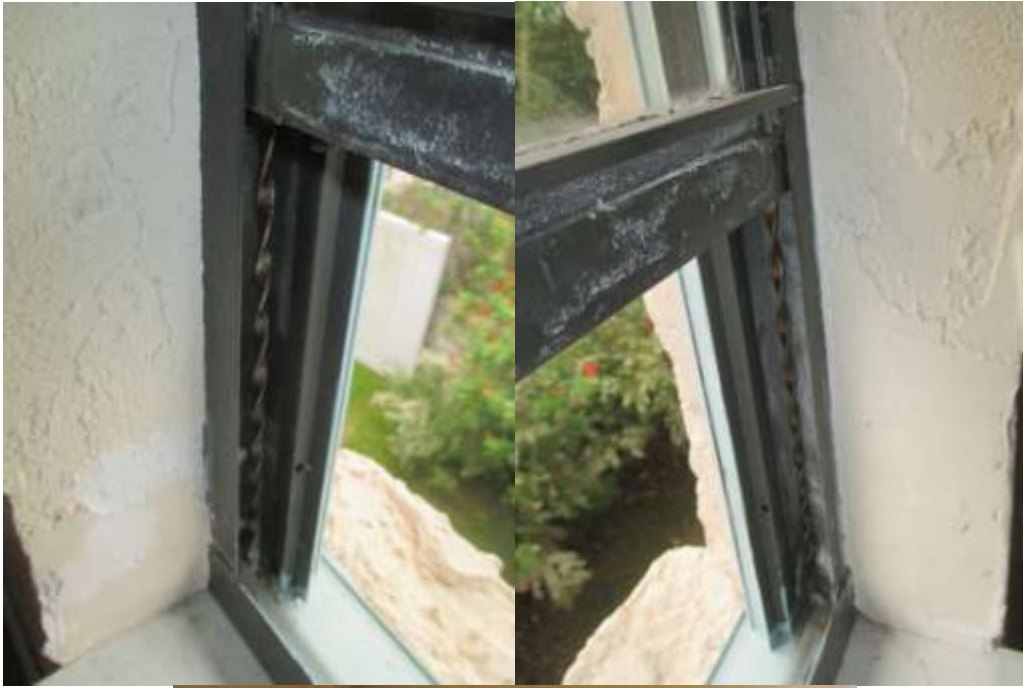
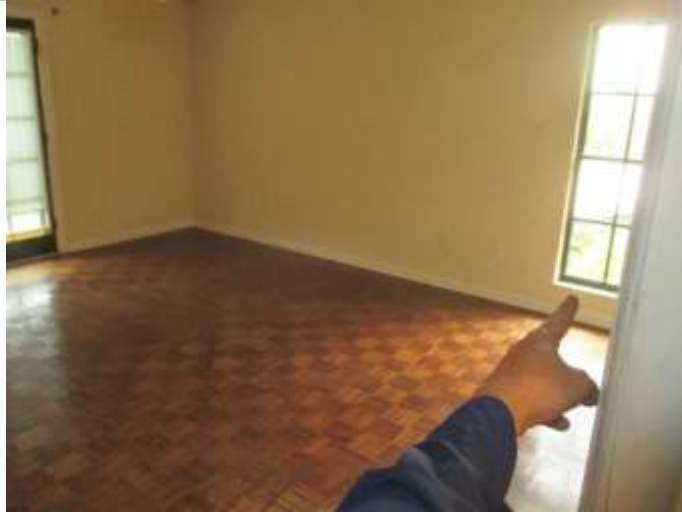
Repair Needed: The latch was not installed, the control springs were detached in the window would not stay open during operation (east window) in the master bedroom.

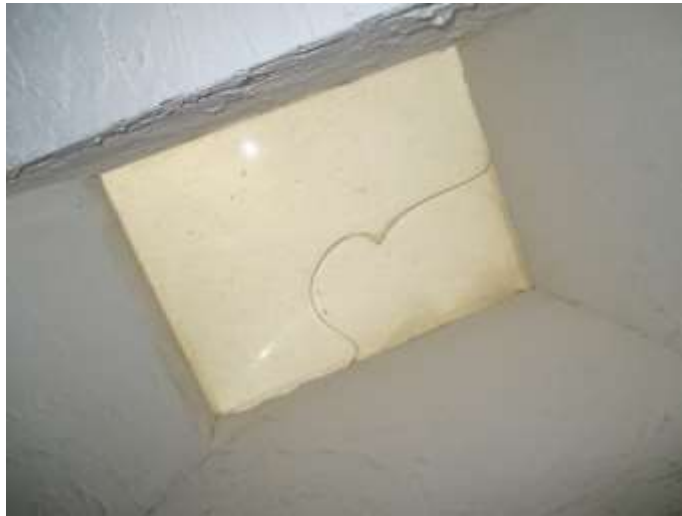
Repair Needed: We noted what appeared to be the seal loose in the skylight over the master bathroom.

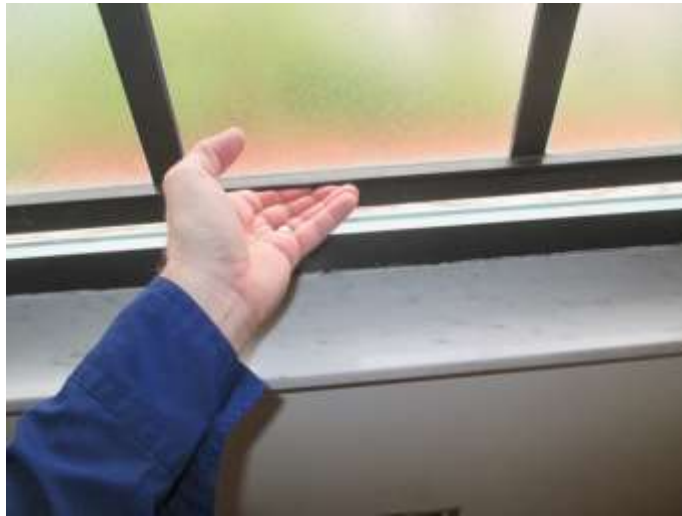
Repair Needed: The control springs were detached in the window would not stay open in the second-floor hall bathroom.

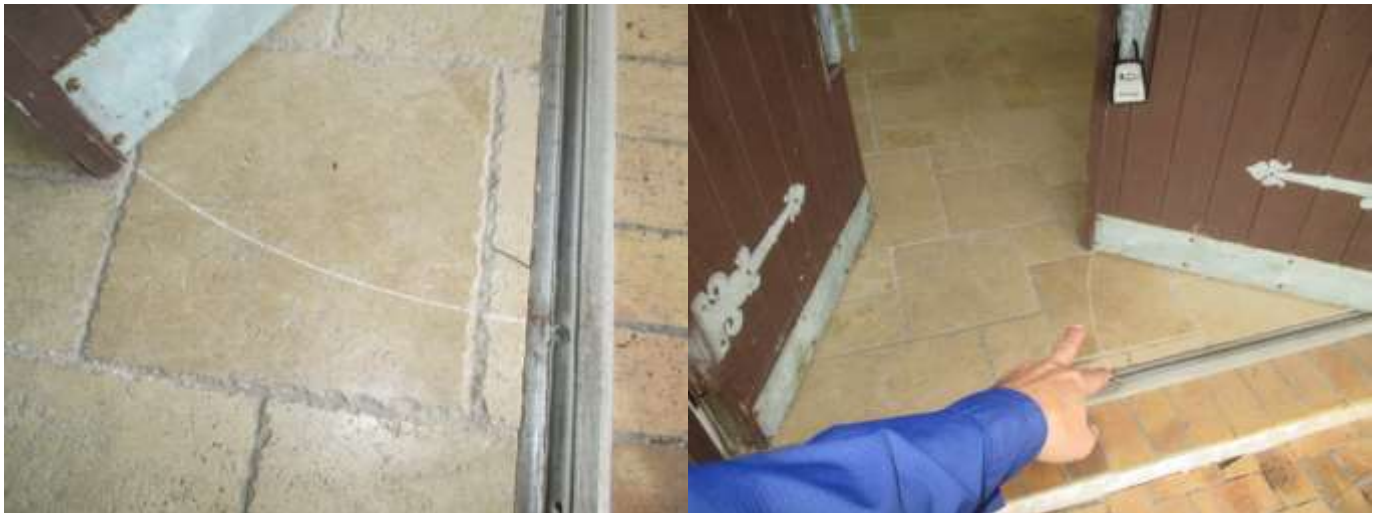
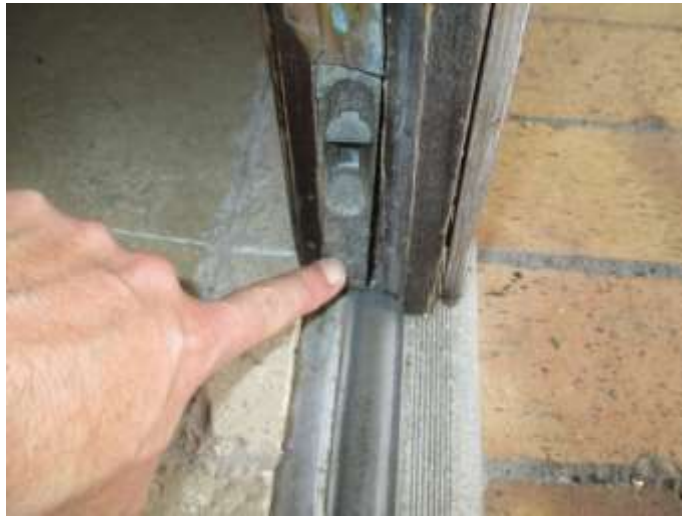
Repair Needed: The bottom latch pin on the right main entry door rubbed against the flooring during operation. This has scuffed the floor in this area. The bottom latch was also damaged and will likely need to be replaced.

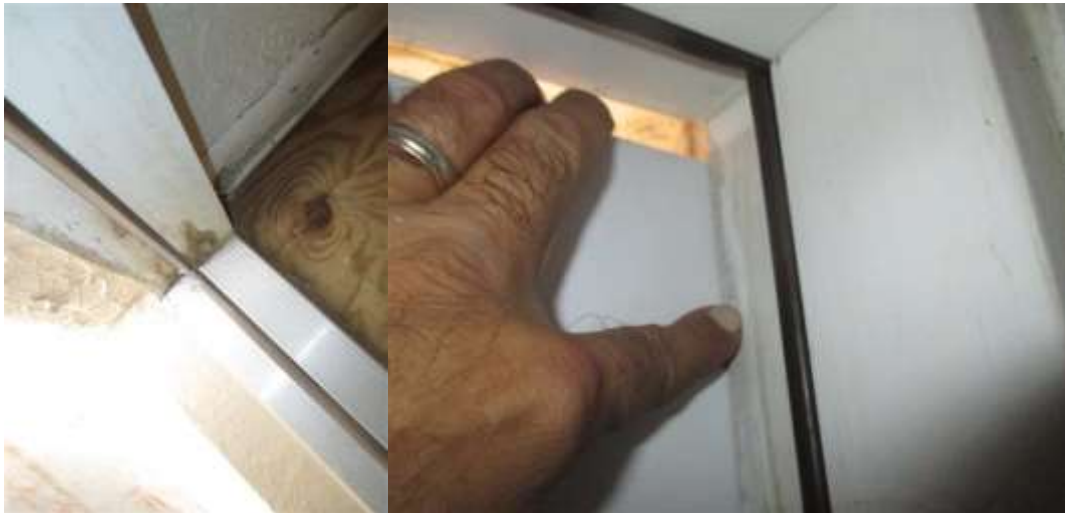
Repair Needed: The doorway between the second floor hallway and the west deck rubbed against the doorframe. We also noted deterioration to the base of the doorframe.

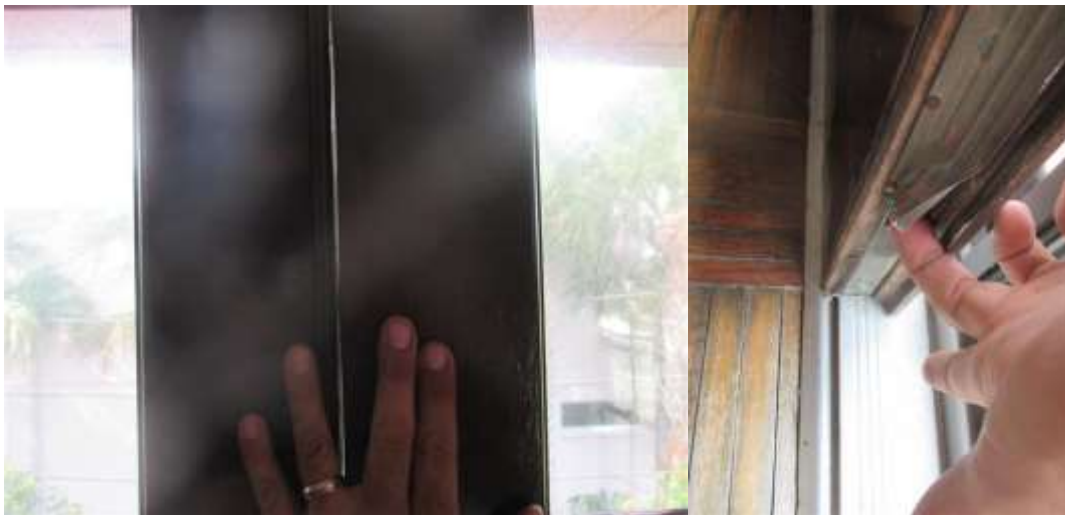
Repair Needed: The exterior doors in the southwest bedroom needed adjustment to seal fully when closed. The lower pin latch on the left side of the doorway would not disengage.

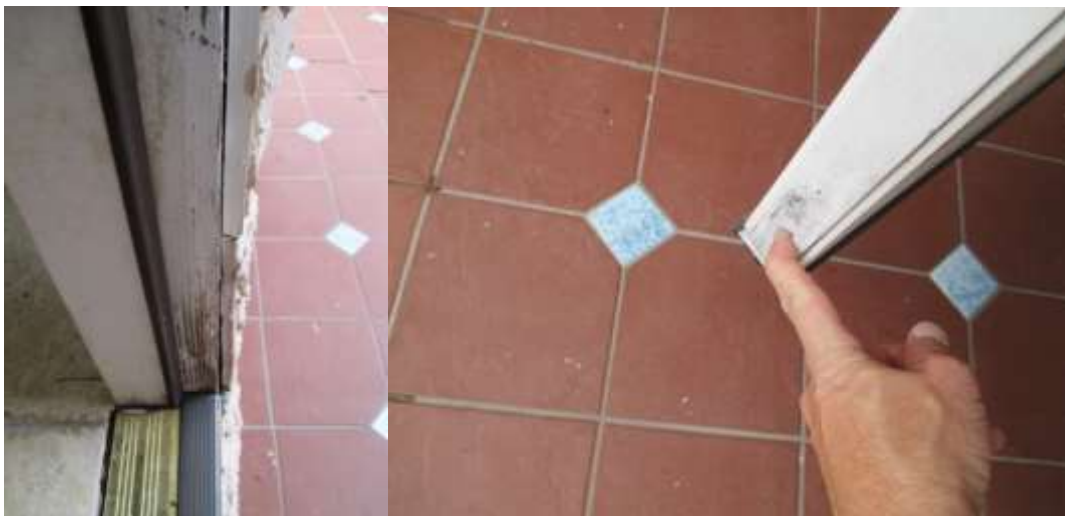
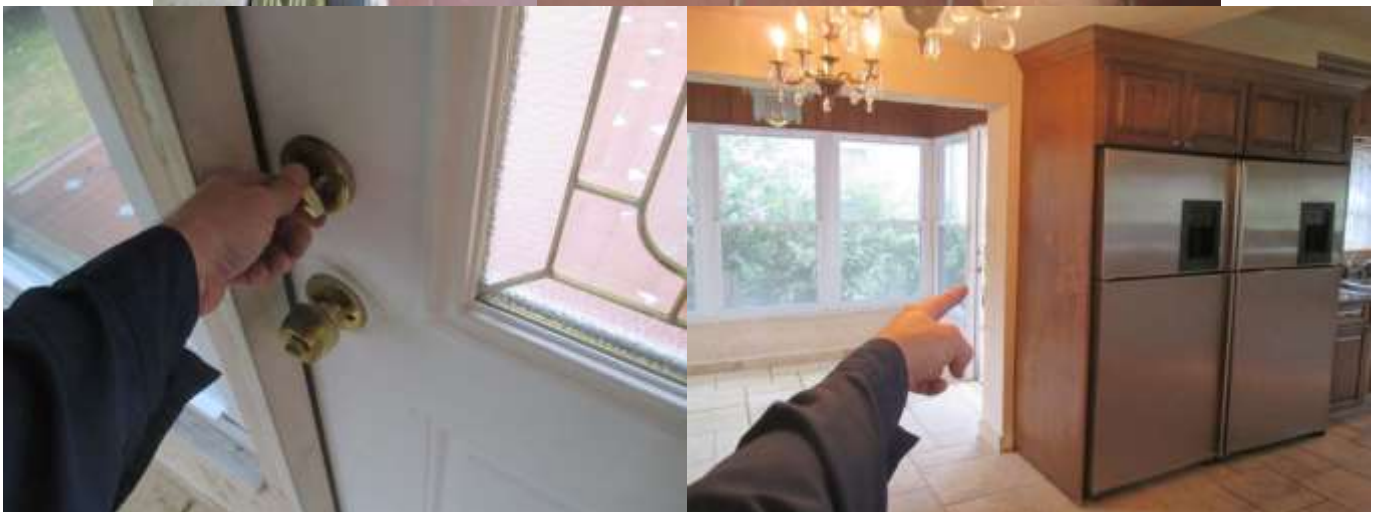
Repair Needed: We noted some wood deterioration on the exterior door in the breakfast nook area that should be repaired and resealed prevent further damage. The door should also be adjusted to latch properly.

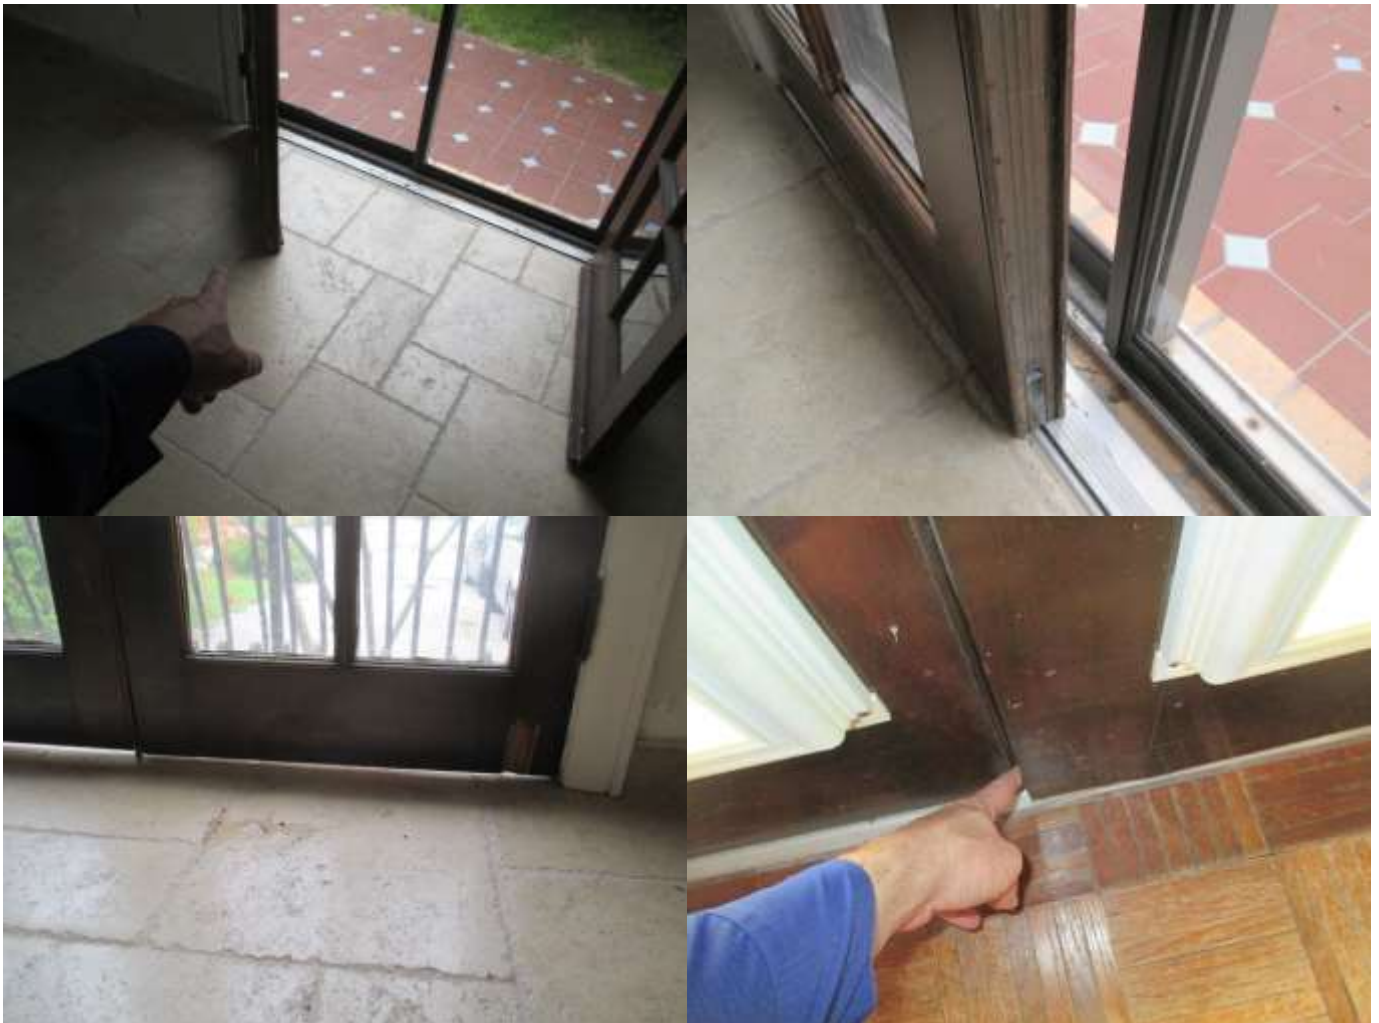
Maintenance Needed: Many of the exterior double doors (over sliding glass doors) were warped and/or were in need of adjustment to prevent rubbing against one another, on the flooring, or the frame during operation.

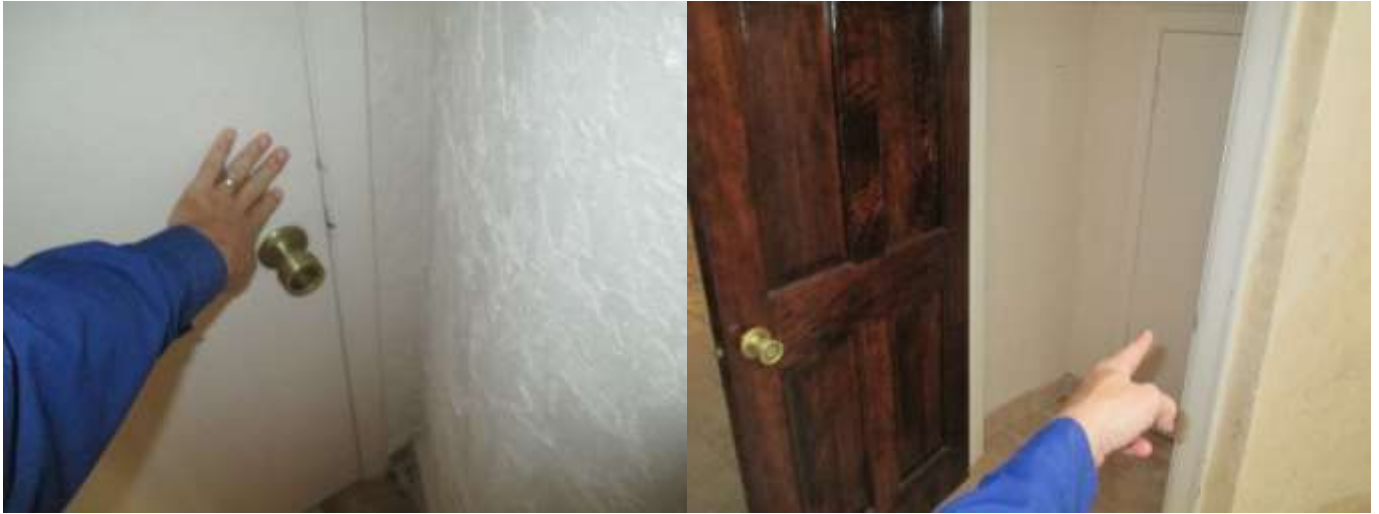
Adjustment Needed: The interior closet door (under the stairs) should be adjusted latch properly.

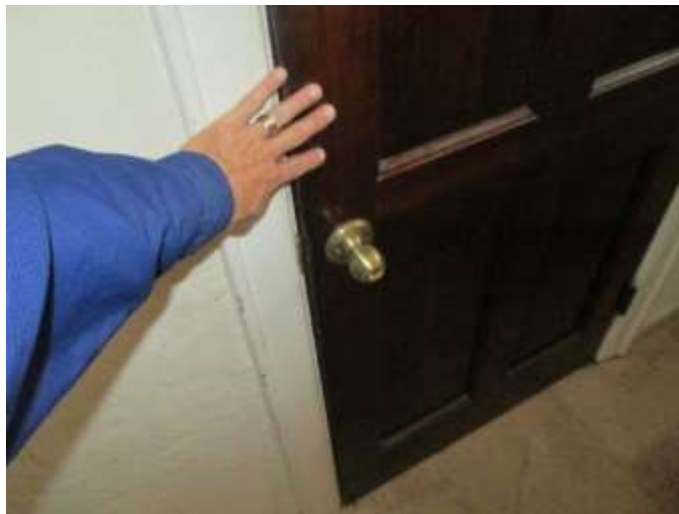
Adjustment Needed: The door between the living room and laundry room should be adjusted latch properly.

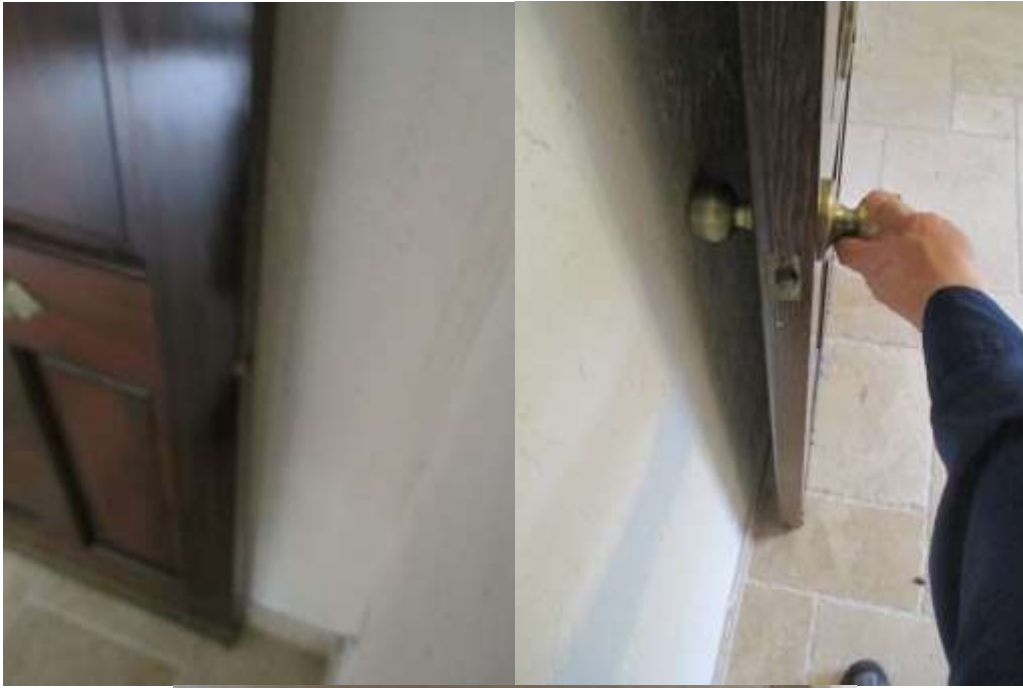
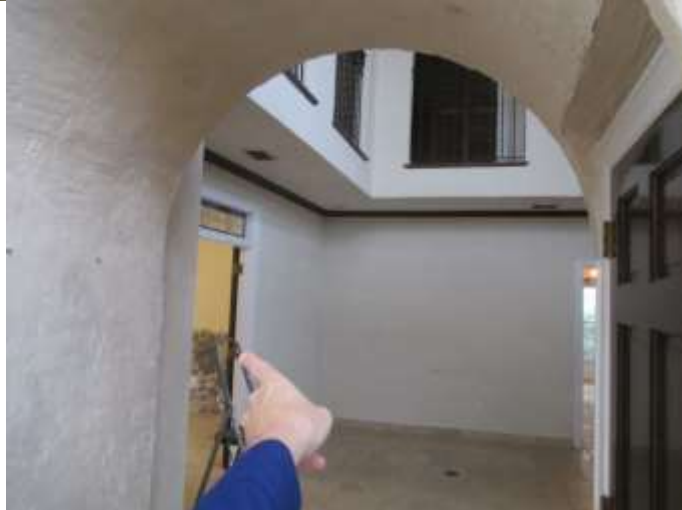
Correction Needed: The doorstops were not installed on the double doors in the east bedroom of the living room area.

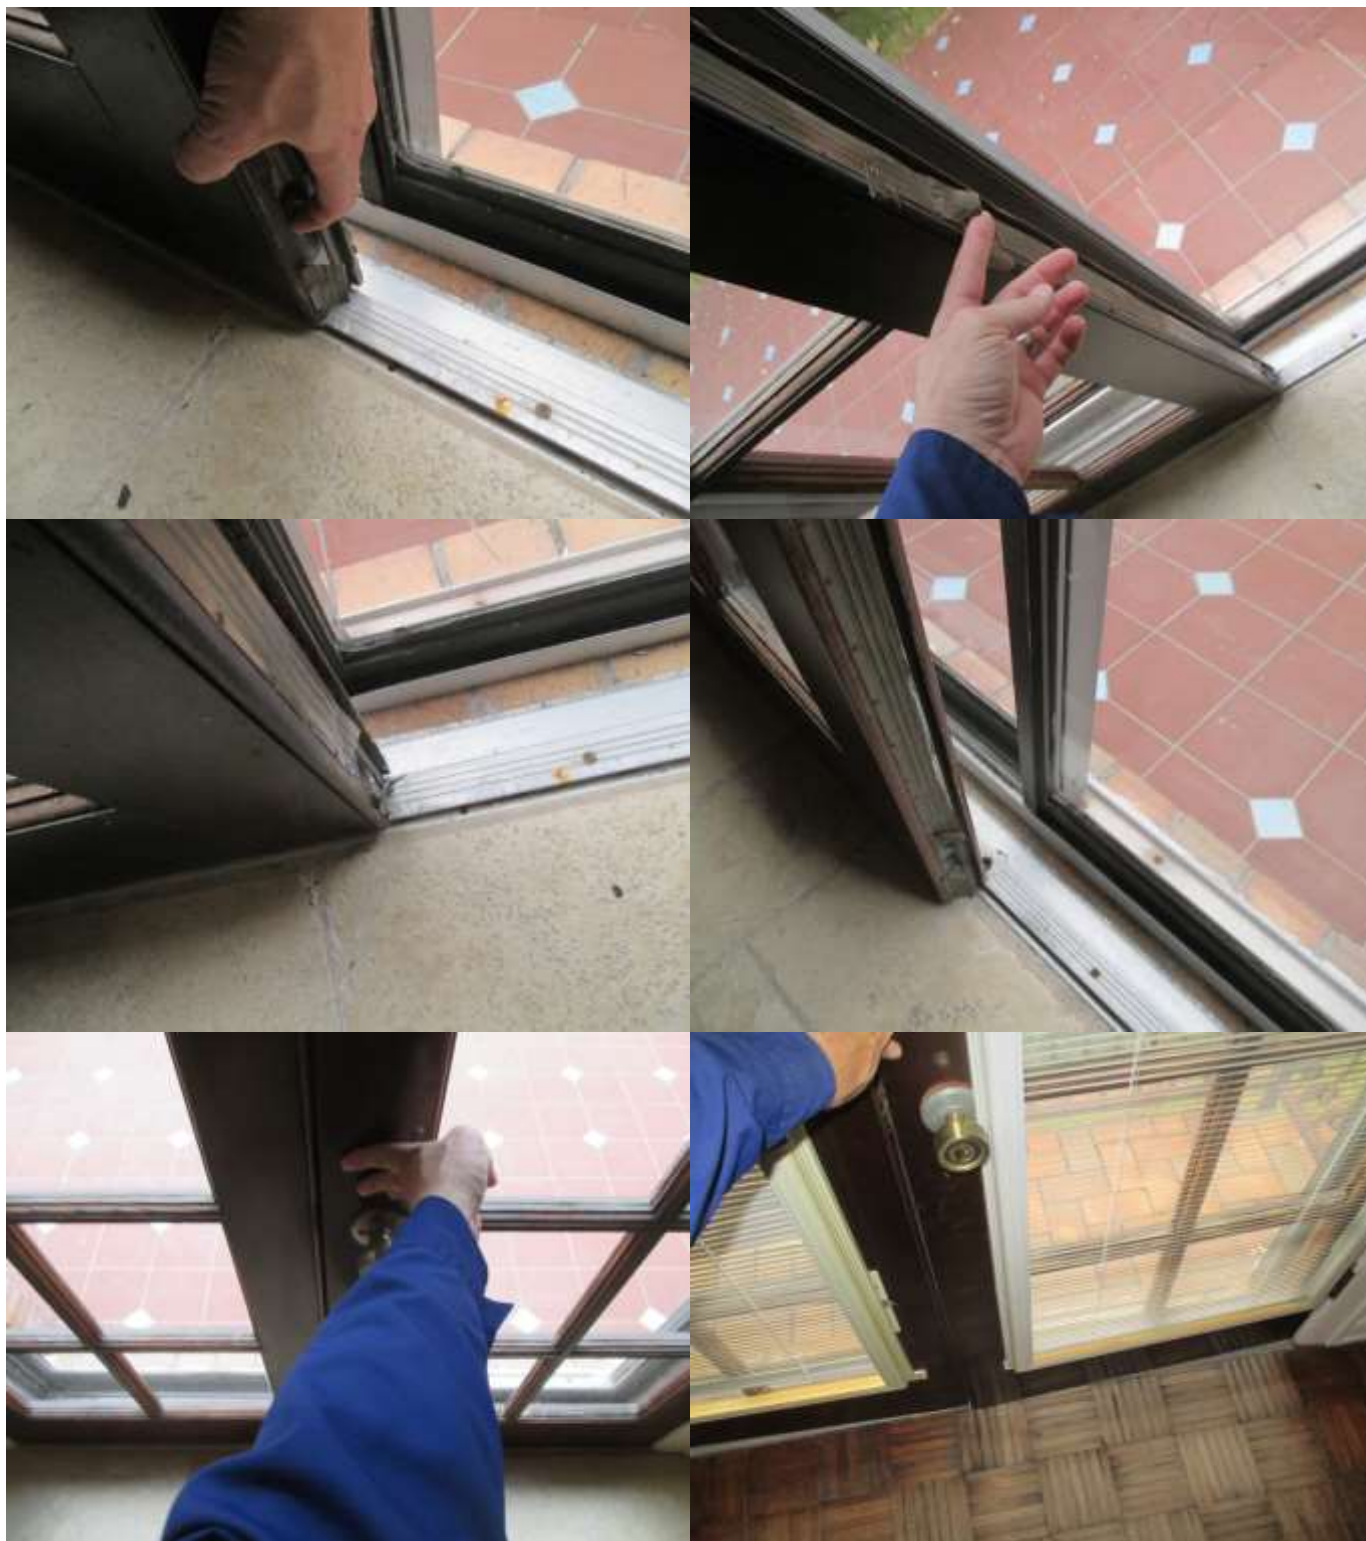
Repair Needed: The bottom latch was stuck in the deployed position on the exterior double doors in the east bedroom. The metal stripping on the side of the door was bent and should be properly secured.

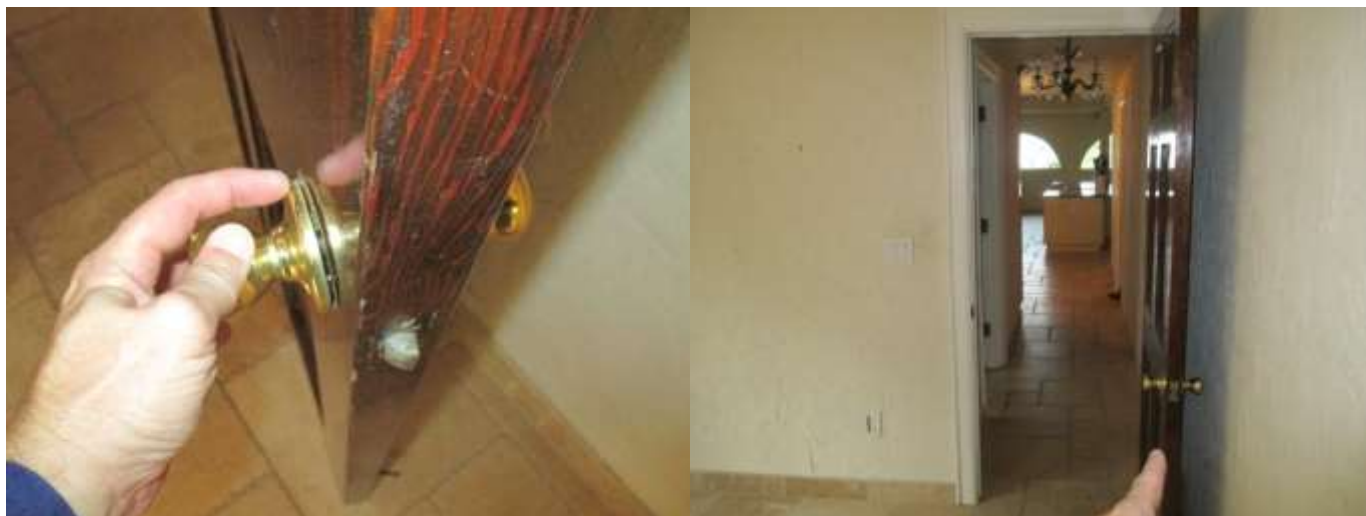
Maintenance Needed: The door knob was loose to the southeast bedroom from the south hall and should be secured.
