INTRODUCTION

GENERAL CONDITION OF DWELLING

The dwelling is a north facing two-story block and framed structure on slab with a hip type roof design. The dwelling was constructed circa 1984.

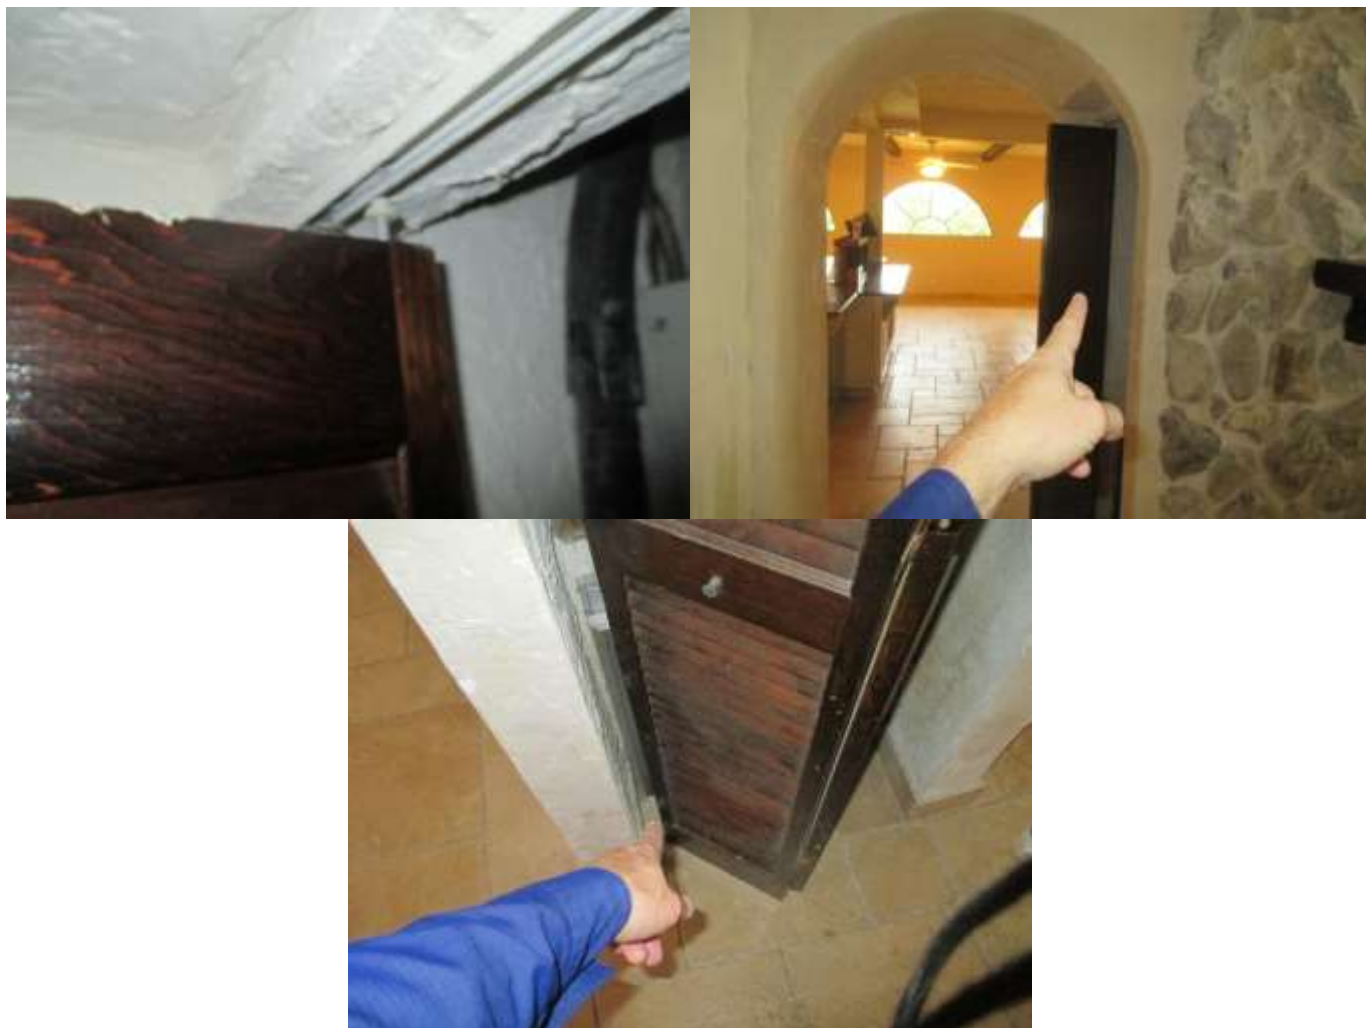
Correction Needed: The air handler closet door (1st floor) was resting on the floor and should be properly secured to ease operation.

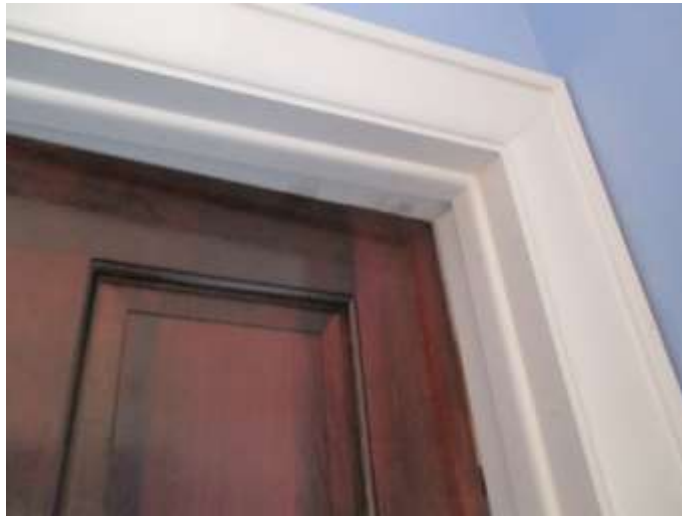
Adjustment Needed: The master bathroom door rubbed against the frame during operation.

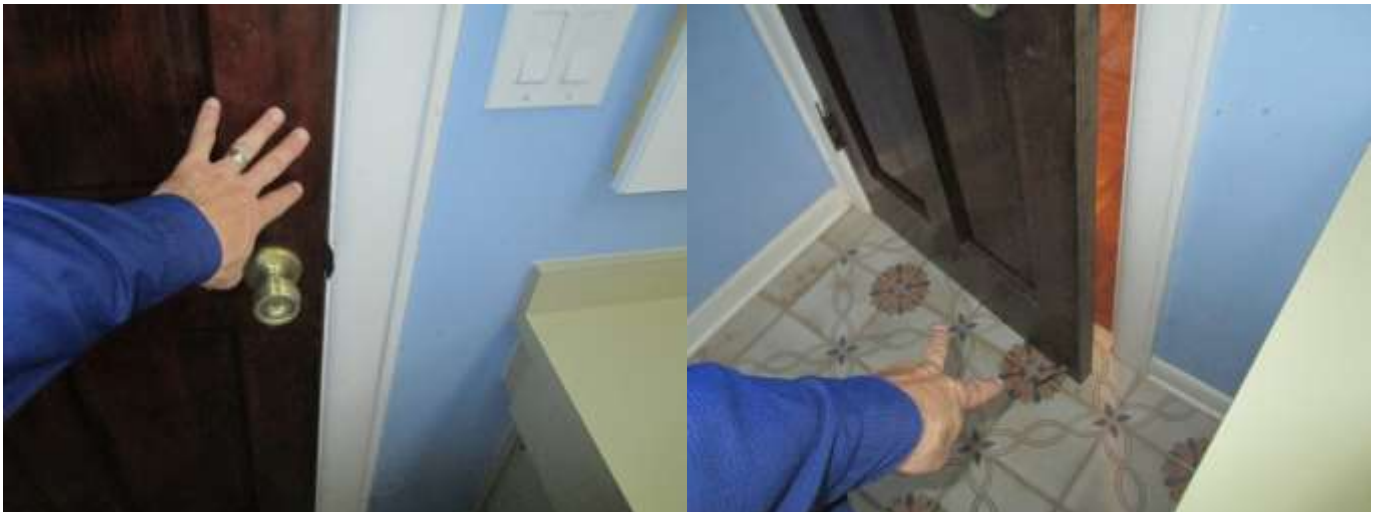
Adjustment Needed: The southeast bathroom door rubbed against the frame and flooring during operation.

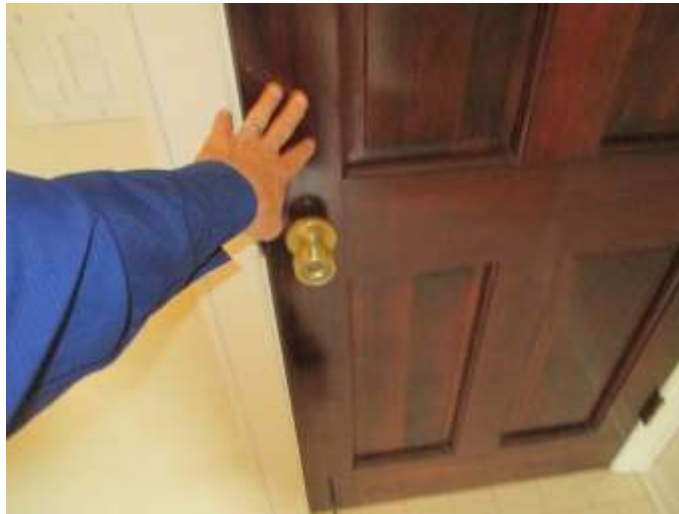
Adjustment Needed: The second-floor hall bathroom should be adjusted latch properly.

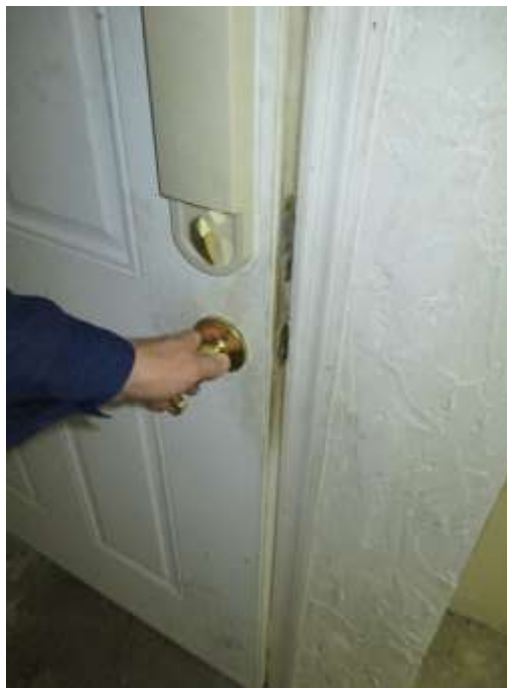
Adjustment Needed: The interior garage door should be adjusted to prevent rubbing against frame.

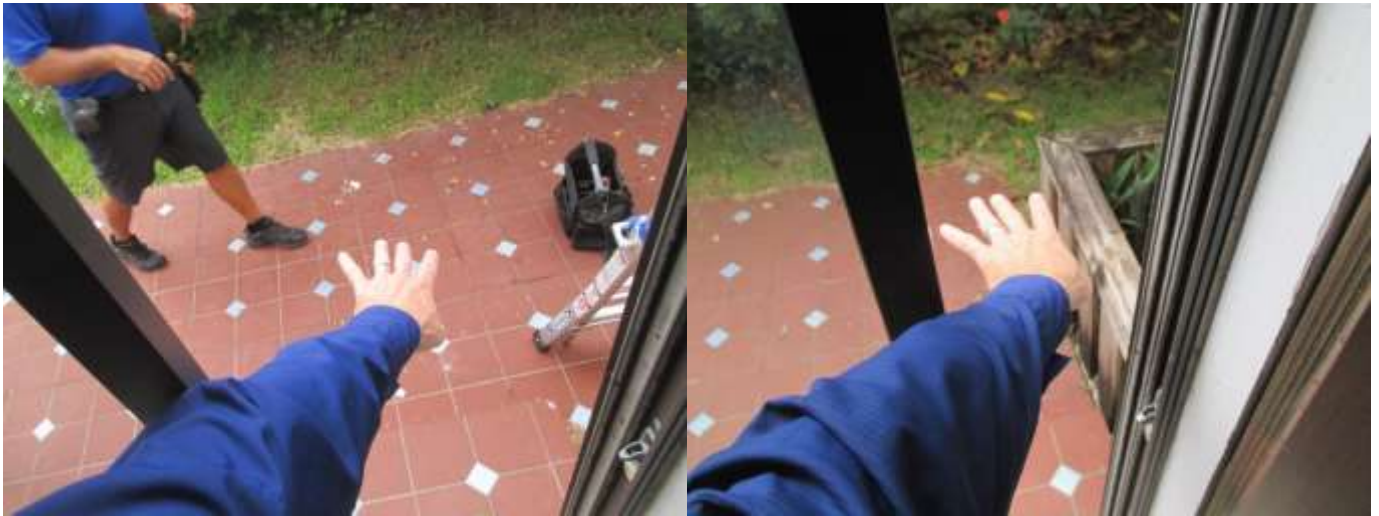
Correction Needed: Screen doors were not installed on the sliding glass doors to the dwelling.

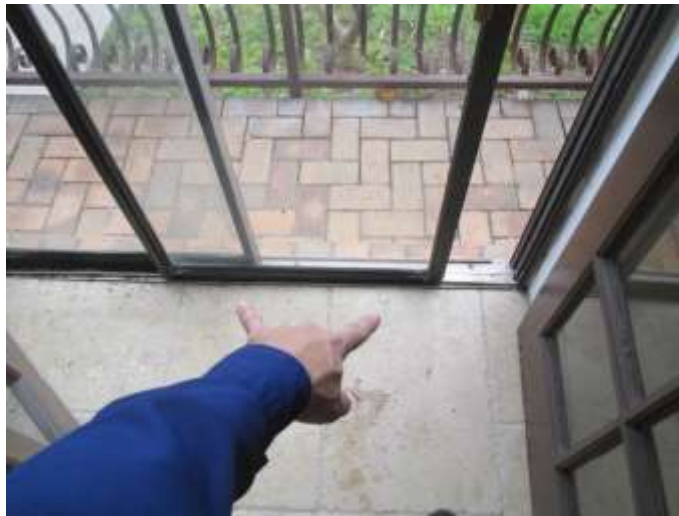
Repair Needed: The sliding glass doors on the north and east walls of the northeast room off of the main hallway did not operate smoothly. We recommend removing the debris from the tracks lubricating them with silicone spray to try and ease operation and may need the track guide rollers replaced.

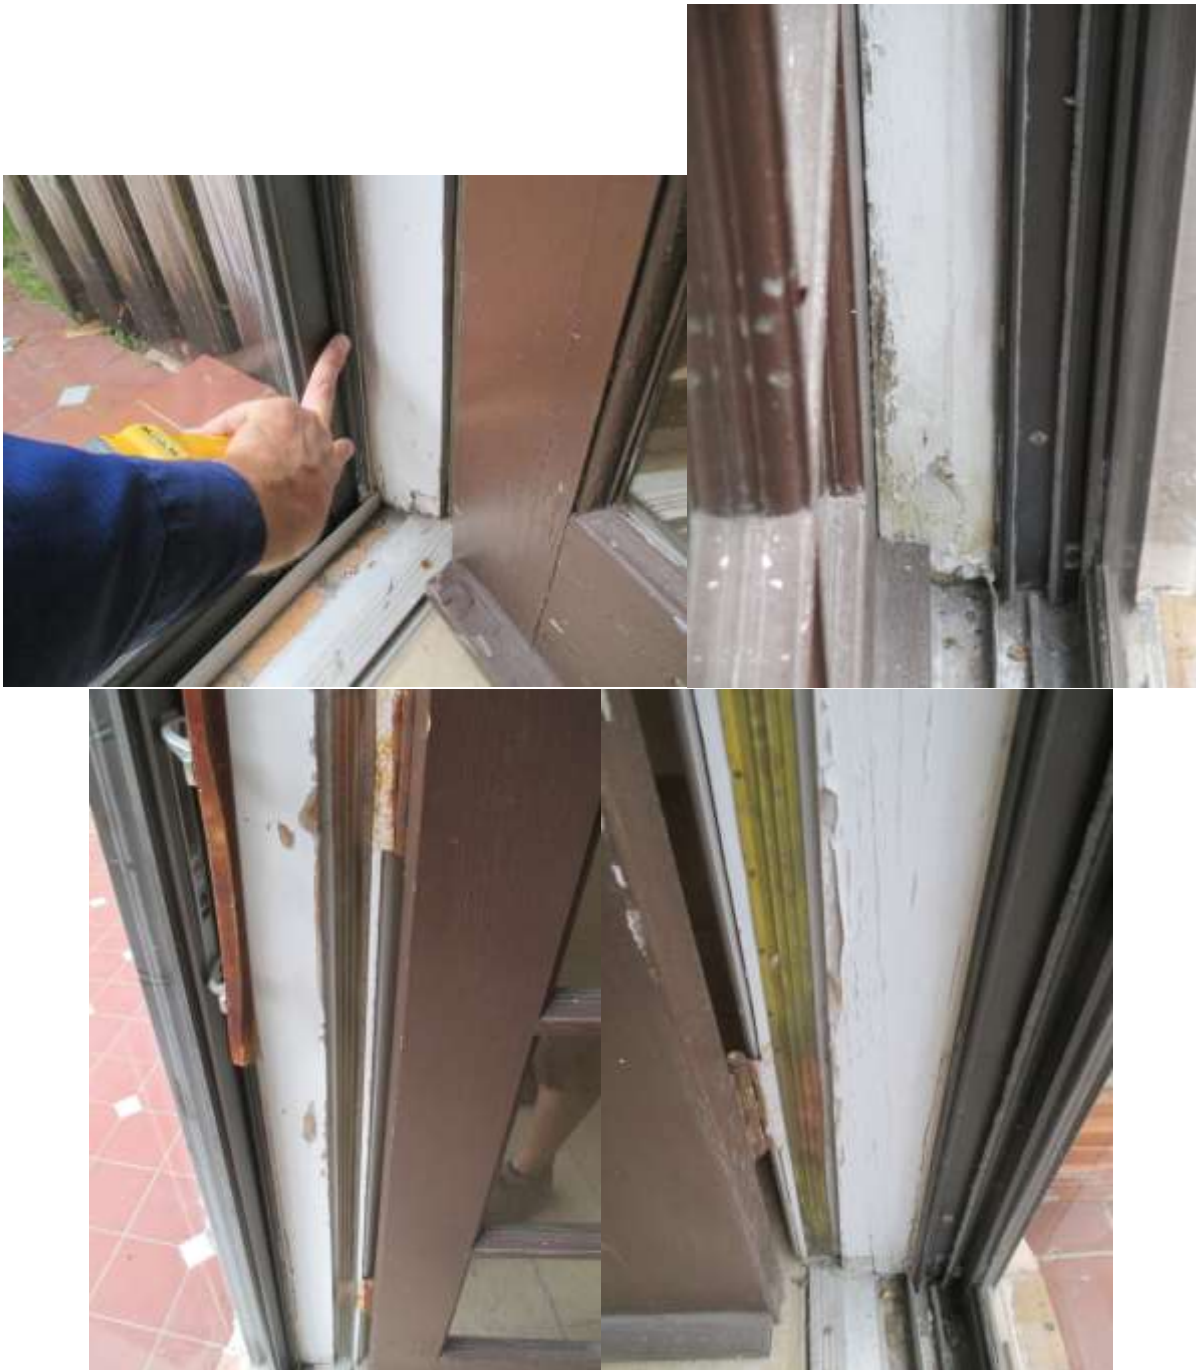
Maintenance Needed: The interior sliding glass door opening should be resealed to help with heating cooling costs.

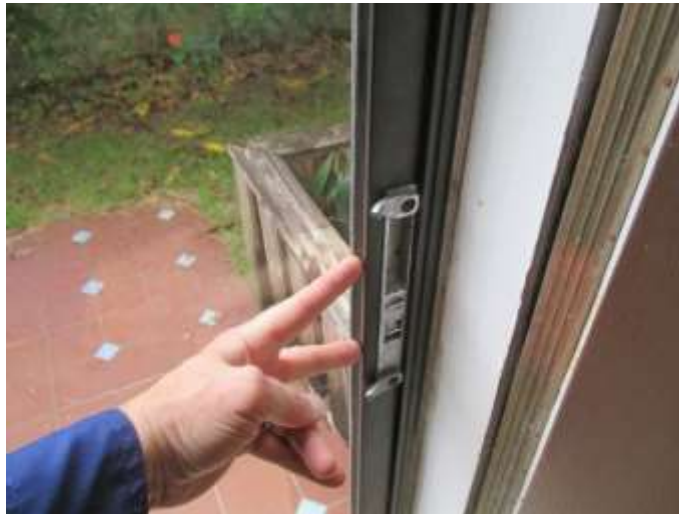
Repair Needed: The handle was damaged on the sliding glass door in the east bedroom.

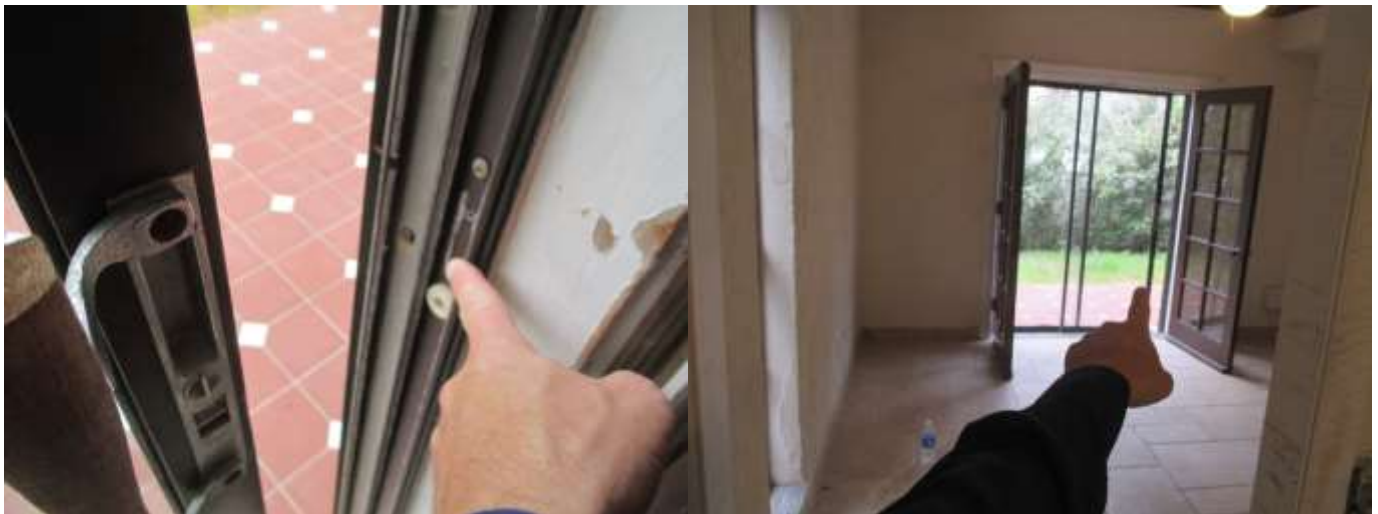
Correction Needed: The receiver was not installed on the south sliding glass door in the southeast bedroom door could not be secured.

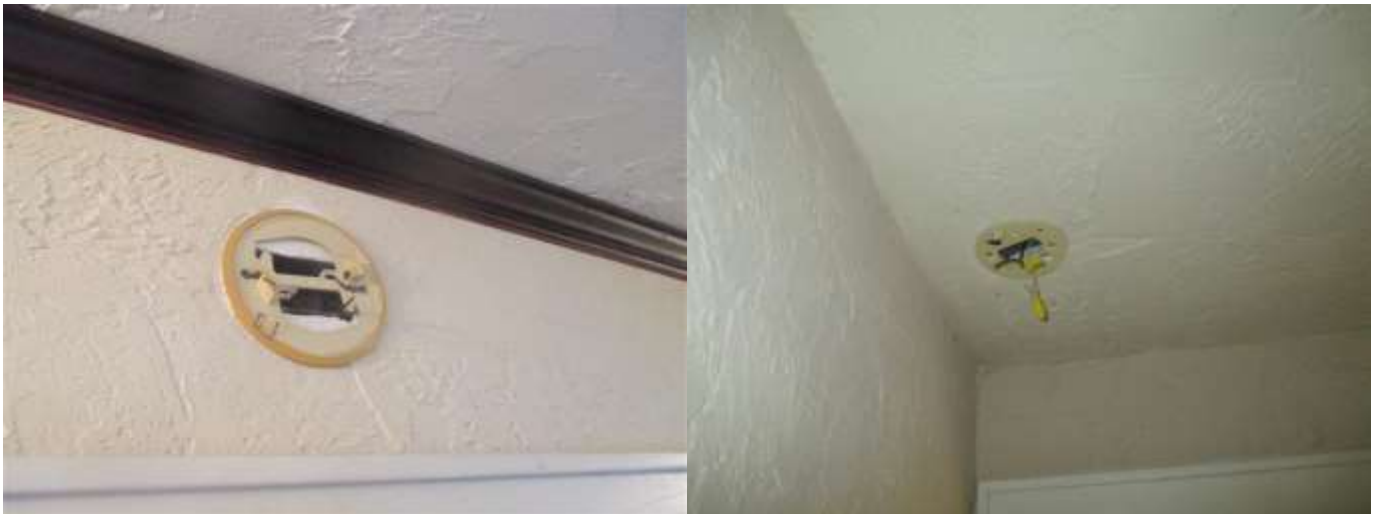
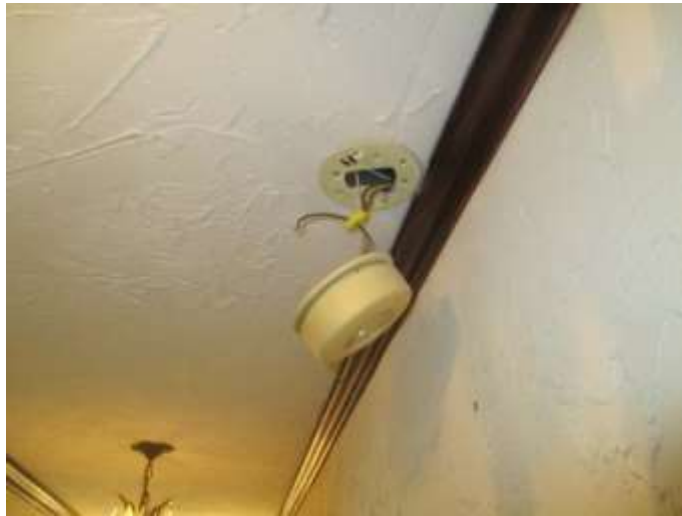
Correction Needed: The smoke detector in the south 1st floor hallway and second floor hallway had been removed. The smoke alarm on the east side of the 2nd floor hallway was hanging by its wiring should be properly secured.

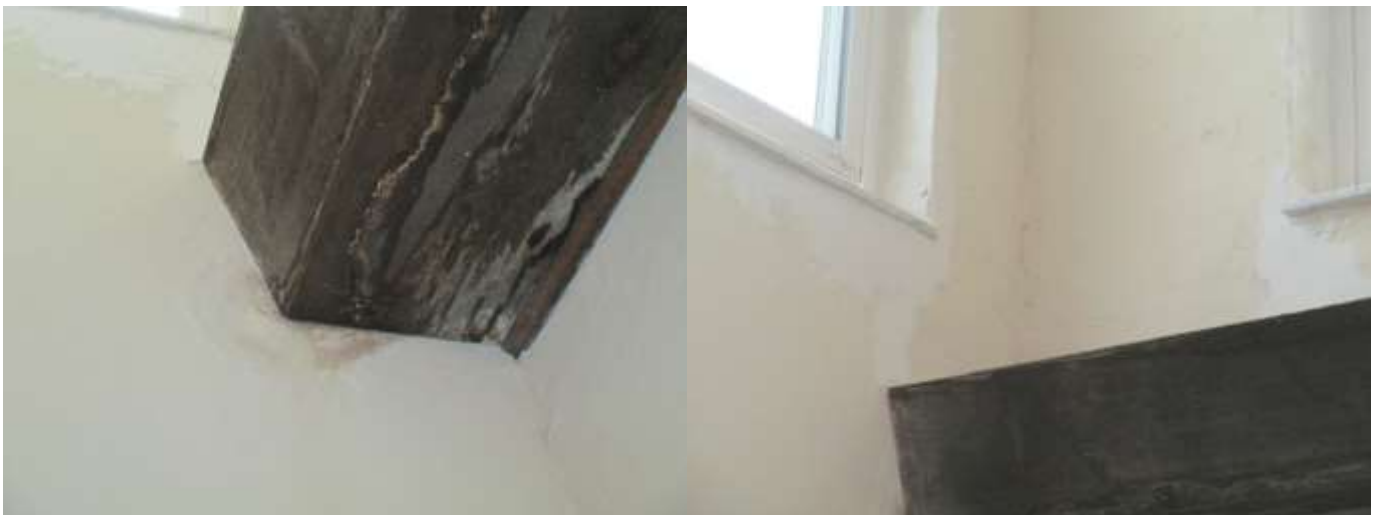
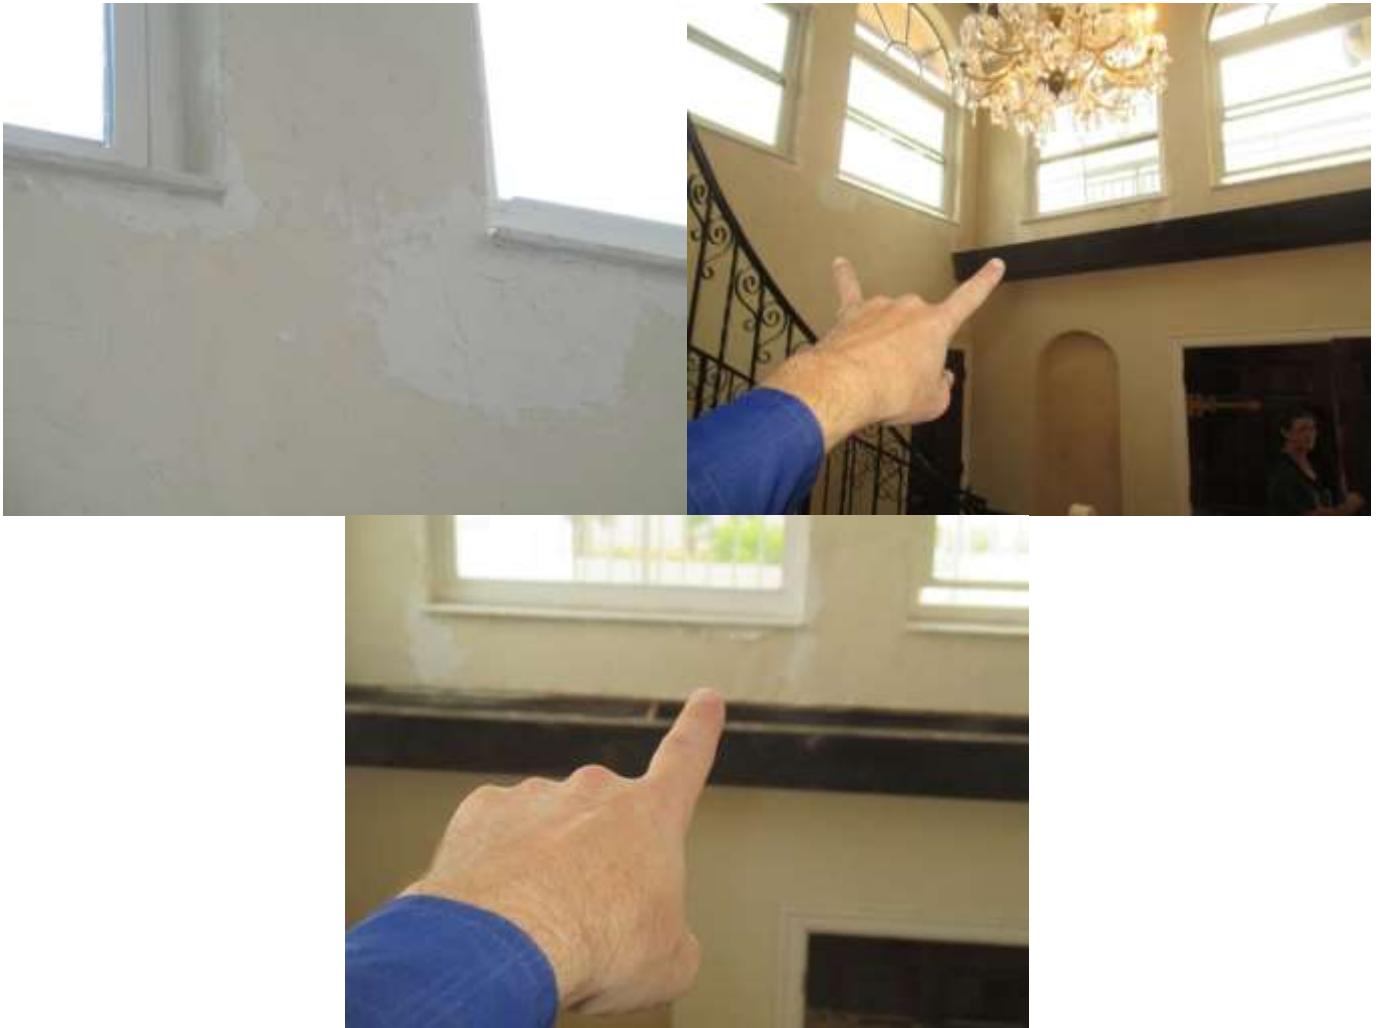
Concern Item: We notice some repairs around the window openings over the north and west walls of the main entry hallway. It appeared that the window opening on the northwest side of the north wall was still actively leaking (see Exterior notes).

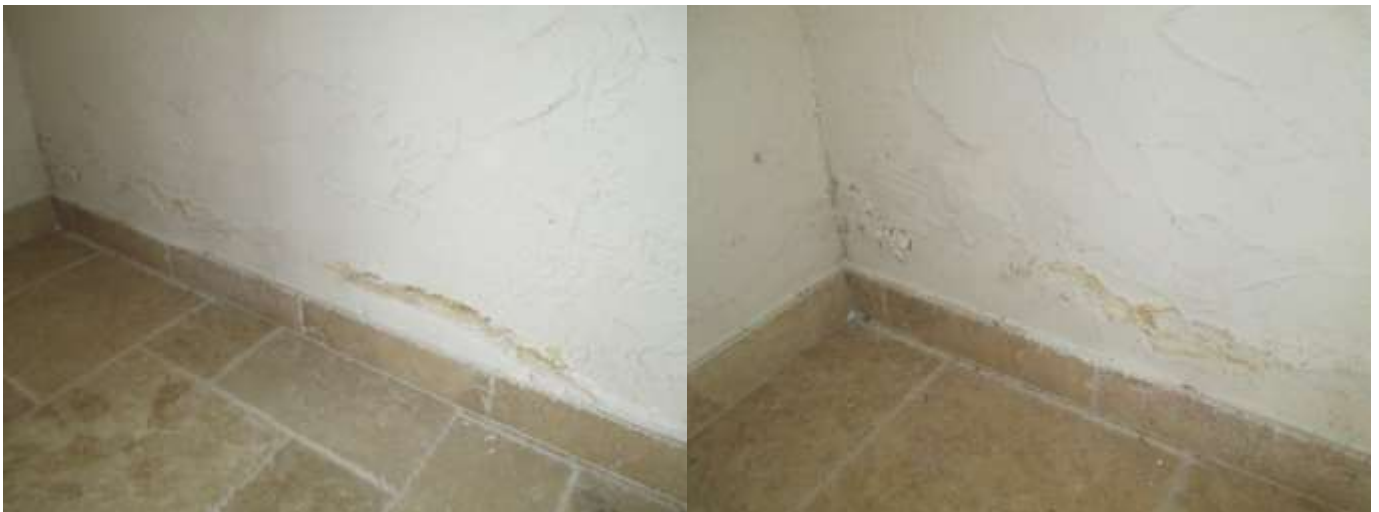
Concern Item: We noted staining to the ceiling and the base of the wall in the northeast corner of the northeast room off of the main entry hallway. These areas tested negative for elevated moisture the time of the inspection.

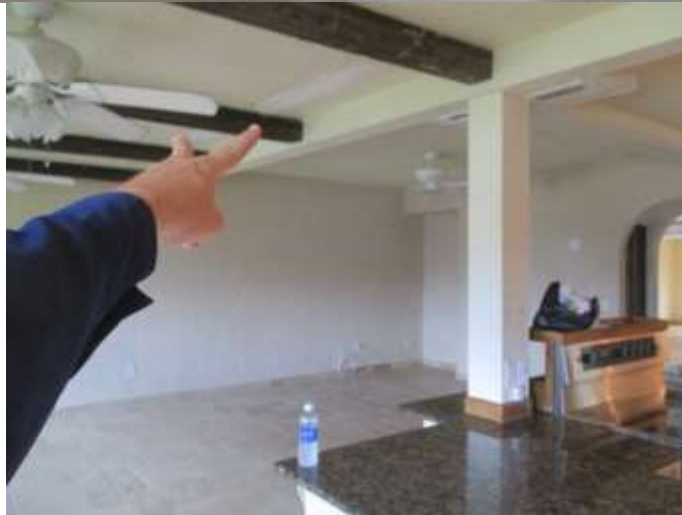
Cosmetic Item: We noted past repairs to the ceiling on the north side of the family room area. These areas tested negative for elevated moisture the time of the inspection.

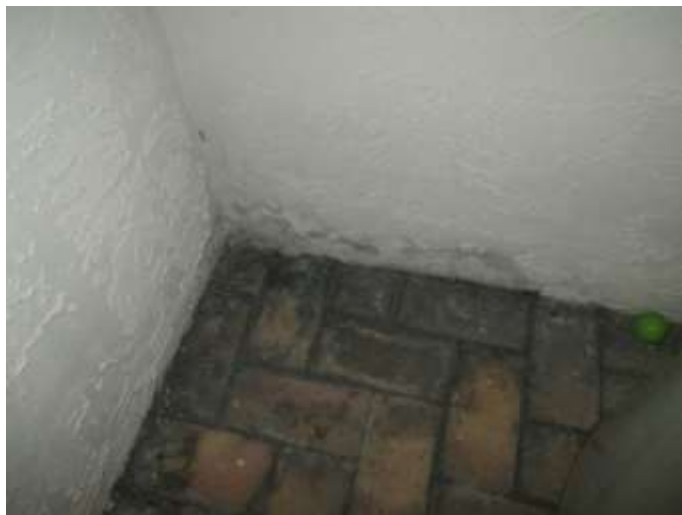
Cosmetic Item: We noted some staining to the wall to the left of the hot water heater unit in the laundry room area. This area tested negative for elevated moisture at time the inspection.

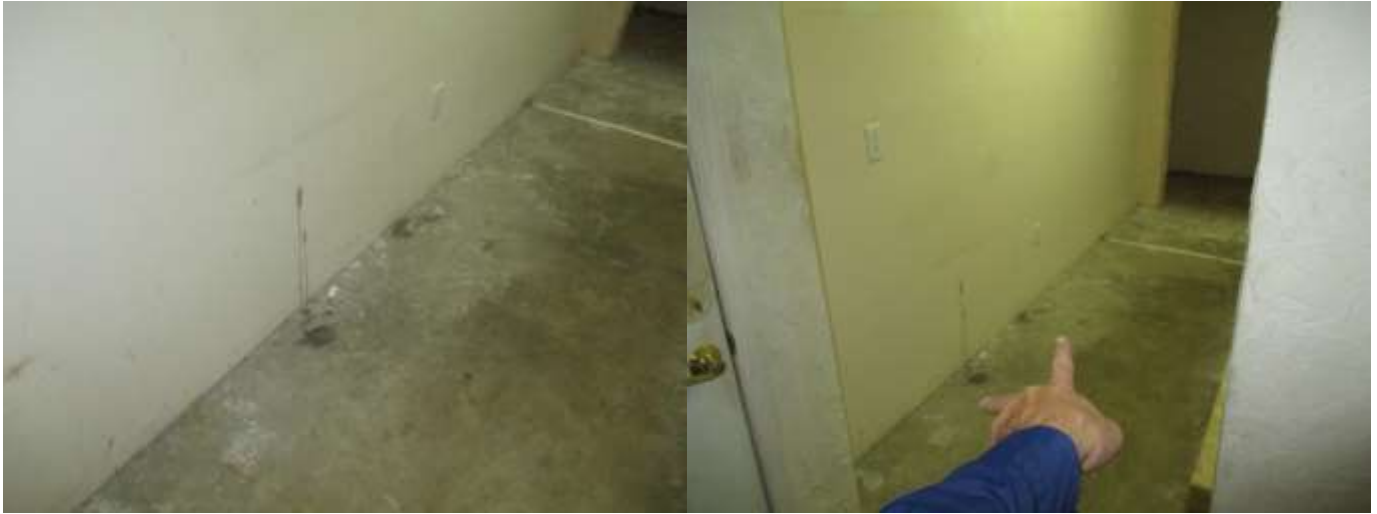
Correction Needed: We noted that the drywall along the west wall of the laundry room was in direct contact with the ground and should be cut to correct this.

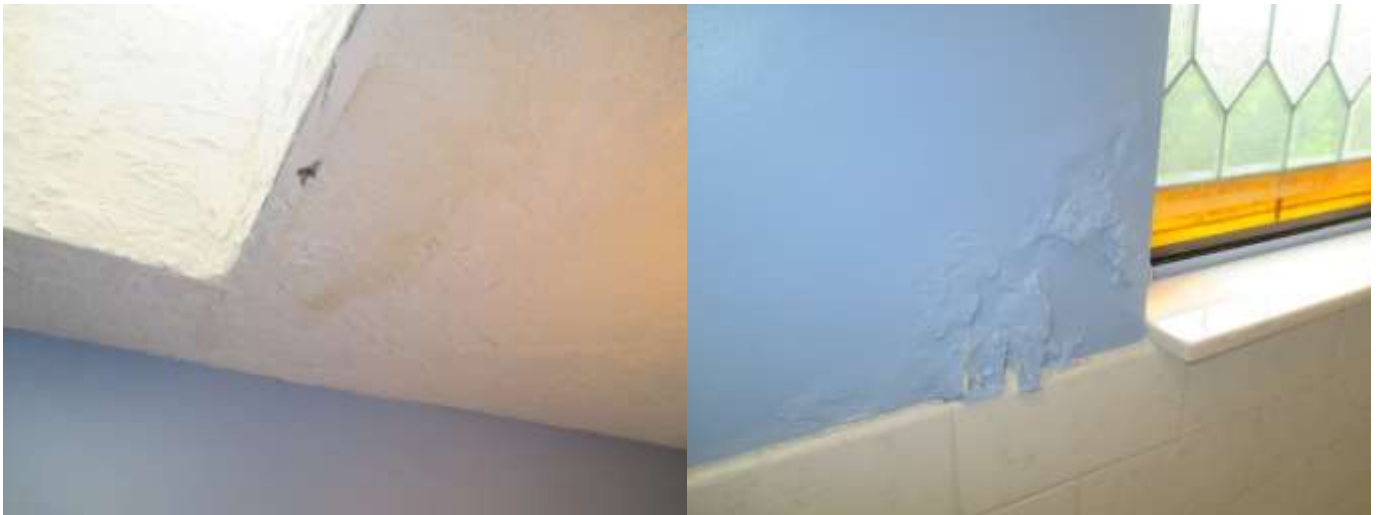
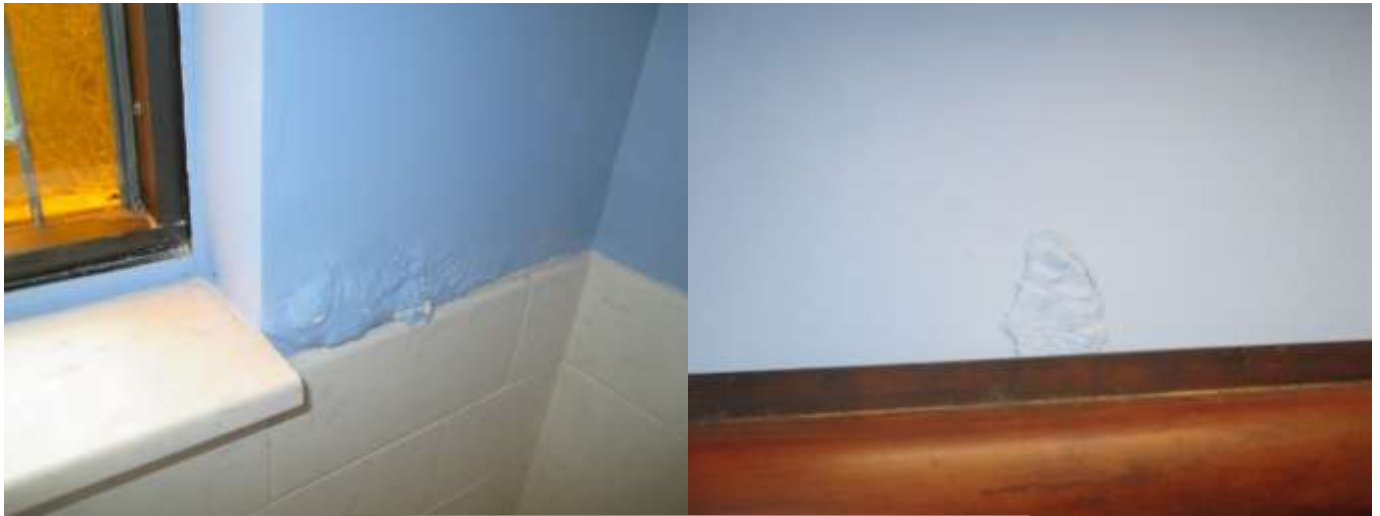
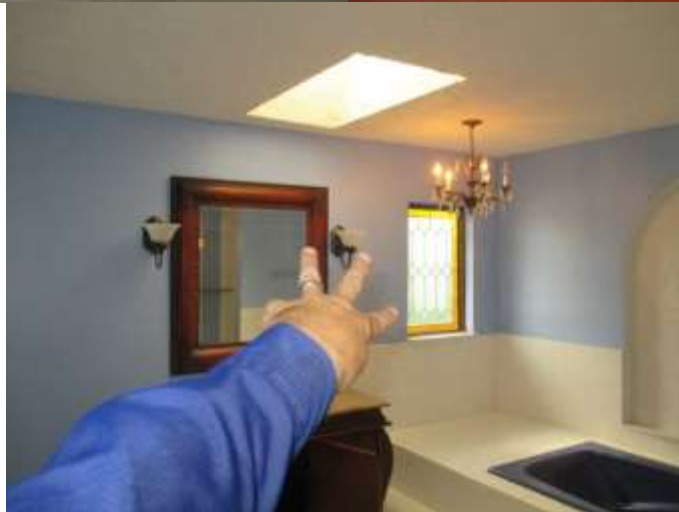
Concern Item: We noted damage to the plaster around the master bathroom window, around the skylight opening and above the mirror over the left sink. Though these areas tested negative for elevated moisture the time of the inspection recommend periodically monitoring this area (see Exterior and Roof notes).

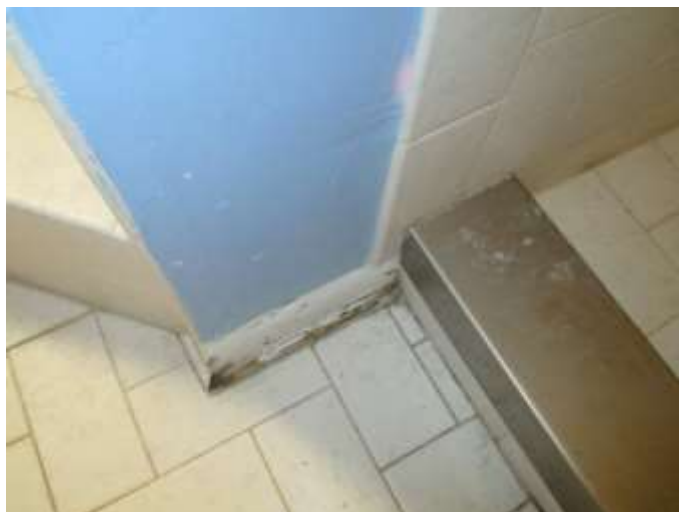
Maintenance Needed: We noted some staining on either side of the threshold to the master bathroom shower. These areas tested negative for elevated moisture the time the inspection should be resealed to prevent further damage.

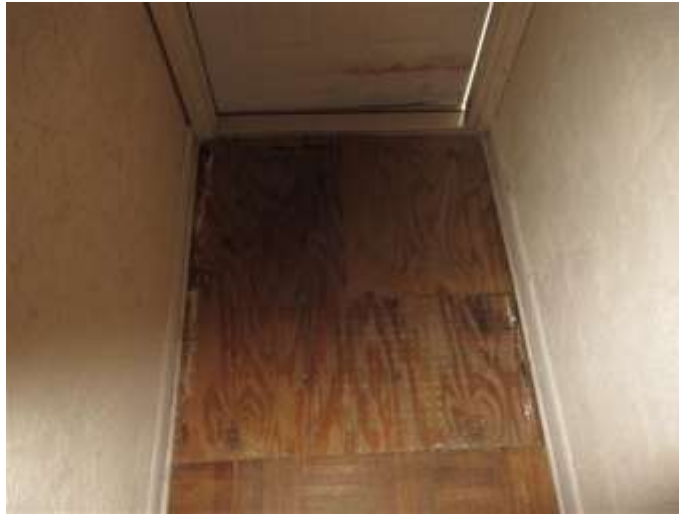
Repair Needed: The floor coverings at the west end of the second-floor hallway were missing.

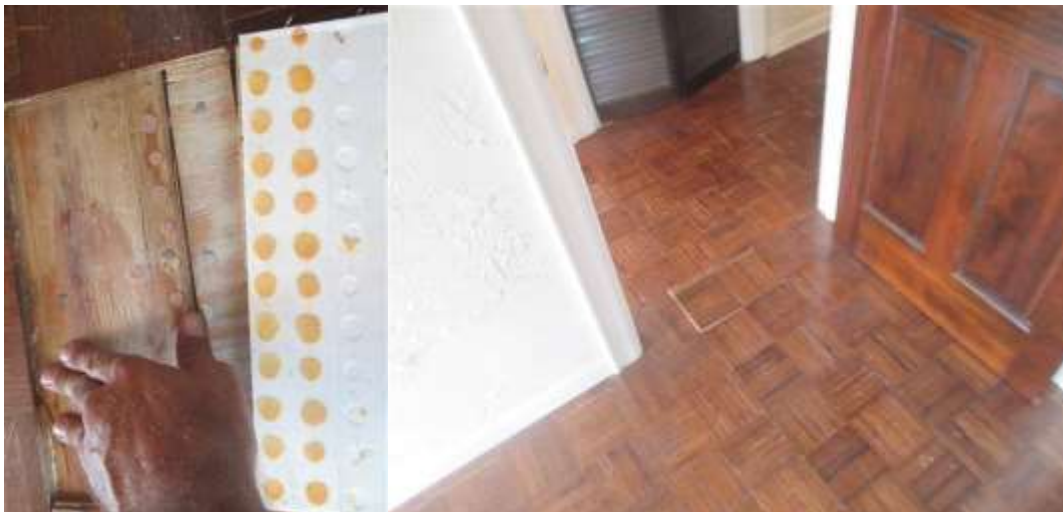
Repair Needed: At the doorway to the southwest bedroom, we noted that the wood flooring was raised. The subfloor below this area will need to be leveled.

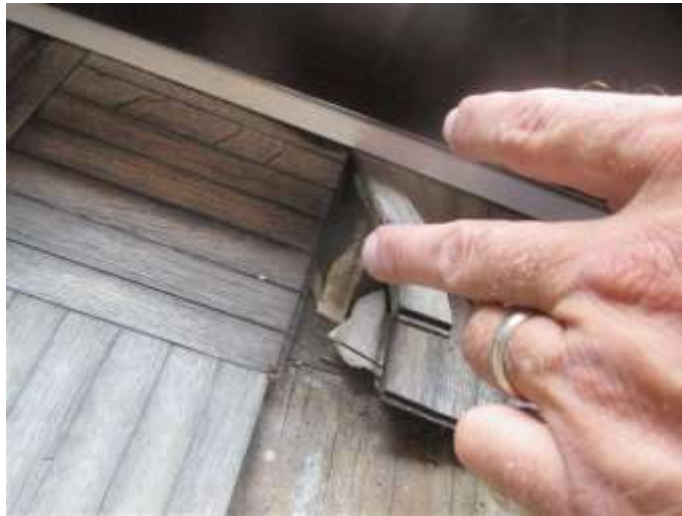
Repair Needed: We noted deterioration and staining to the wood flooring at the threshold for all of the exterior bedroom doors.

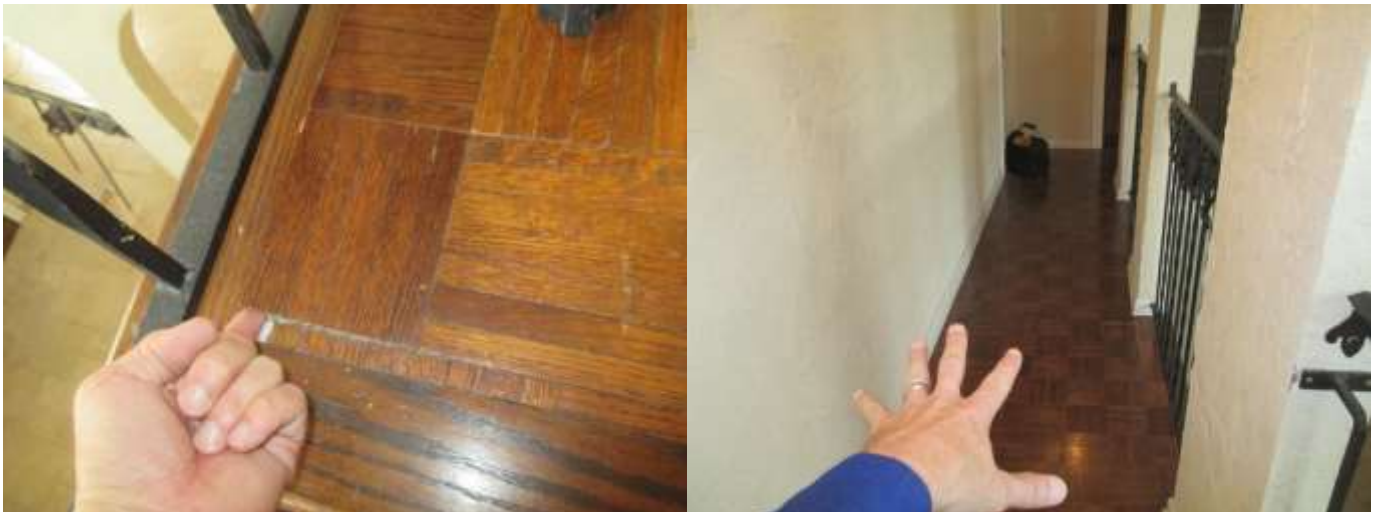
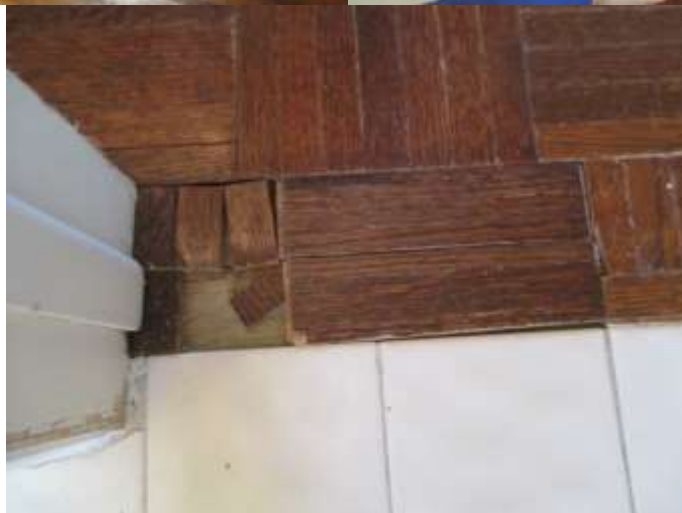
Repair Needed: We noted loose flooring randomly throughout the 2nd floor.

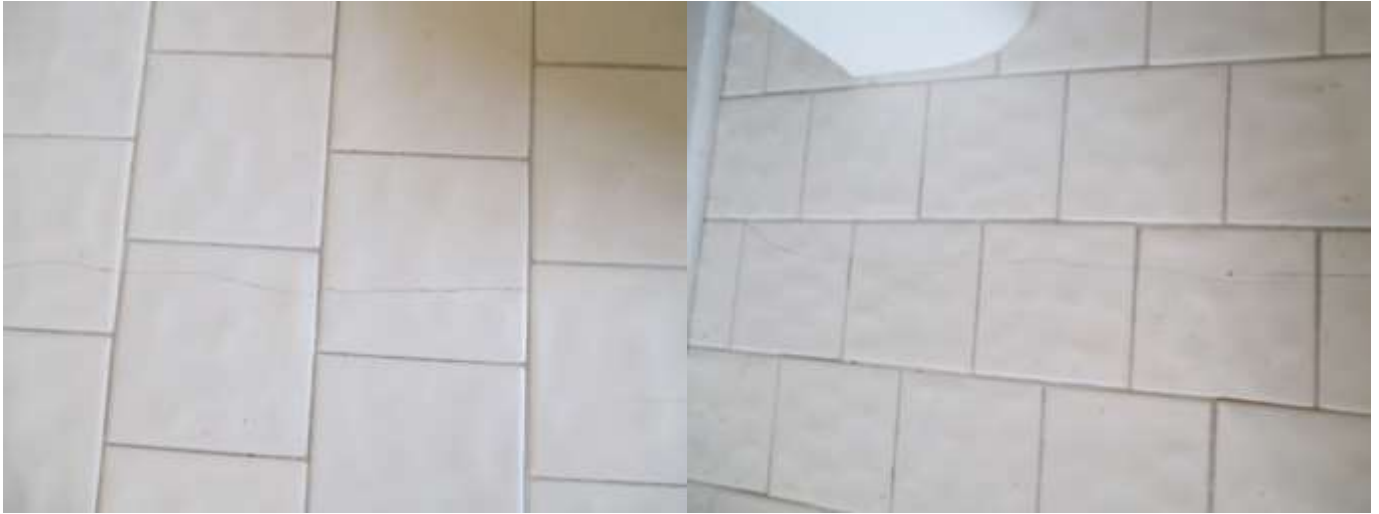
Maintenance Needed: Noted some cracking in the tile flooring in the second-floor hall bathroom that should be resealed and/or replaced to prevent moisture intrusion.

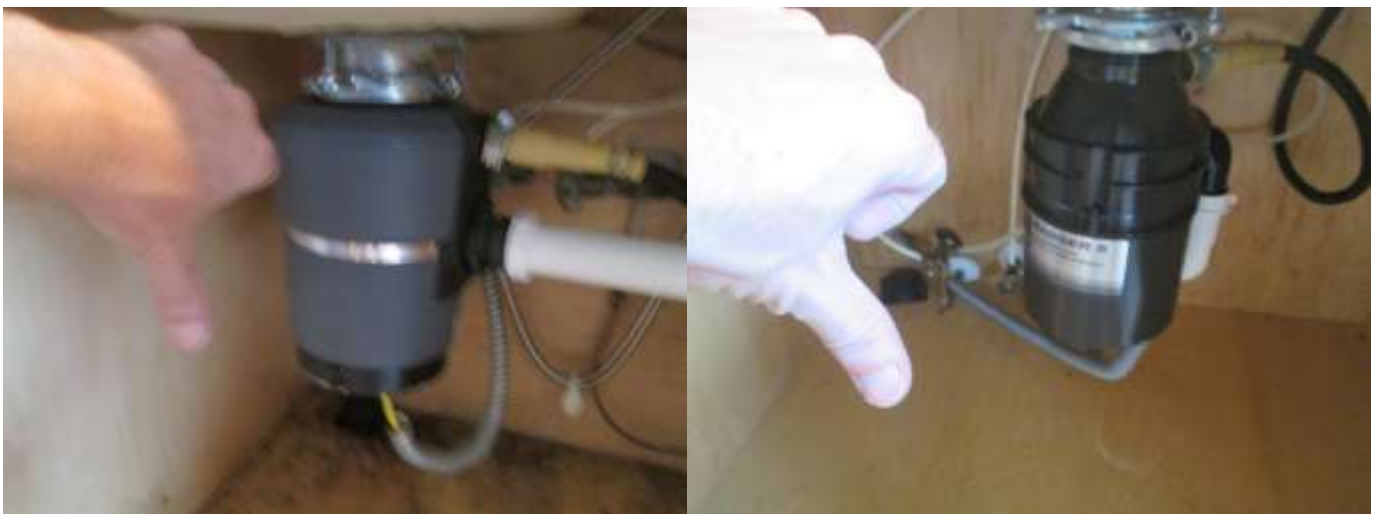
Repair Needed: Both of the kitchen food disposals were not operational the time of the inspection.

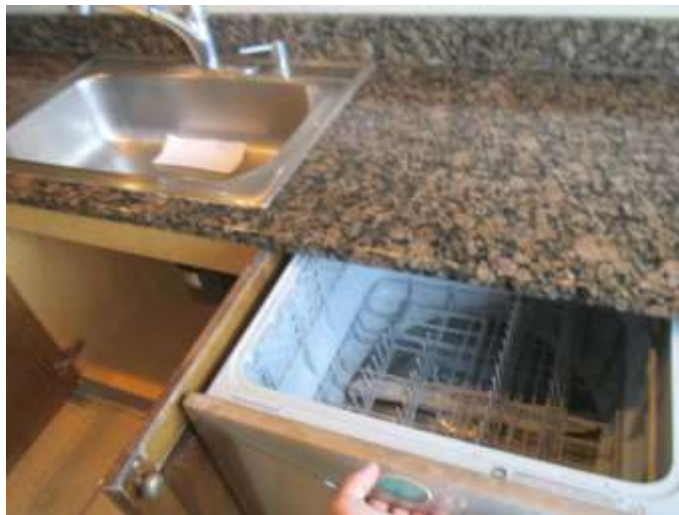
General Information Item: The right dishwasher was not able to be operated at the time of the inspection due to the sink backing up and recommend having this operational at final walk-through.

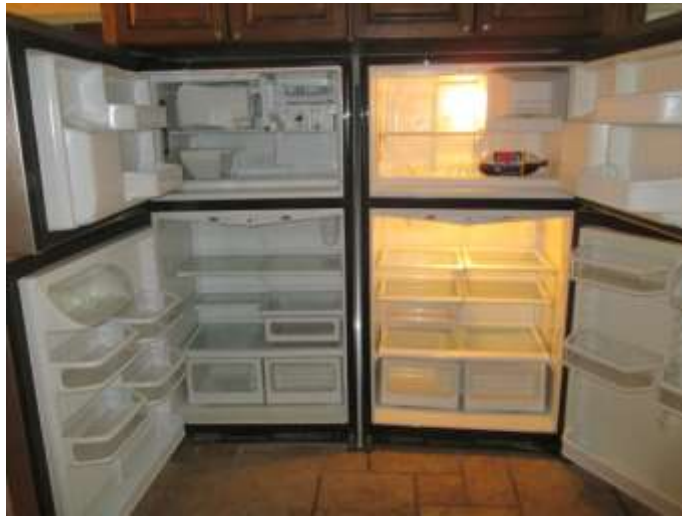
For General Information: The refrigerator was turned off or unplugged at the time of inspection. There was insufficient time during inspection to test the functioning of this unit. We recommend having the unit turned on 24 hours prior to final walk-through so it can be checked at the final walk-through.

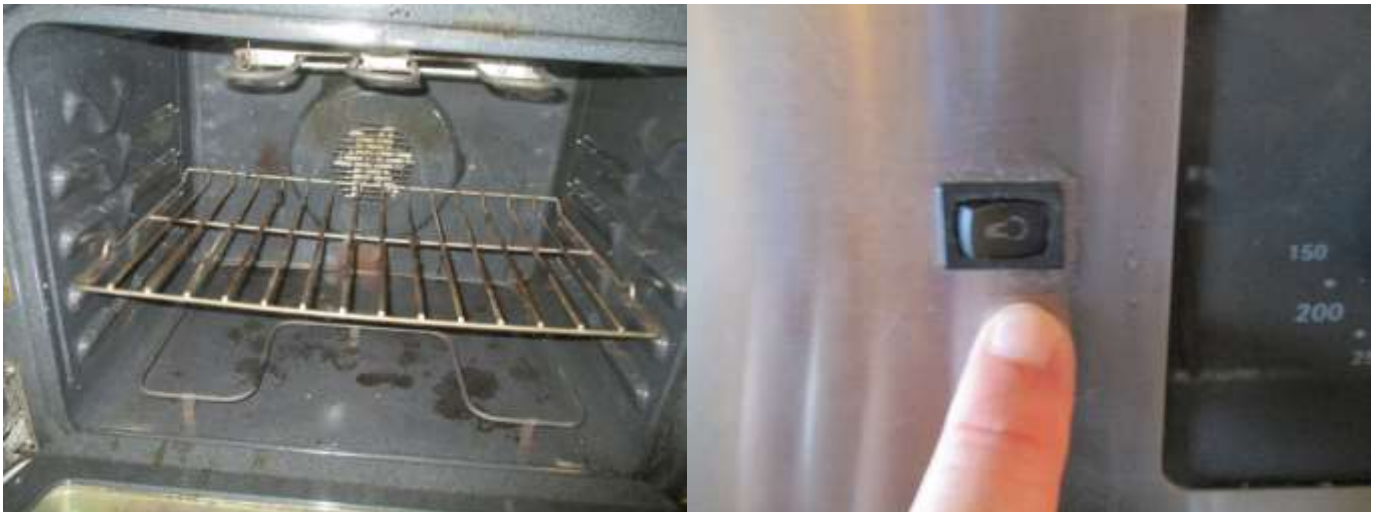
Repair Needed: The oven light (in the island) was not operational at time of the inspection likely needs the light bulb replaced.

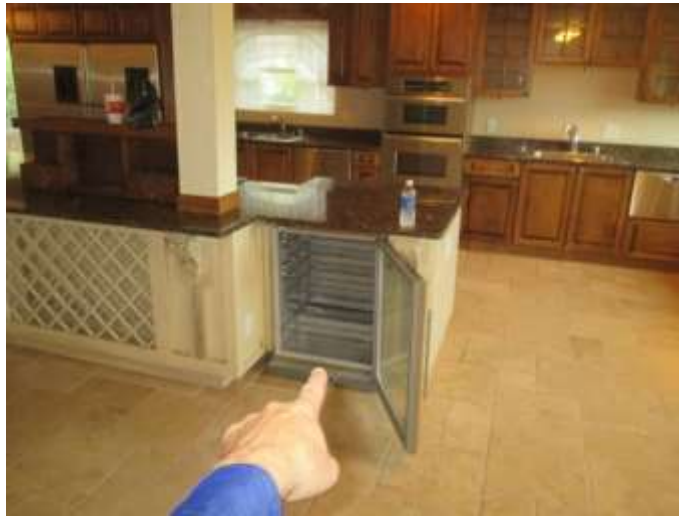
Repair Needed: Wine cooler on the north side of the kitchen island did not appear to be operational.

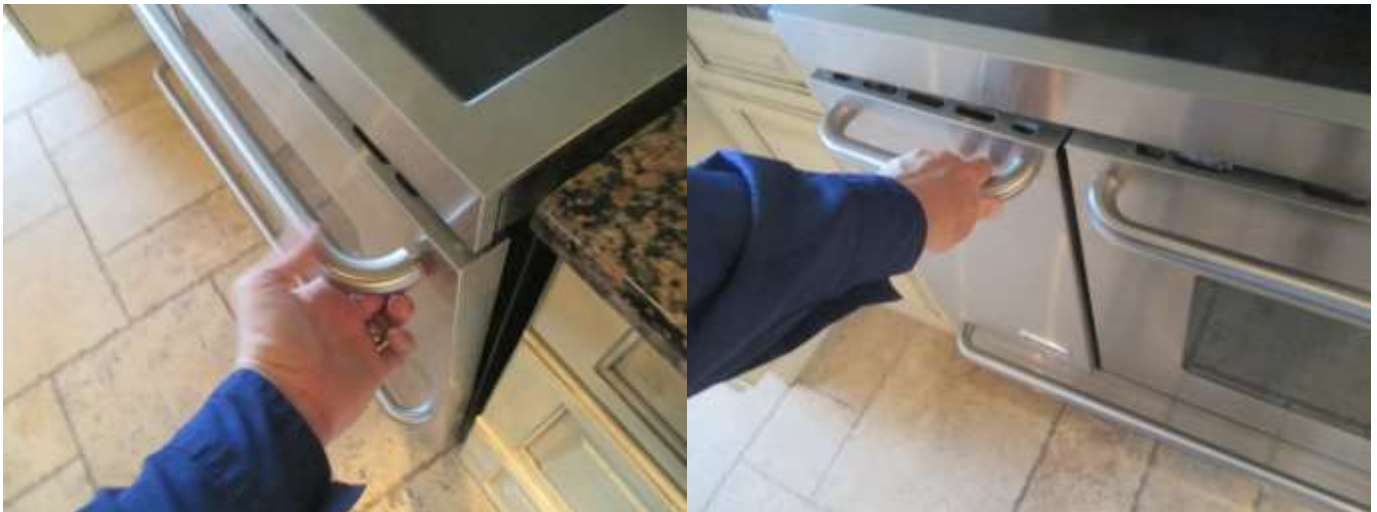
Maintenance Needed: The islands oven handle was loose and should be secured. The small oven door should be adjusted to close properly.
